CHRISTCHURCH CITY COUNCIL
BU 3522-001 EQ2
Lyttelton Library
18 Canterbury St, Lyttelton

QUANTITATIVE ASSESSMENT REPORT

- Revision C
- 13 September 2013

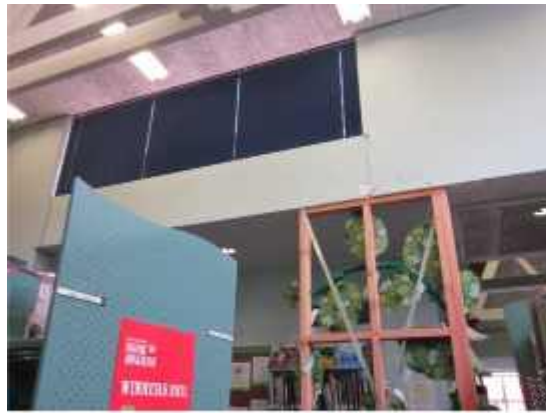
PHOTO 18: Temporary propping of the ceiling on grid line 4.

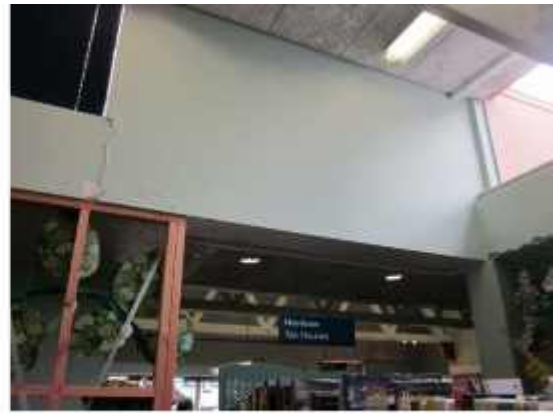
PHOTO 19: Temporary propping of the ceiling on grid line 4.

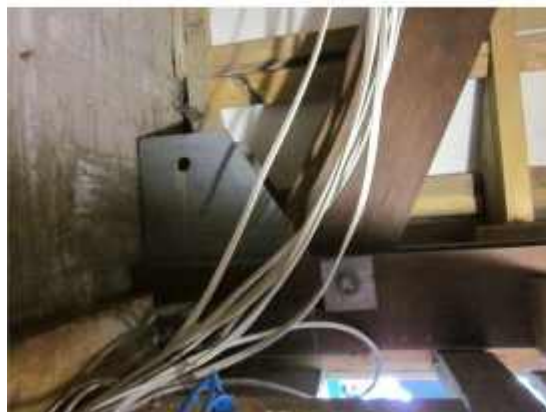
- Cracking of concrete shear walls both internally (the most critical location being the cracking in the wall in the vicinity of the timber truss support near the grid intersection D/5) and externally.

PHOTO 22: Supporting bracket to roof truss T3 – grid D/5

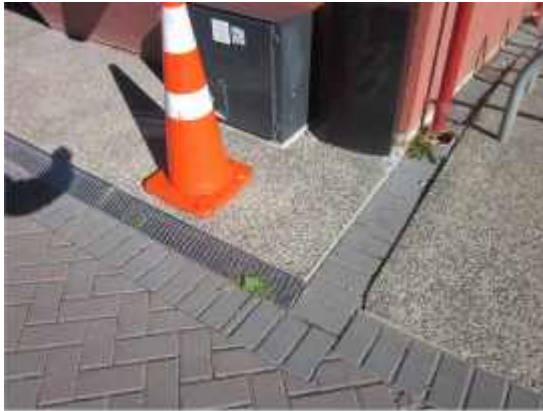
- 4) Minor settlement is apparent due to the levels differences in the paving adjacent to the building. The architectural drawings appear to indicate an existing retaining wall in front of the building which supports the footpath in front of the building. If this retaining wall is of the same age as the retaining wall in front of the adjacent Service Centre building then the footpath settlement which is noted further later in this report may indicate that the wall has started to fail and full collapse may be of concern and so further investigation of the existing retaining wall should be undertaken. Refer to photo 32.

PHOTO 32: View of visible settlement between the structure and the adjacent paving

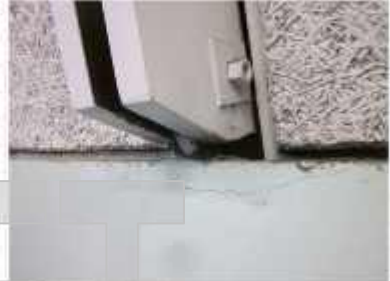
Photo of crack monitoring locations 34 & 35

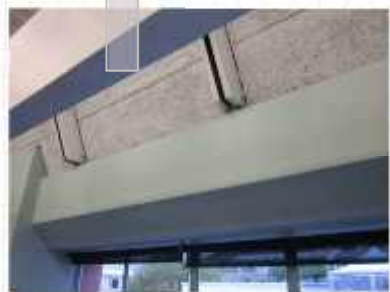
General view on concrete lintel

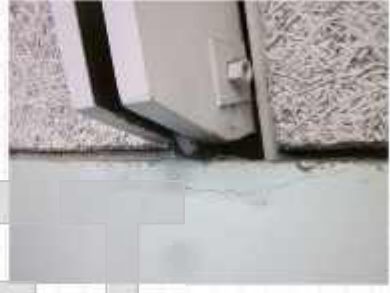
Photo of crack monitoring locations 34 & 35
