Manse Place Housing Complex  
Qualitative Engineering Evaluation

**Reference:** 232537  
**Prepared for:**  
Christchurch City Council

Functional Location ID: BE 0414 EQ2

Address: 319 Main North Road

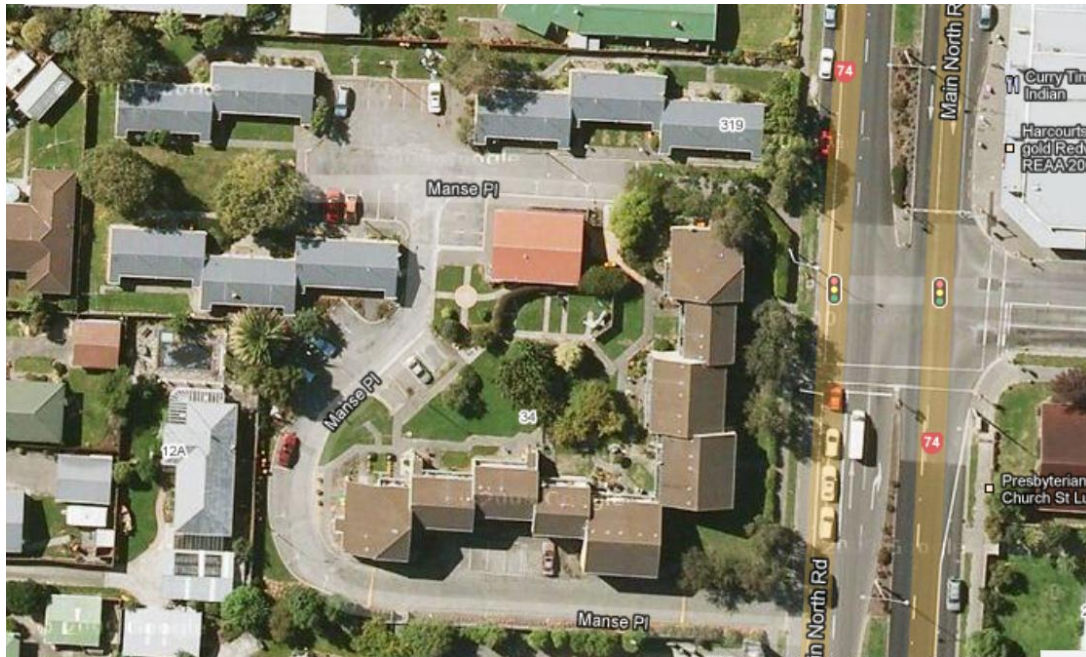
- Some cracks were found in the exterior cladding (Photos #1).
- A few cracks were found in the interior Gib lining.
- The roof structure was inspected locally by accessing a trap tile and appeared to be in good condition in the area inspected.
- A floor level survey using the zip level was carried out on the slab-on-grade and structural slab and has shown that the levels do not exceed DBH guidelines limits (see Appendix A).

<p>#1.</p>	<p>Cracking on exterior cladding of block A at Manse Place Housing Complex.</p>

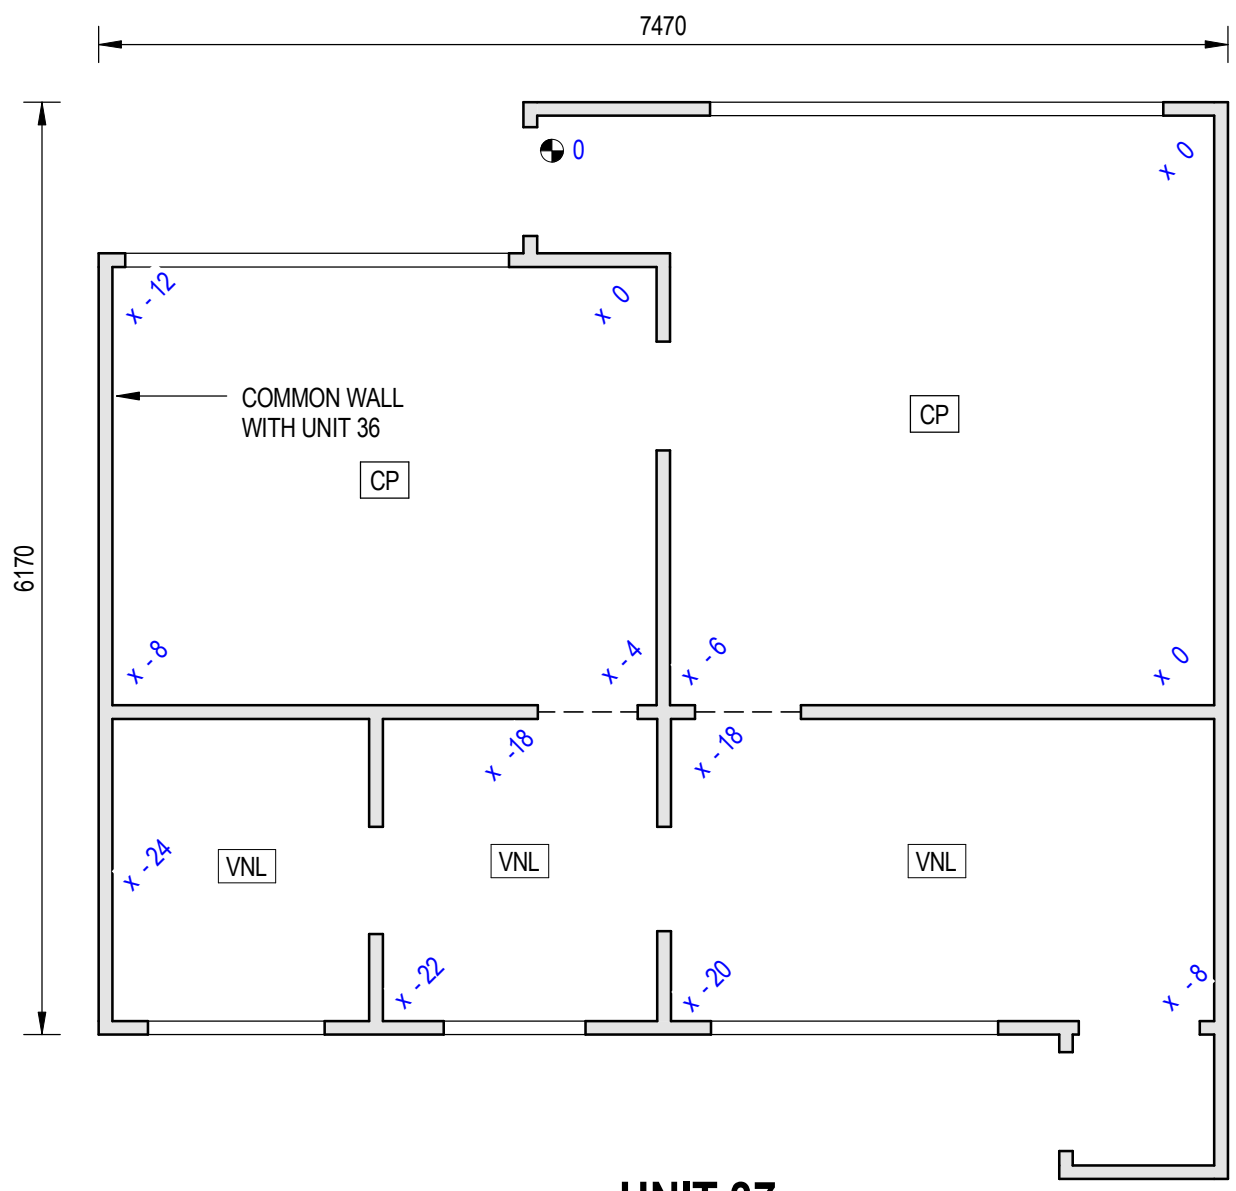
PRELIMINARY NOT FOR CONSTRUCTION	
PROJECT No. 232537	
SCALE 1:50	SIZE A4
DRAWING No. SK-036	REV A

PROJECT	
Manse Place -325 Main North Road	
TITLE	
LEVEL SURVEY - UNIT 36

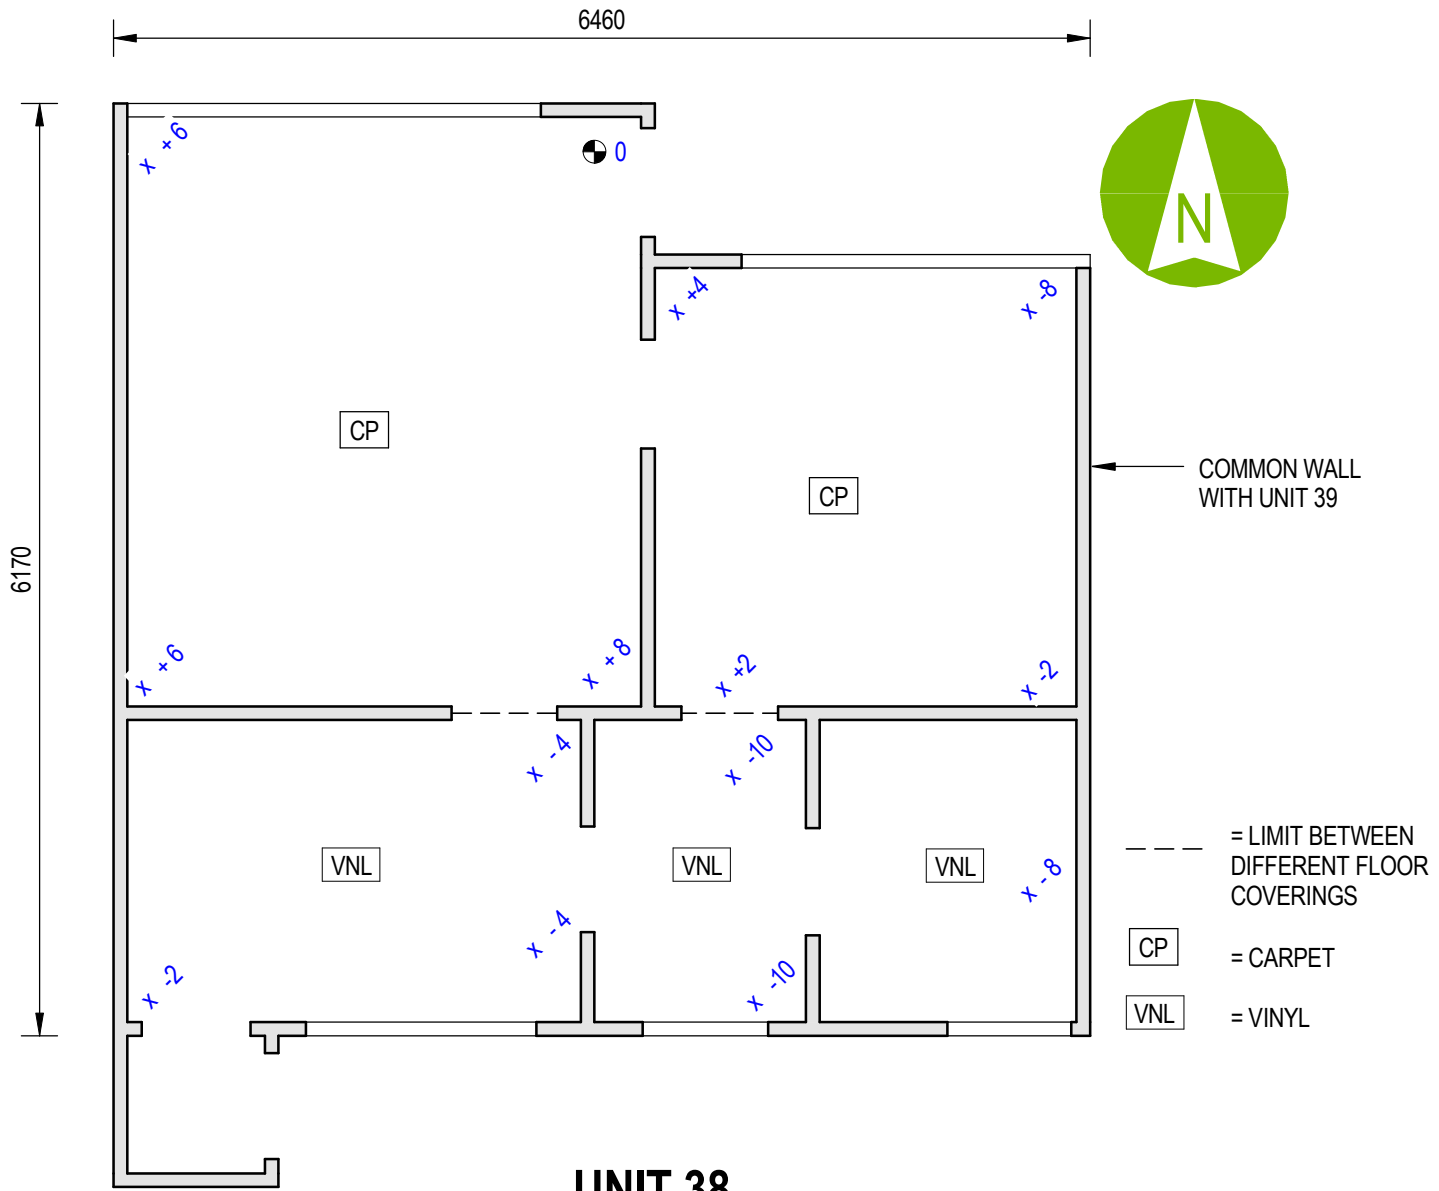
PRELIMINARY NOT FOR CONSTRUCTION	
PROJECT No. 232537	
SCALE 1:50	SIZE A4
DRAWING No. SK-037	REV A

PROJECT	
Manse Place -325 Main North Road	
TITLE	
LEVEL SURVEY - UNIT 37

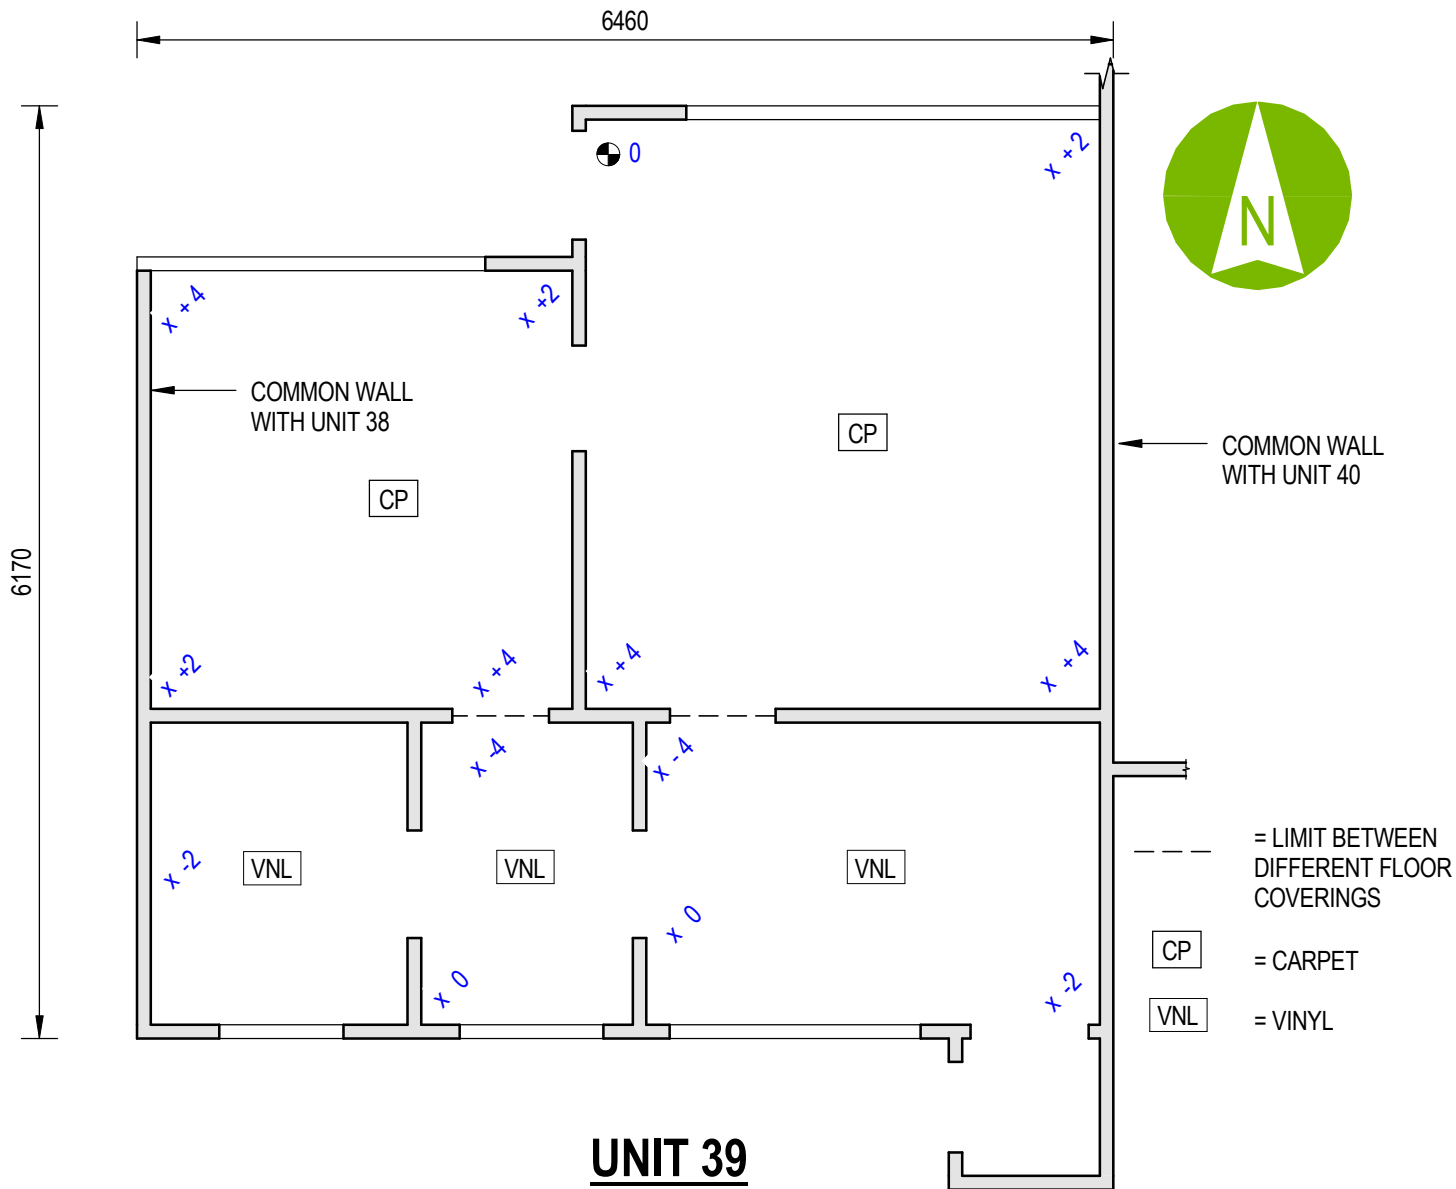
PRELIMINARY NOT FOR CONSTRUCTION	
PROJECT No. 232537	
SCALE 1:50	SIZE A4
DRAWING No. SK-038	REV A

PROJECT	
Manse Place -325 Main North Road	
TITLE	
LEVEL SURVEY - UNIT 38

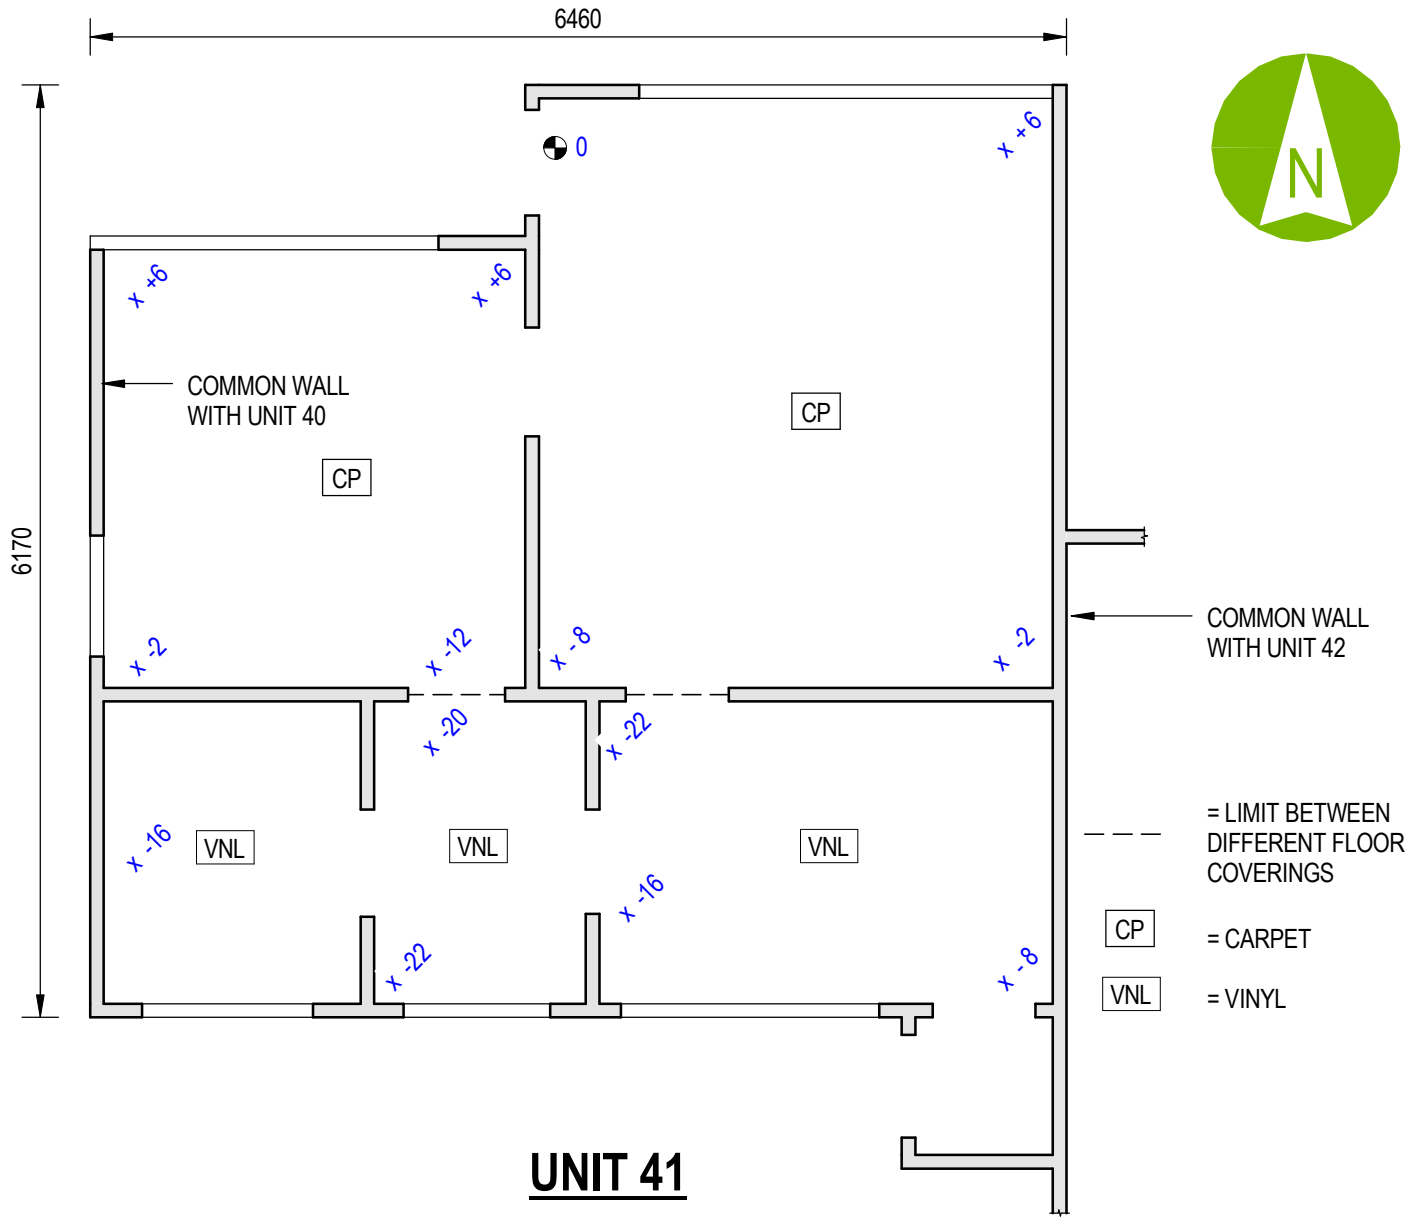
PRELIMINARY NOT FOR CONSTRUCTION	
PROJECT No. 232537	
SCALE 1:50	SIZE A4
DRAWING No. SK-040	REV A

PROJECT	
Manse Place -325 Main North Road	
TITLE	
LEVEL SURVEY - UNIT 40

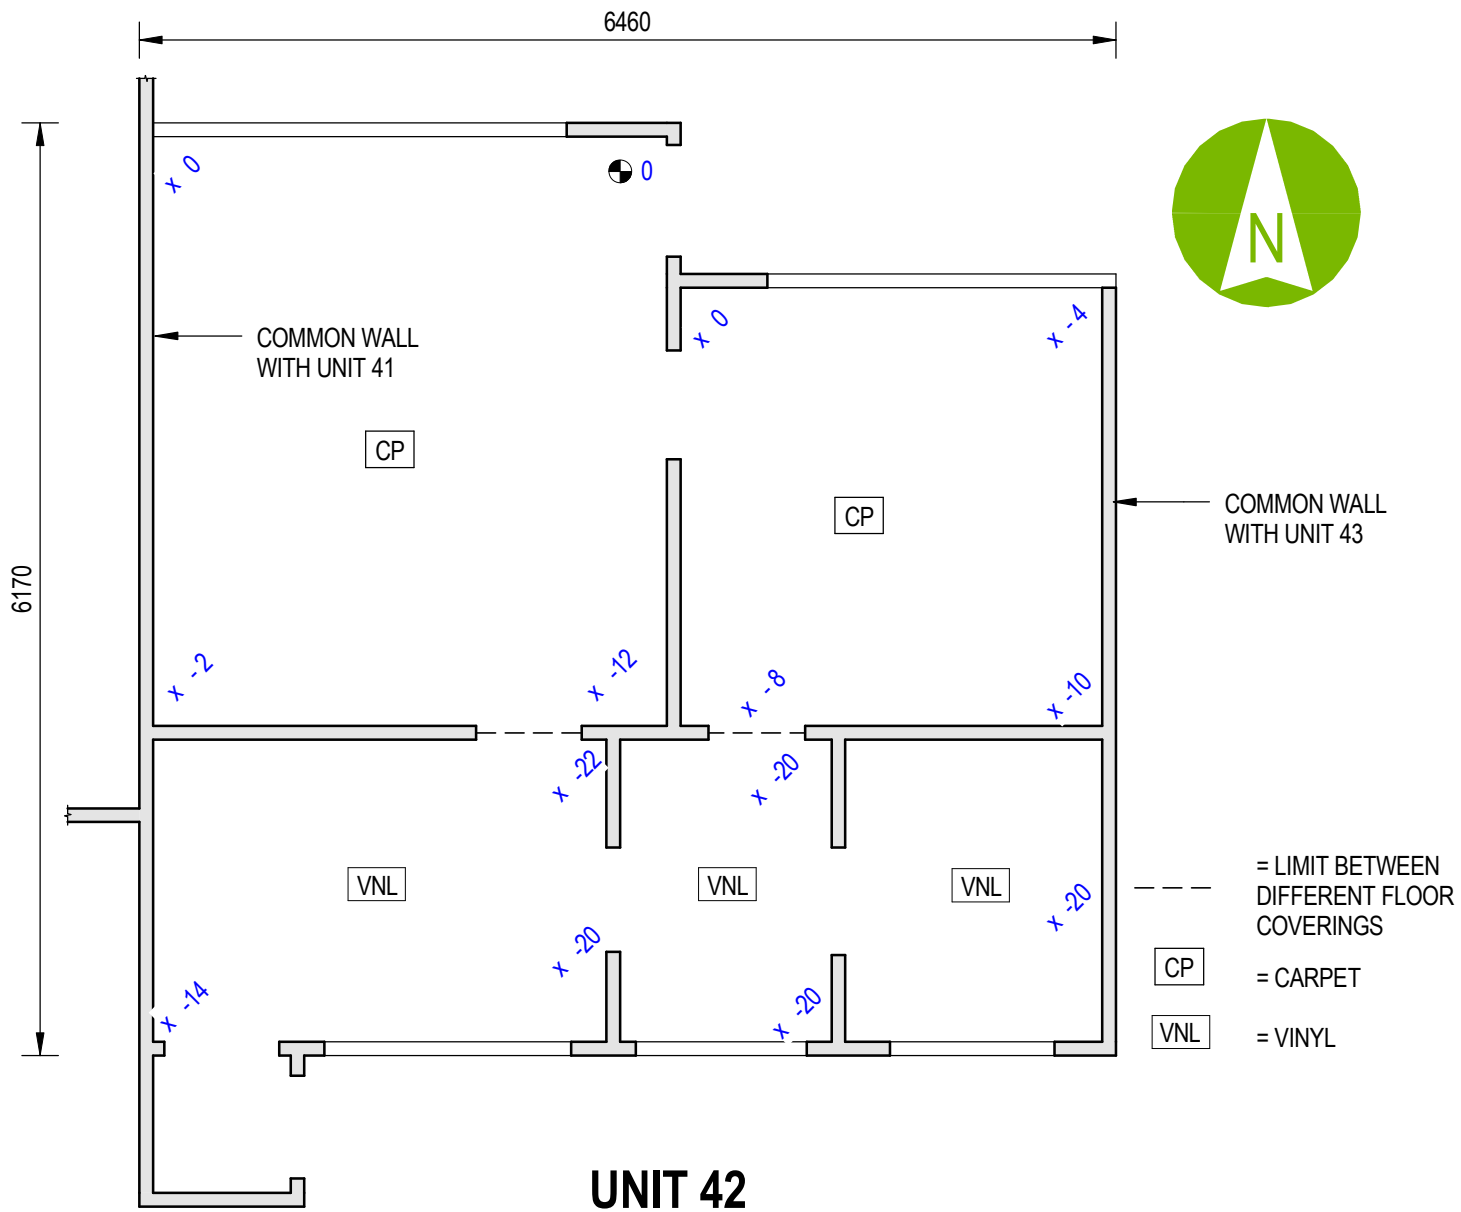
PRELIMINARY NOT FOR CONSTRUCTION	
PROJECT No. 232537	
SCALE 1:50	SIZE A4
DRAWING No. SK-041	REV A

PROJECT	
Manse Place -325 Main North Road	
TITLE	
LEVEL SURVEY - UNIT 41
