Christchurch City Council
PRK_2119_BLDG_001 EQ2
Parklands Reserve - Toilet/Changing Rooms
Queenspark Drive / Donnington St

QUALITATIVE ASSESSMENT REPORT
FINAL

- Rev B
- 23 May 2013

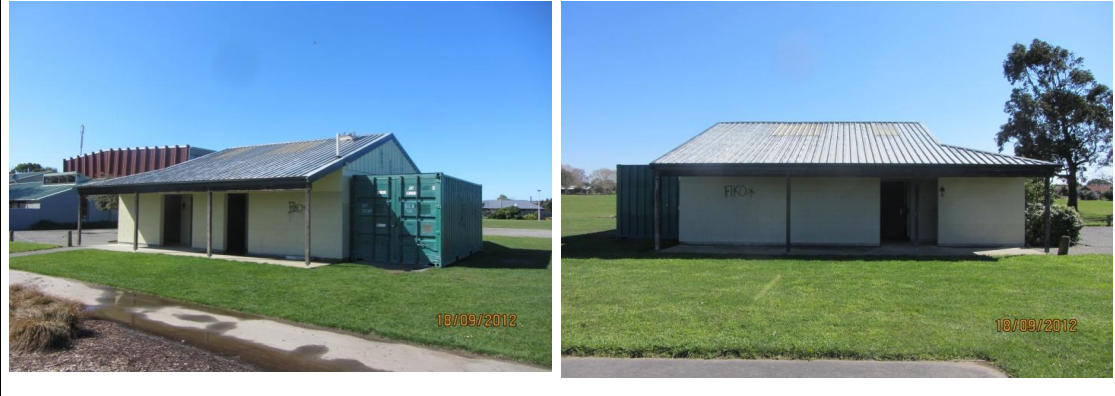
1.1 Photos (attach sufficient to describe building)

Building is a single storey reinforced masonry building with a timber framed roof clad with corrugated metal. Building is used as a toilet and changing room facility
