Christchurch City Council

PRK_3575_BLDG_001 Port Levy Fire Shed Detailed Engineering Evaluation Report

September 2013

Detailed Engineering Evaluation

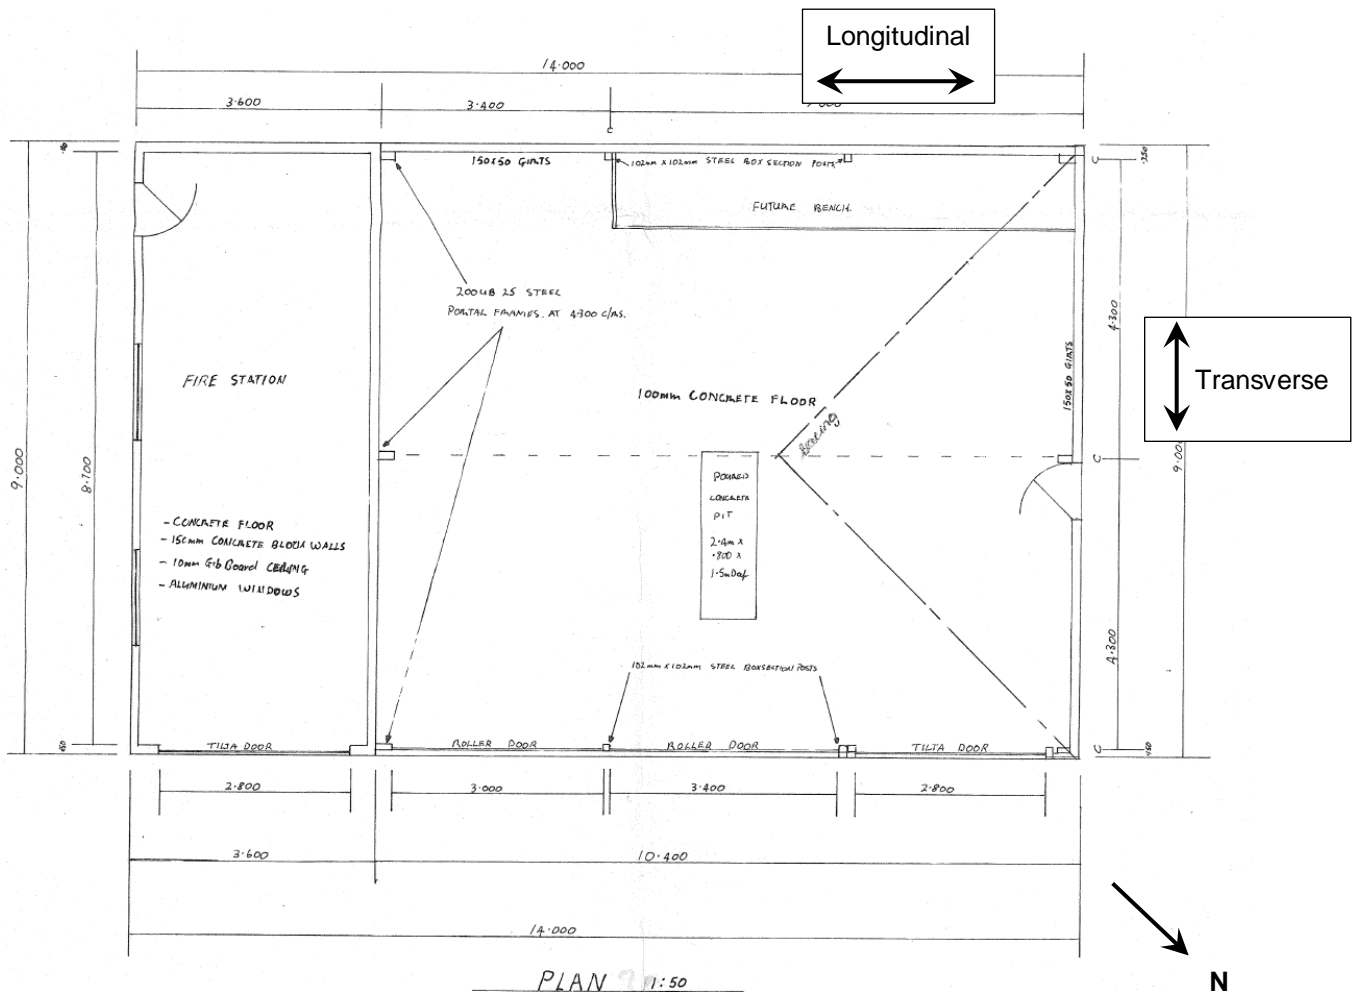
Figure 2 Original building plan

The building is a single storey steel portal frame and reinforced concrete masonry wall construction. The roof is pitched to a central transverse ridge; the roof consists of corrugated

metal cladding on timber purlins. The timber purlins are bolted to the load bearing steel portal frame at each end and at midspan. Corrugated metal cladding on timber frames makes up the external walls. The walls on the eastern side of the building, and the internal wall are constructed from reinforced concrete masonry. The ground floor slab consists of 100 mm reinforced concrete slab on grade. Foundations consist of isolated concrete pad foundations.
