Riccarton House

Detailed Engineering Evaluation Report

14th February 2012

Re: Riccarton House Detailed Engineering Evaluation

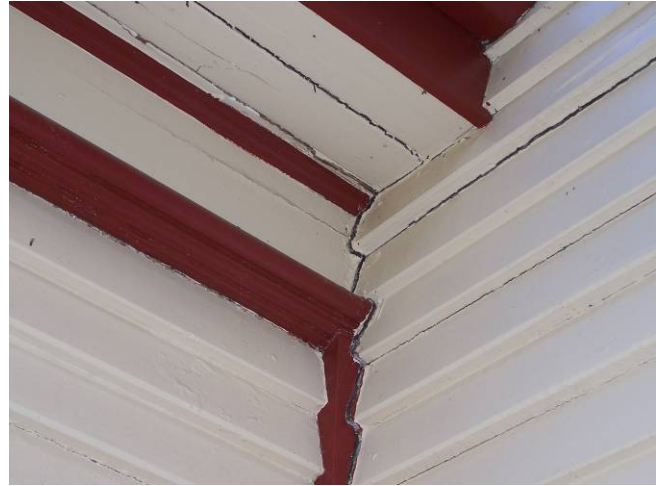
Separation between timber weatherboards

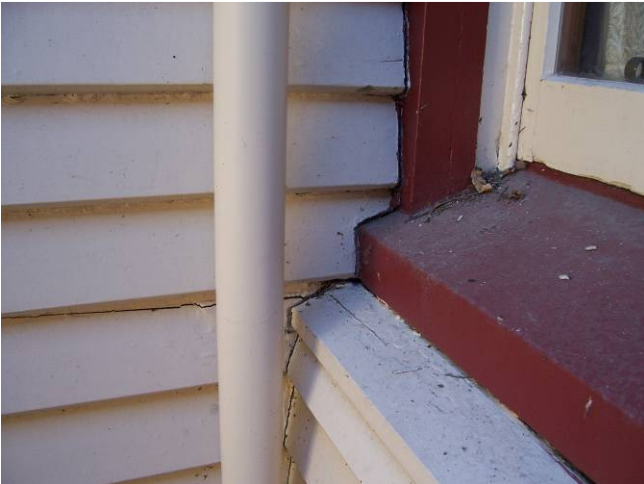
Separation between timber weatherboards

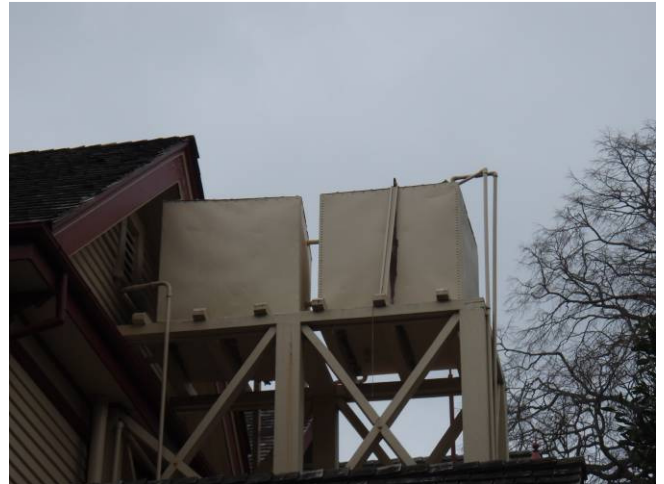
Displaced water tanks

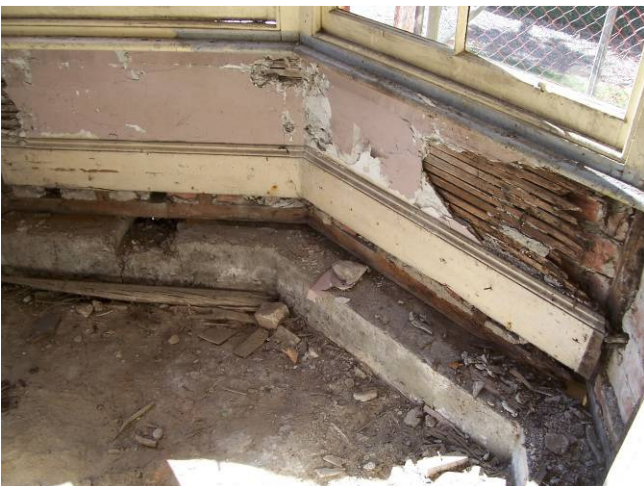
Morning room bay window from inside

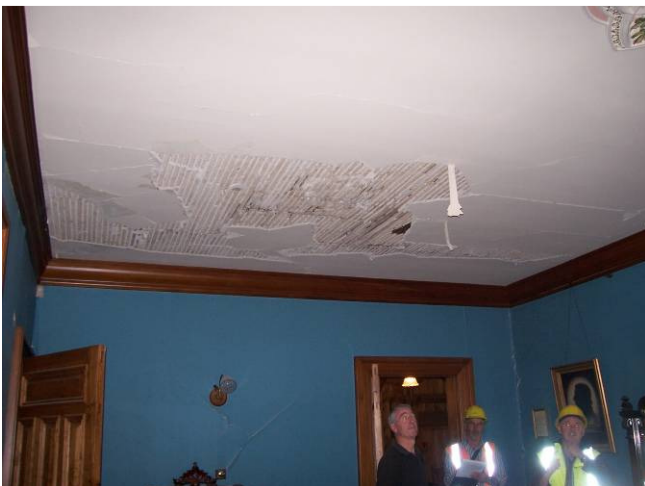
Lath and plaster ceiling delamination in dining room
