CHRISTCHURCH CITY COUNCIL
PRK_0895_BLDG_006 EQ2
Ruru Lawn Cemetery – Portacom Office
Raymond Road, Bromley

QUALITATIVE ASSESSMENT REPORT

- Rev B
- 23 November 2012

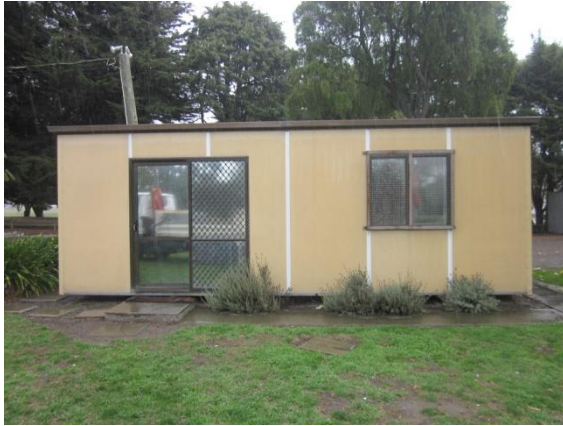
Photo 1: Front Elevation of Building

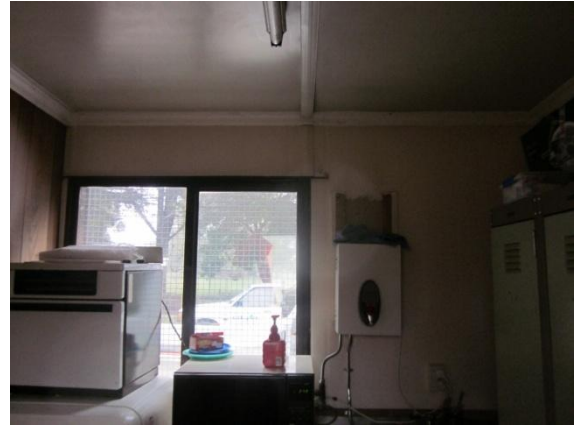
Photo 2: Internal View

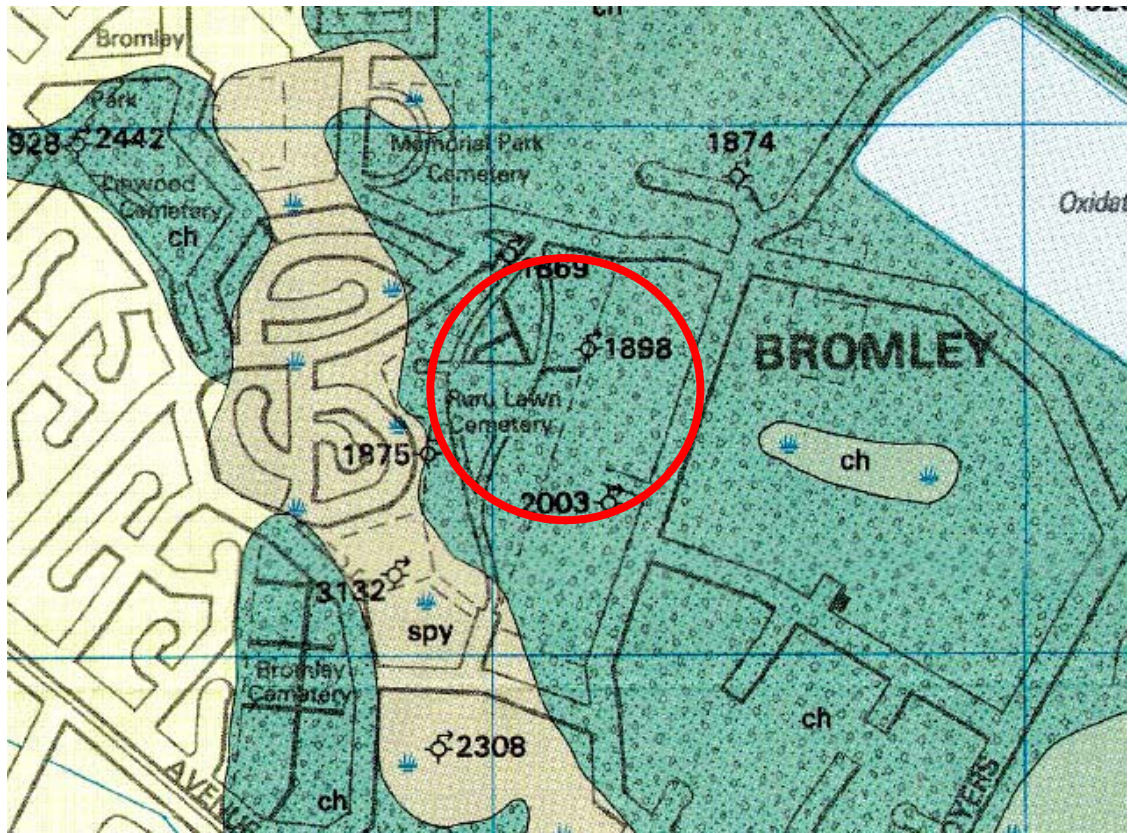
■ **Figure 3 – Local geological map (Brown et al, 1992). Site marked in red.**

The site is shown to be underlain by Holocene deposits comprising predominantly sands of fixed and semi-fixed dunes and beaches from the Christchurch Formation. The area immediately to the west of the site is underlain by peat swamps, now drained, from the Springston Formation.

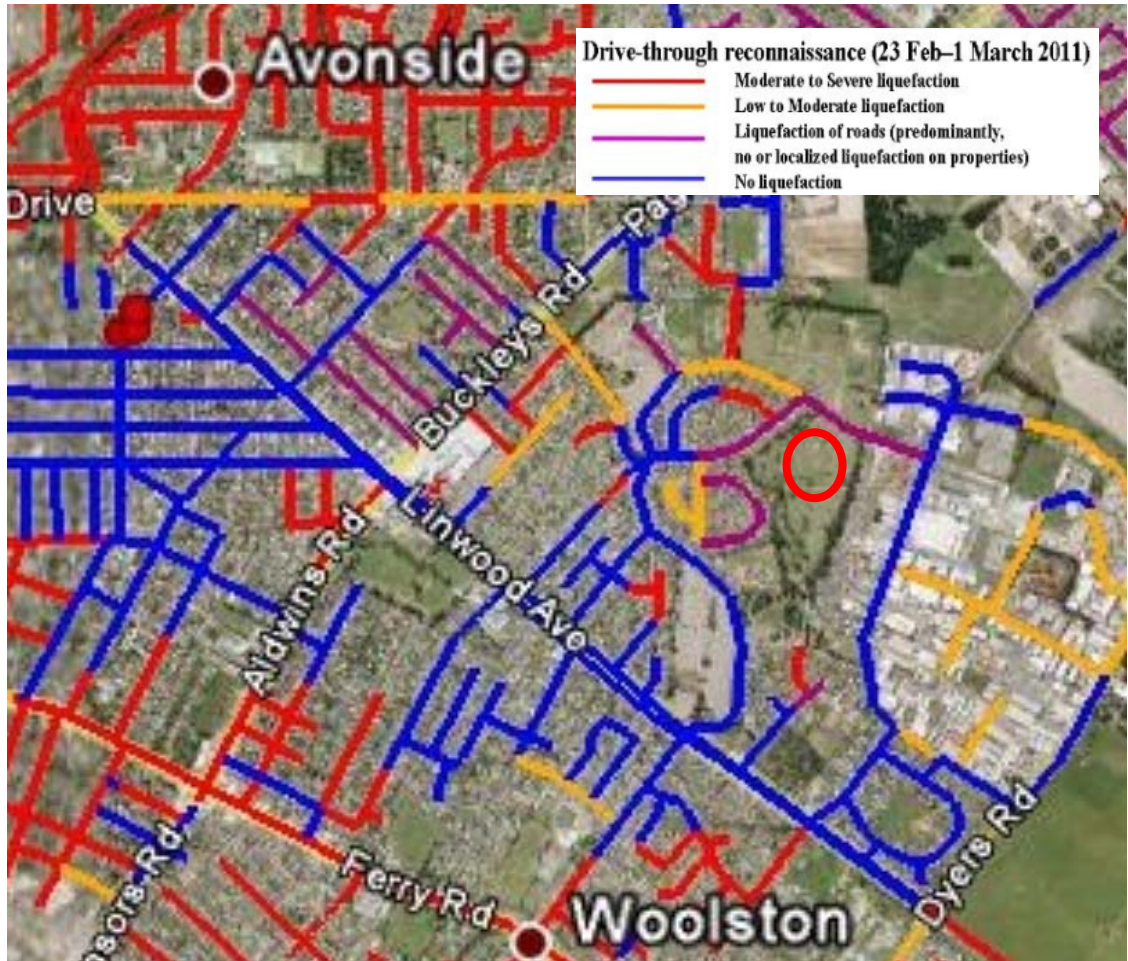
■ **Figure 4 – Liquefaction map (Cubrinovski & Taylor, 2011). Site marked in red.**

Following the 22 February 2011 event drive through reconnaissance was undertaken from 23 February until 1 March by M Cubrinovski and M Taylor of Canterbury University. Their findings show predominantly liquefaction of roads with no or localised liquefaction in the areas near the site. In parts of the area immediately west of the site low to moderate and moderate and severe liquefaction had been noted.
