CHRISTCHURCH CITY COUNCIL
PRK_1360_BLDG_001 EQ2
Spit Reserve Toilet
217 Rocking Horse Road, Southshore

QUALITATIVE ASSESSMENT REPORT
FINAL

- Rev B
- 23 May 2013

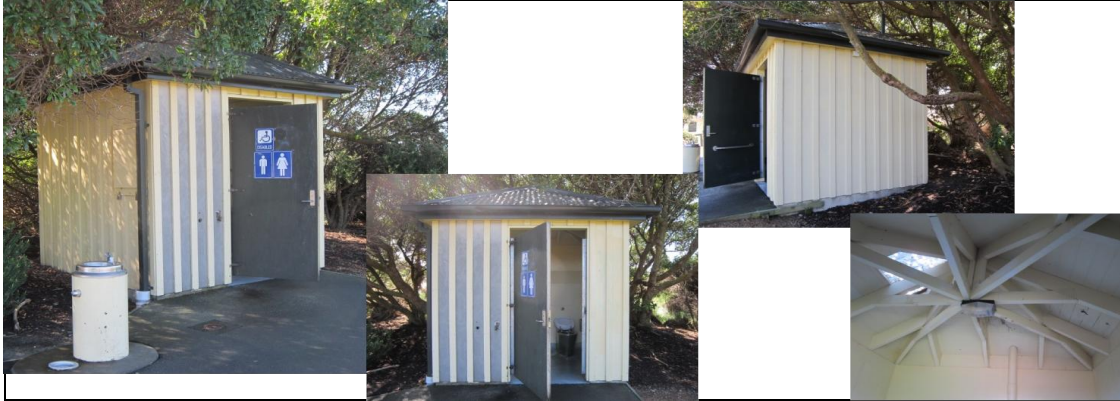
1.1 Photos (attach sufficient to describe building)

The building in Spit Reserve at 217 Rockinghorse Lane is one storey and is currently used as a public toilet. The building has timber-framed walls and a concrete floor slab. The main lateral load-resisting system appear to be the timber framing in the walls. The roof is timber-framed with metal sheeting as cladding. The building is assumed to have been constructed in the 1970's.
