CHRISTCHURCH CITY COUNCIL
PRK_2347_BLDG_004 EQ2
Travis Wetland Toilets
280 Beach Road, Burwood

QUALITATIVE ASSESSMENT REPORT
FINAL

- Rev B
- 23 May 2013

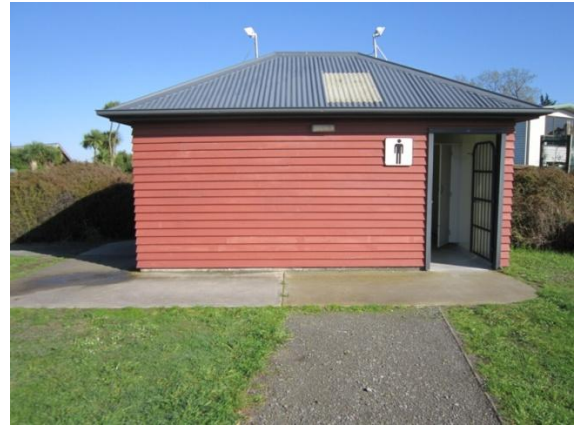
Photo 2: East elevation

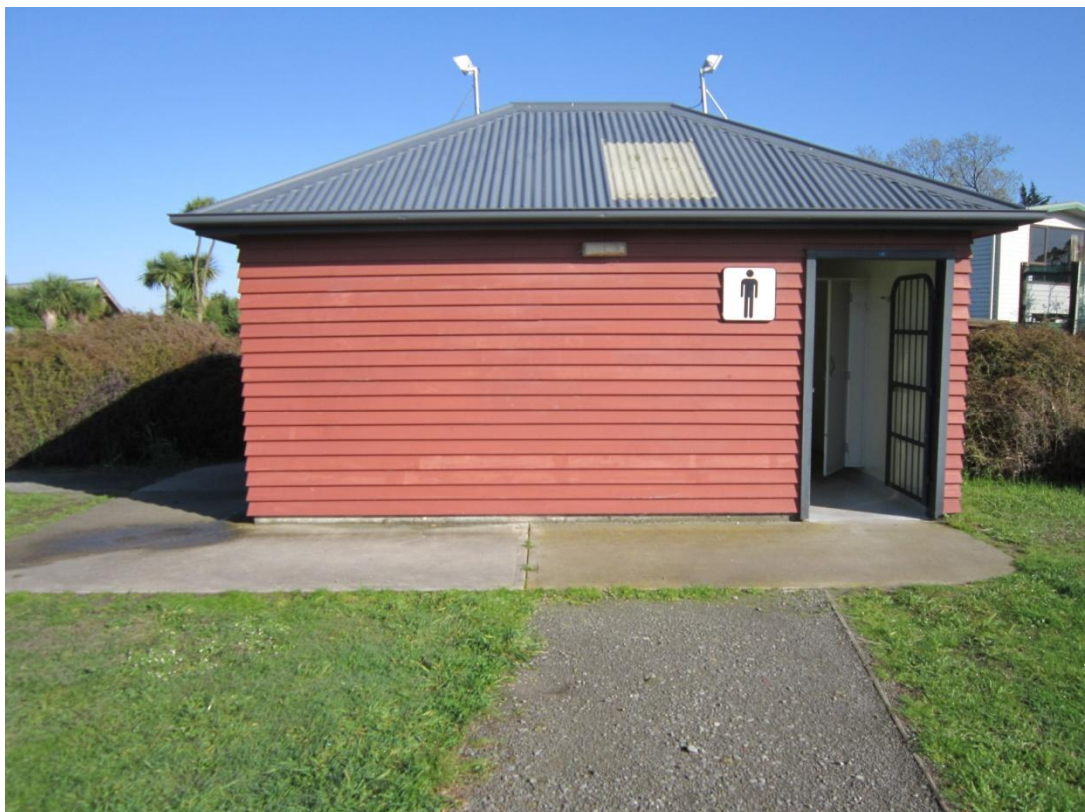
■ **Figure 7 - Overview of the toilet block**

The building is a timber construction with metal roofing supported on a concrete slab on grade floor. At the time of the site walkover no significant damage to the land surrounding the structure was noted. However, the site walkover was conducted more than 18 months after the earthquake event and any liquefied ejecta may have since been removed from the site. Small amount of silt ejecta was however noted near the perimeter of the structure. Some undulation in the surrounding ground was observed, however this is likely to be a landscaping feature rather than damage caused by the earthquake event.

Additionally, hair line cracks were in the floor slab and some separation of the outside pavement slabs was noted. No significant evidence of settlement due to liquefaction was noted. Therefore, the above separation and settlement may have been caused by ground shaking.

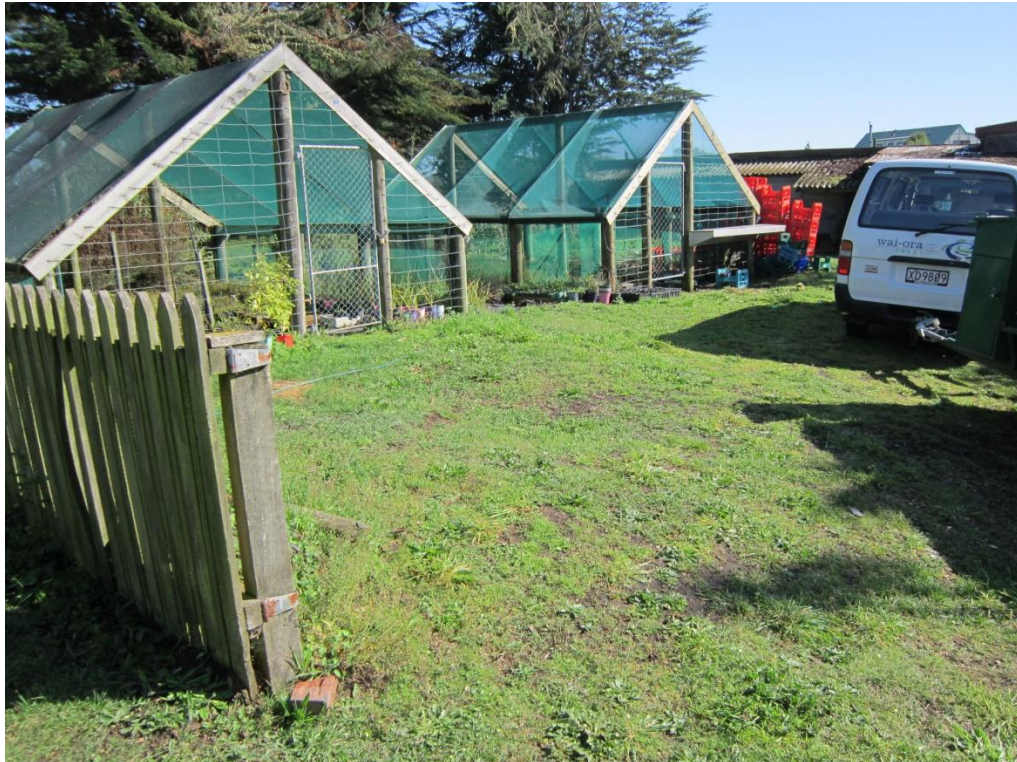
■ **Figure 11 - Overview of the plant nursery**

Undulating ground was noted around the structure. However, this topography is expected to have existed before the earthquake. Some loose silt and sand material at ground surface was noted, which may be remnant ejecta from the earthquake event. However, other than for this no other significant land damage was noted during the site walkover.

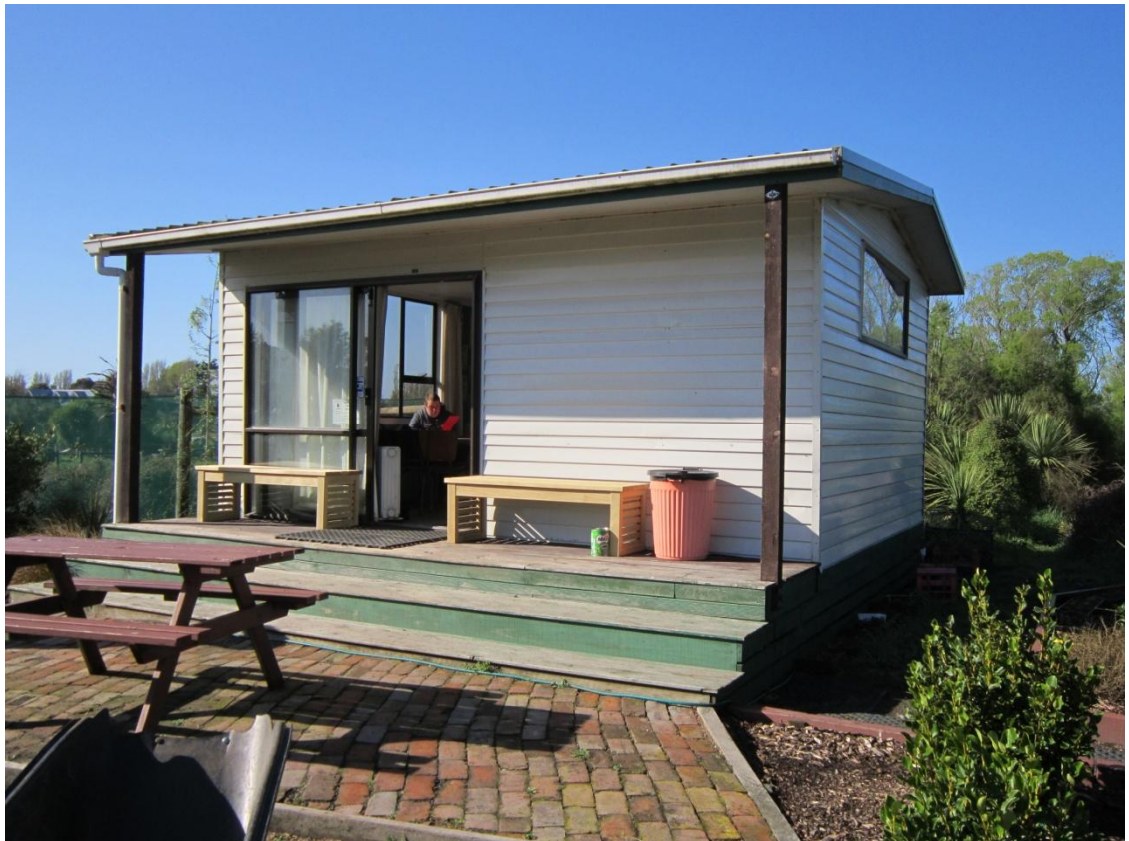
■ **Figure 13 - Overview of building**

Some separation of the concrete block encasing the piles and adjacent ground was noted. This may indicate some differential settlement between adjacent ground and the respective posts. Significant amount of cracking (up to 10 mm wide) was also observed in the concrete slab west of the structure. However, the level and nature of this damage indicates that it is likely to have been a result of vehicle or other repeated loading on the unreinforced concrete slab rather than damage caused by the earthquake event.

Some patches of loose sand and silt material were noted around the property. This may be remnant liquefied ejecta from the earthquake event. No significant evidence of other land damage was found during the site walkover.

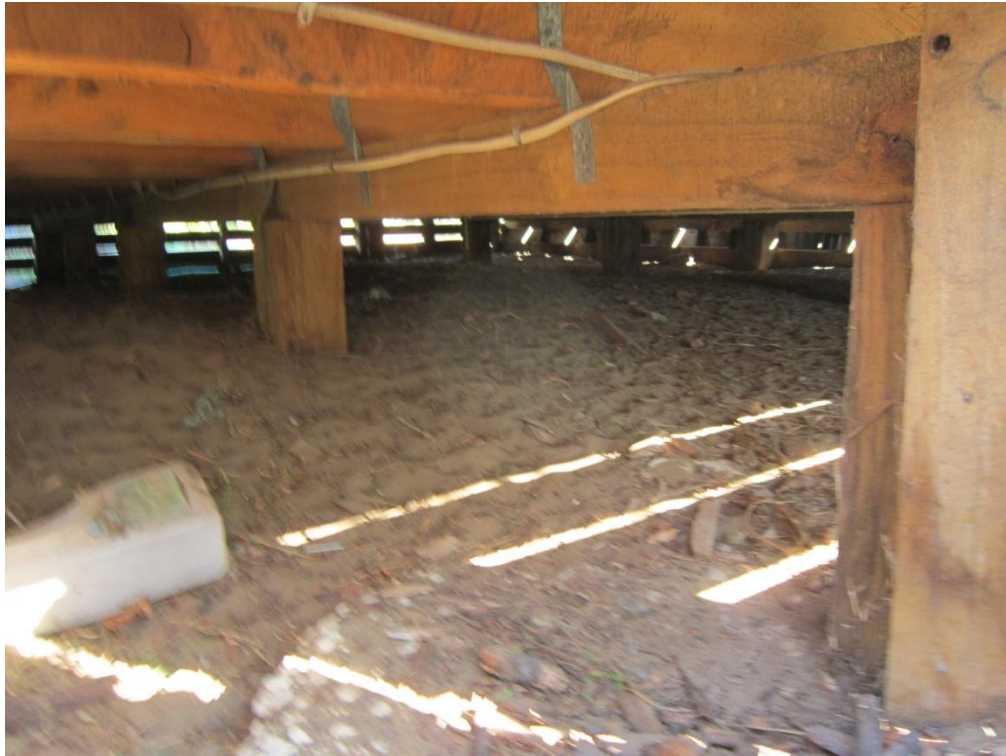
■ **Figure 14 - Observed foundation for the building**
