Victoria Park – Rangers House
Qualitative Engineering Evaluation

Reference: 228903
Prepared for:
Christchurch City Council

Functional Location ID: PRK 1829 BLDG 008

Date: 5 July 2013

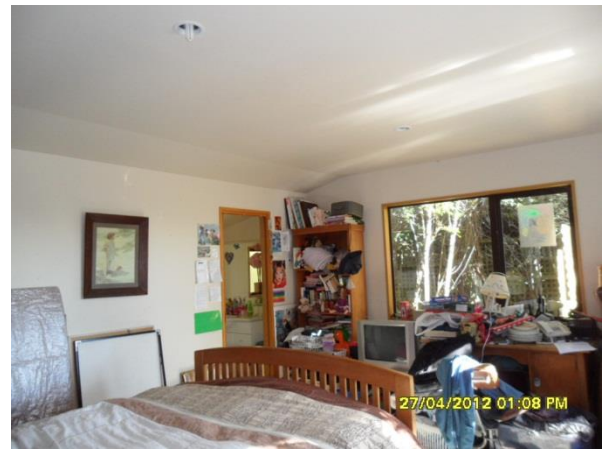
Levels Survey Results	N	Variations in floor levels in the northeast corner of the house and the south end bedroom towards the hallway are over the DBH's Guidelines, with falls of more than 1:200 or 0.5%. The rest of the house is within the guidelines.			
Building %NBS From Analysis	100%	Based on an analysis of bracing capacity and demand.			
Qualitative L4 Report Recommendations					
Geotechnical Survey Required	N	Geotechnical survey not required due to lack of observed ground damage on site.			
Proceed to L5 Quantitative DEE	N	A quantitative DEE is not required for this structure.			
Approval					
Author Signature

Client: CHRISTCHURCH CITY COUNCIL		Date: 13.6.12	
Project/Job: VICTORIA PARK - RANGERS HOUSE		Job No: 228903	
Subject: LEVEL SURVEY		Sheet No: 1-1	By: DH
