Whakahoa Village Units Block E
BU 2680-005 EQ2
Detailed Engineering Evaluation
Quantitative Report
Christchurch City Council

Detailed Engineering Evaluation Quantitative Report

Date: September 2012
Reference: 6-QUCCC.93
Status: Final

Gowerton Place, Richmond

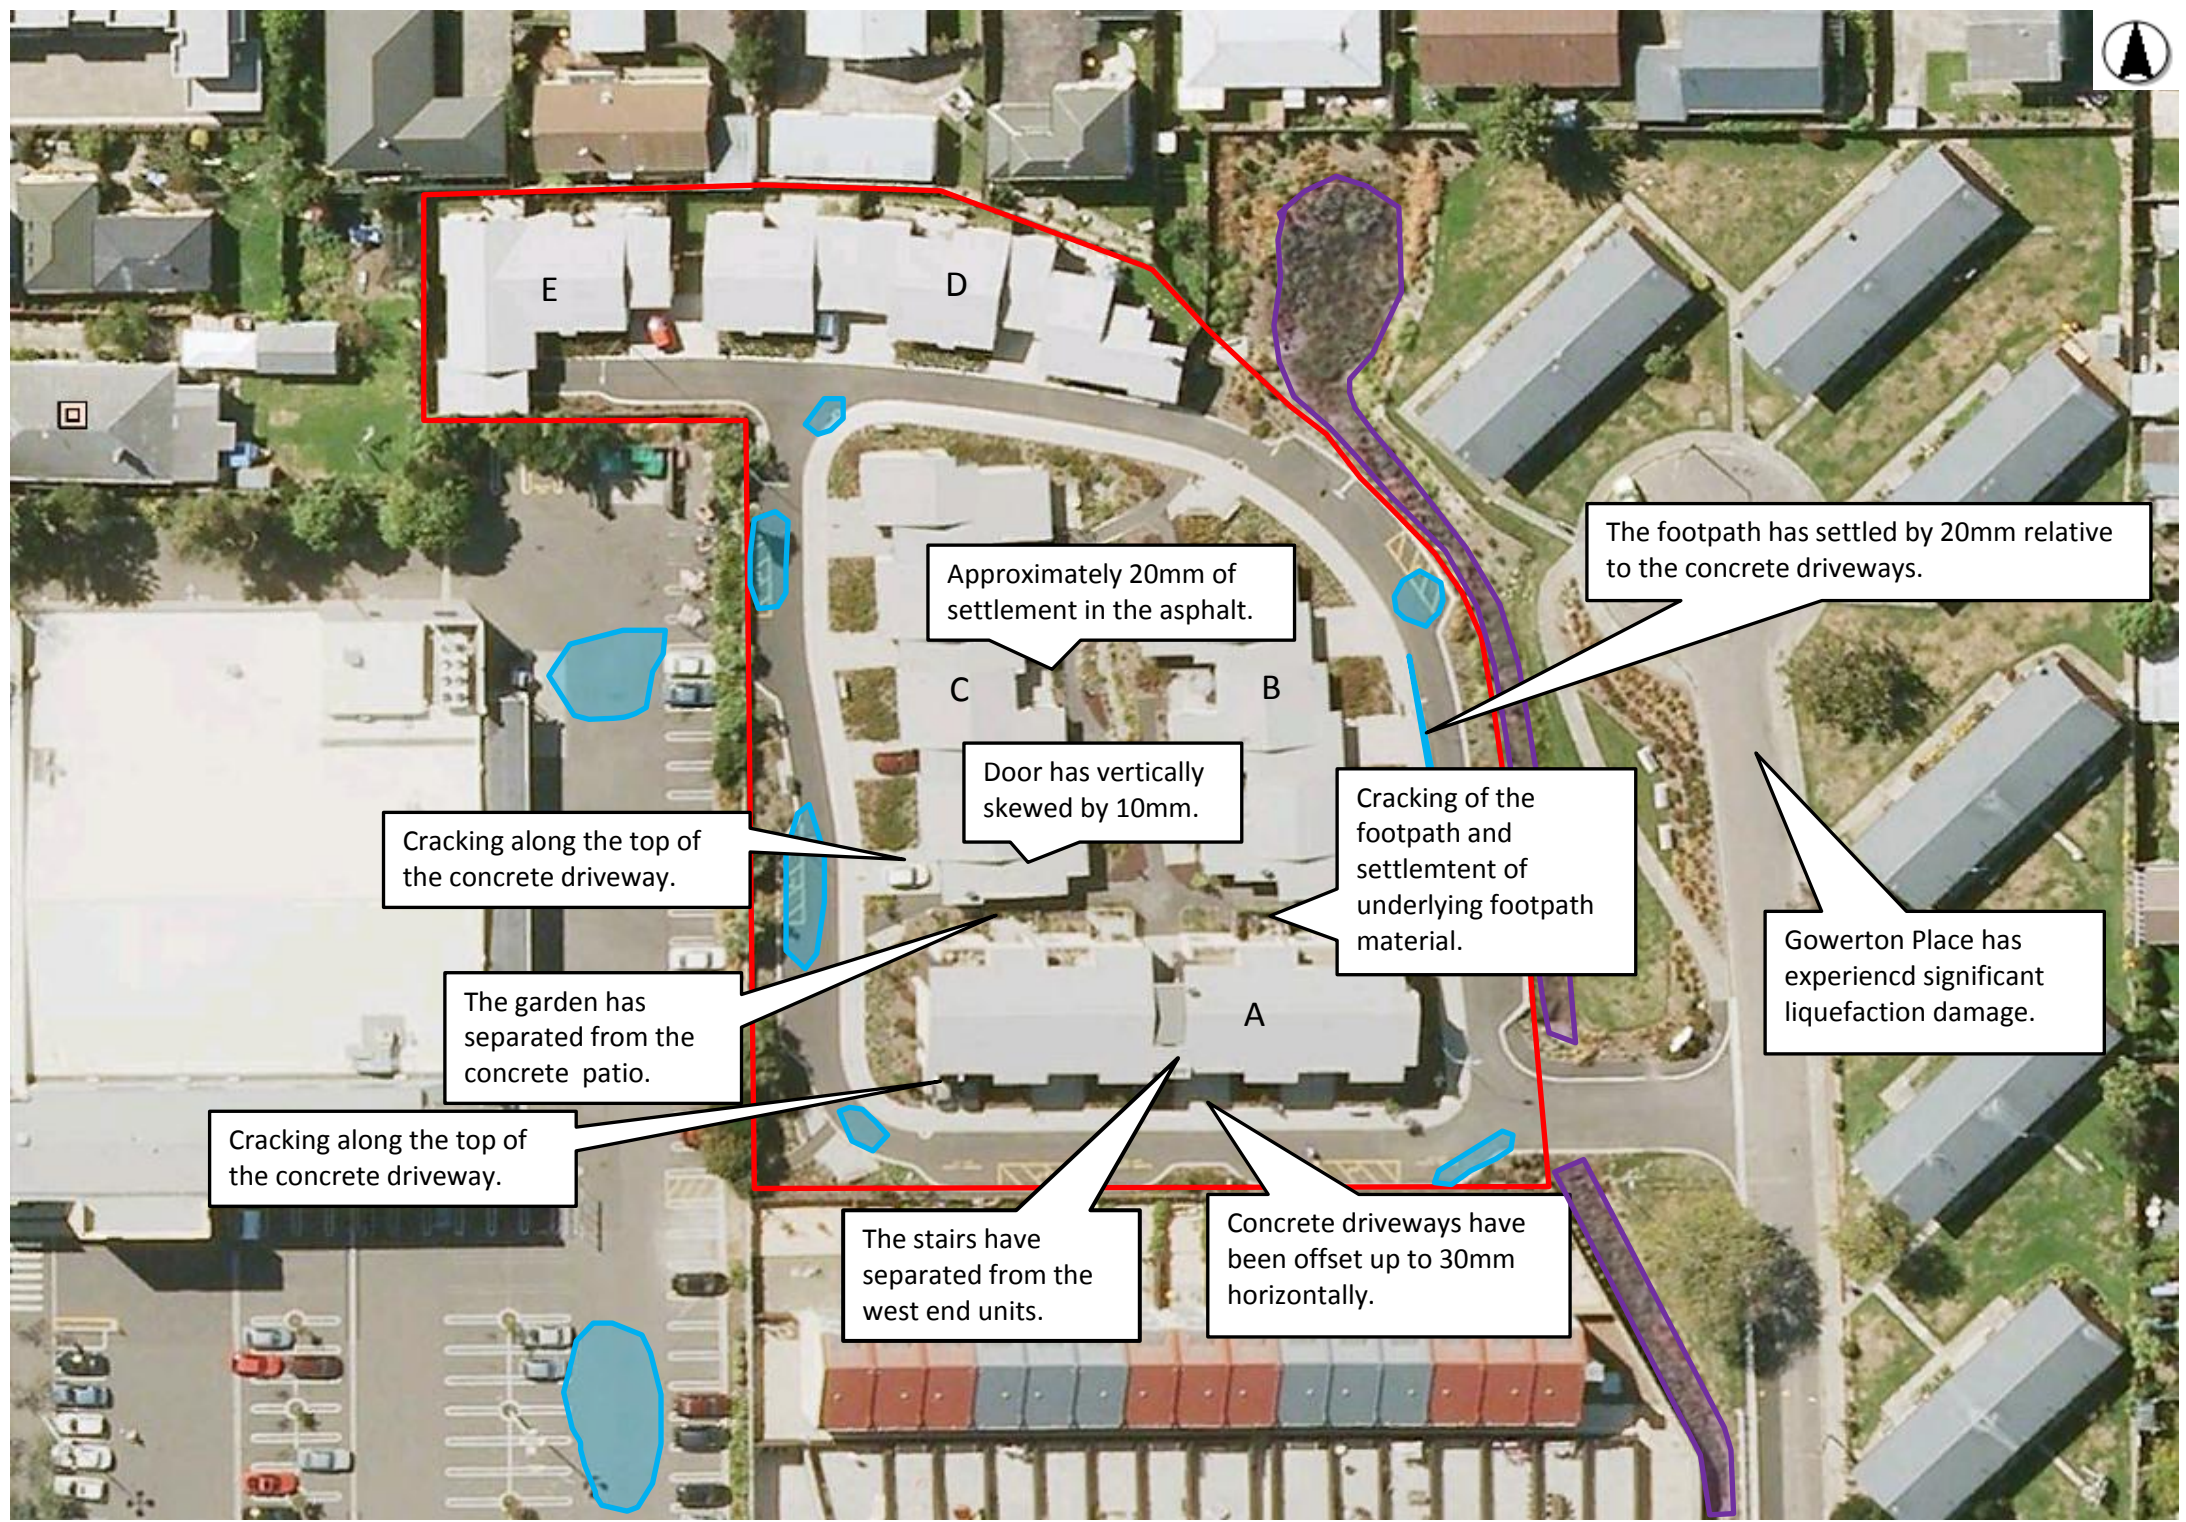
Observed Ground Heave

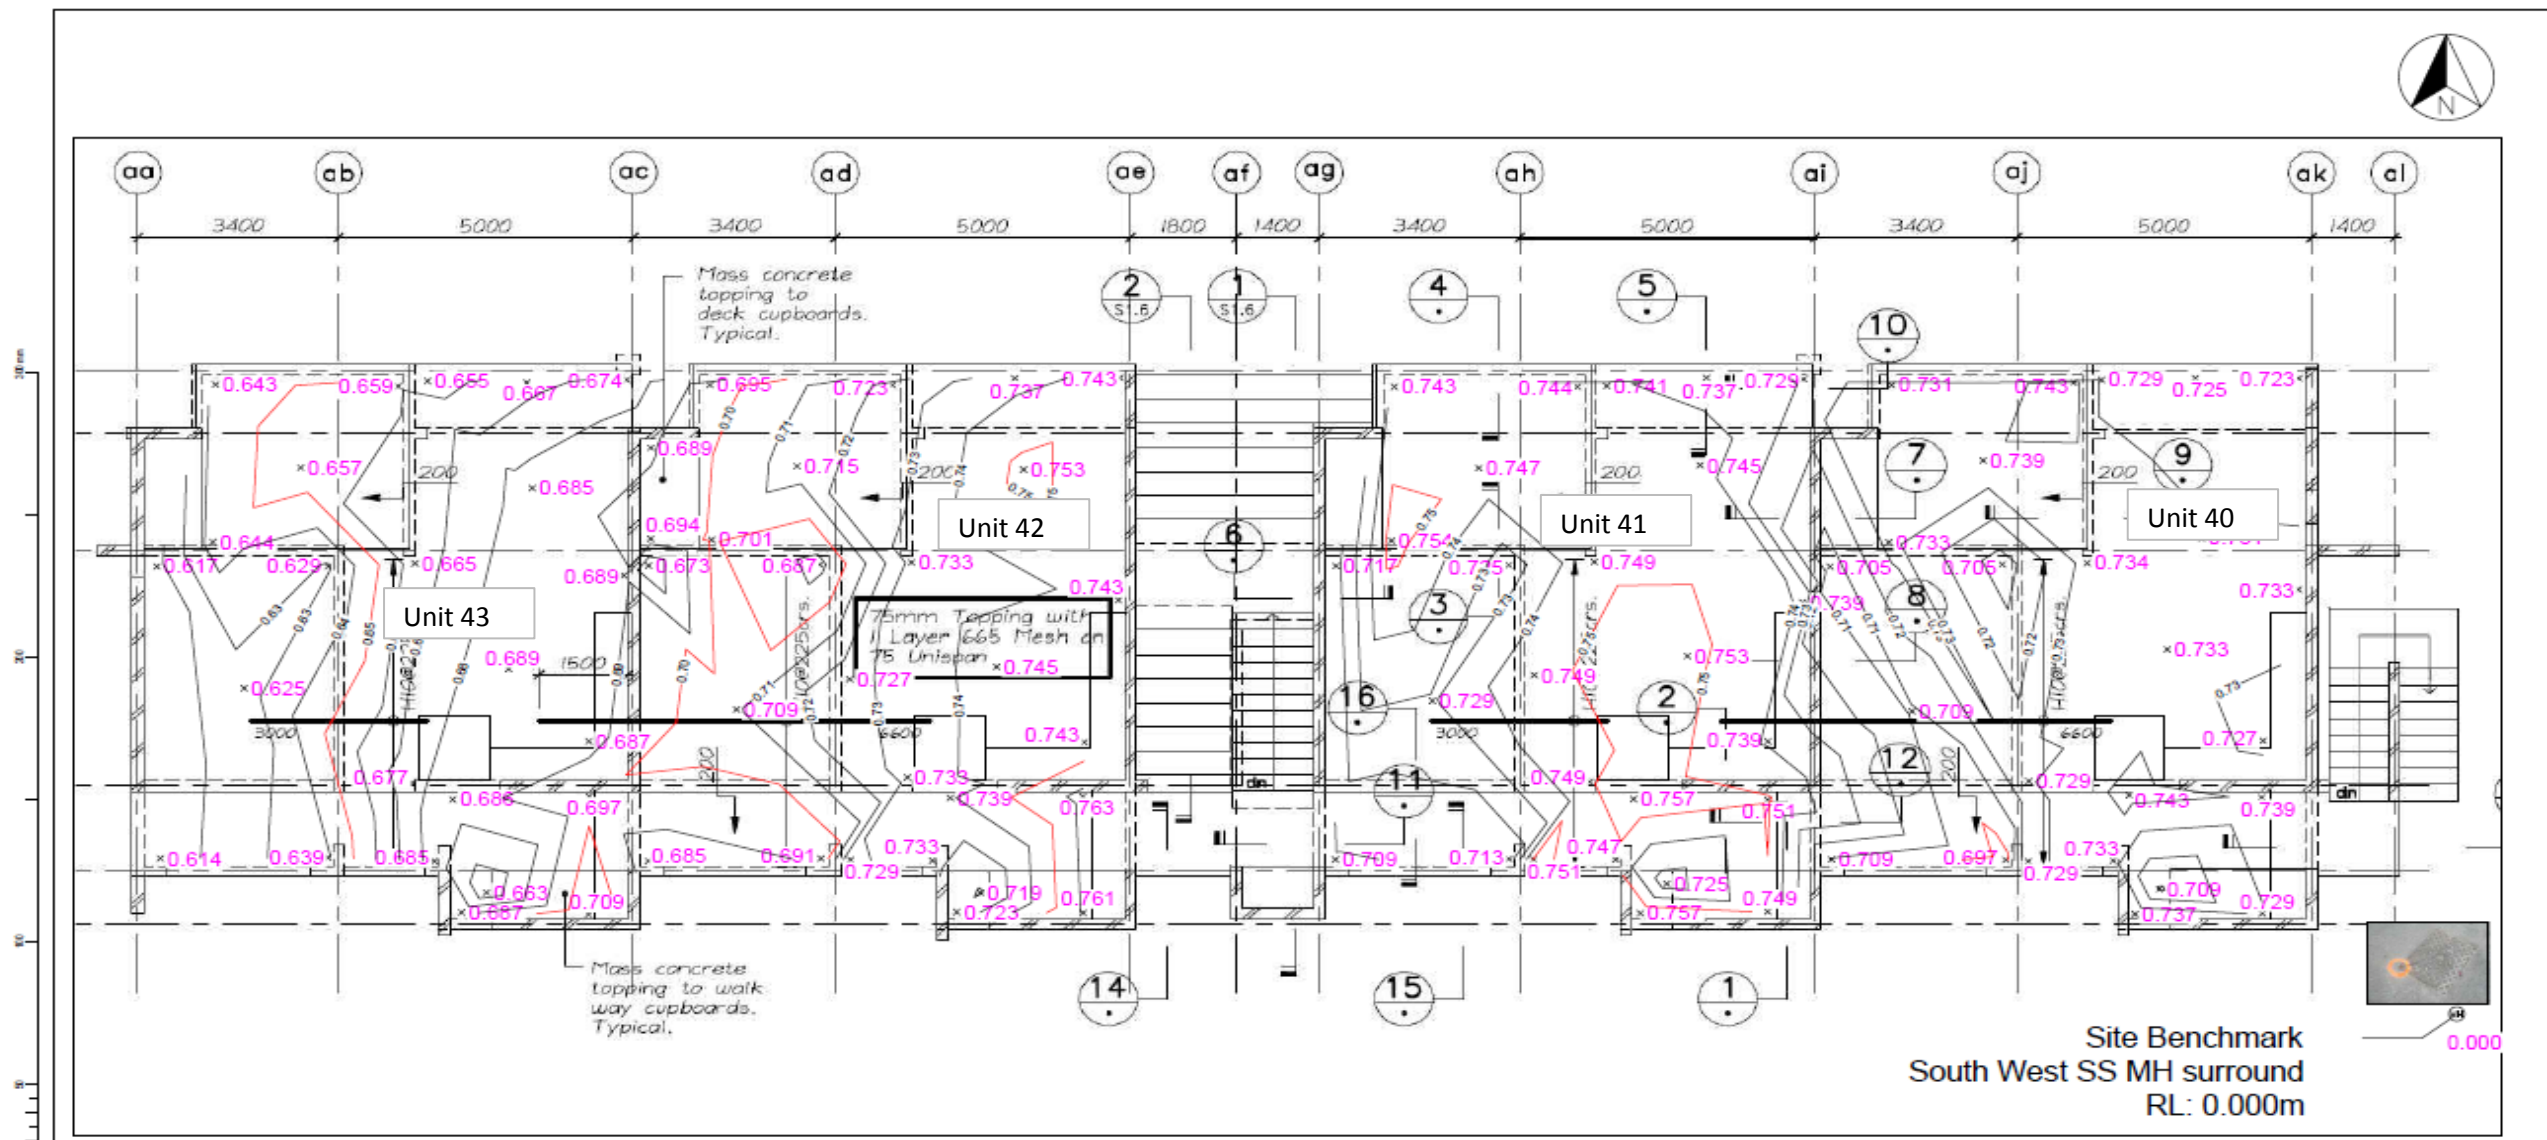
Ground Floor Block A

The level survey results are consistent with the observations of differential settlement of the western units of Block A. Observations include pavement cracking of the driveway outside the western most unit (unit 43) separating from the stair well.
