# HORNBY LIBRARY, SERVICE CENTRE AND SW LEISURE CENTRE KYLE PARK

## Preliminary CPTED Review

Christchurch City Council

6 March 2019

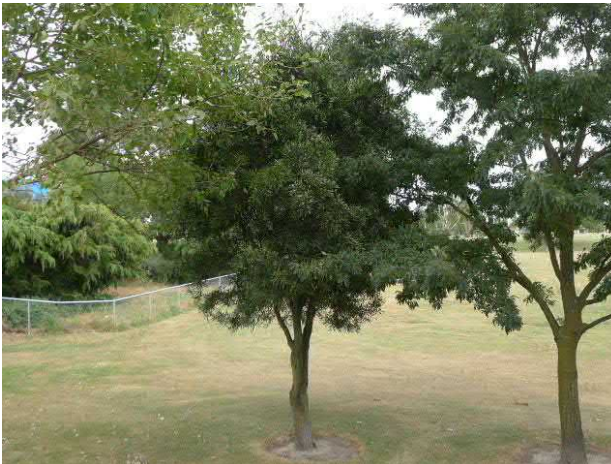
**17 - 93381**

16	93380	Quercus cerris	Turkey Oak	8.0	8.0	0.28	2	3	3	Reasonably good foliage density. No significant structural defects. Minor mower damage to base.
17	93381	Acacia melanoxylon	Tasmanian Blackwood	7.0	6.0	0.2	2	3	3	Reasonably good foliage density. Included unions, and partial suppression.
18	93382	Populus nigra	Black Poplar	12.0	12.0	0.38	4	4	4	Sparse crown, more than 30% decline.
19	93385	Arbutus unedo	Irish Strawberry Tree	3.5	3.5	0.2	2	3	3	Reasonably good foliage density. Multiple stems near base, canopy to near ground level.
20	93384	Cedrus atlantica	Atlas Cedar	6.0	6.0	0.2	2	3	3	Reasonably good foliage density. Asymmetrical form. Minor bark wound, but no significant structural defects.

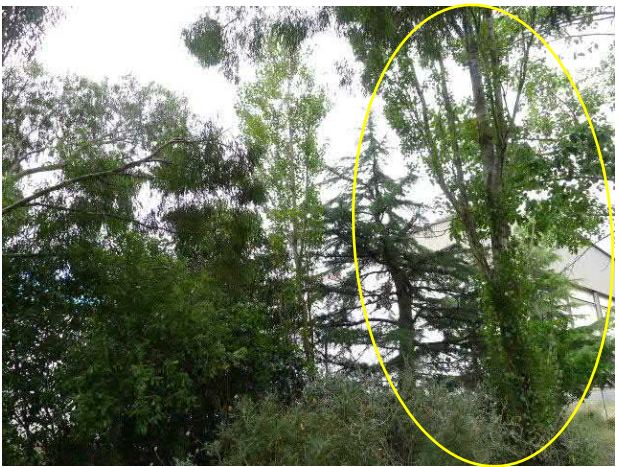
**47 - 93445**

46	46	Populus nigra Italica	Lombardy Poplar	8.0	2.0	0.1	3	3	3	Partial suppression, but fair condition overall.
47	93445	Populus nigra Italica	Lombardy Poplar	12.0	4.0	0.3	3	3	3	Sparse mid canopy. Basal wound on the western side, with possible decay. No significant structural defects.
48	93446	Cedrus deodara	Deodar Cedar	8.0	8.0	0.35	3	3	3	Slightly sparse lower canopy. Asymmetrical form due to suppression. No significant structural defects.
49	93447	Cedrus deodara	Deodar Cedar	5.5	4.0	0.18	3	3	3	Slightly sparse lower canopy. Asymmetrical form due to suppression. No significant structural defects.

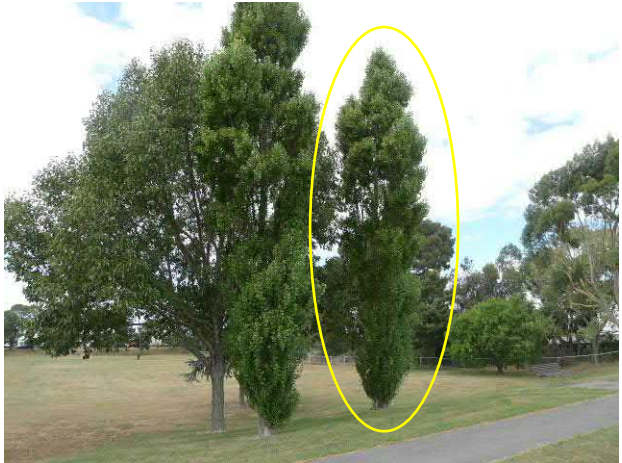
**56 - 93426**

55	93440	Eucalyptus pulchella	White Peppermint Gum	11.0	10.0	0.55	3	4	4	Slightly sparse foliage density, but less than 30% decline. Multiple stems at 1.5m, and multiple included unions in main trunk and scaffold branches.
56	93426	Populus Italica nigra	Lombardy Poplar	11.0	2.5	0.3	2	3	3	Reasonably good foliage density. One-sided crown due to lateral suppression from an adjacent tree, but no significant structural defects.
57	93421	Cedrus Glauca atlantica	Blue Atlas Cedar	5.0	8.0	0.25	3	3	3	Slightly sparse foliage density, but less than 30% decline. A minor bark wound on lower trunk, but no significant structural defects.
58	93424	Populus Italica nigra	Lombardy Poplar	11.0	3.0	0.3	2	3	3	Reasonably good foliage density. One-sided crown due to lateral suppression from an adjacent tree, but no significant structural defects.

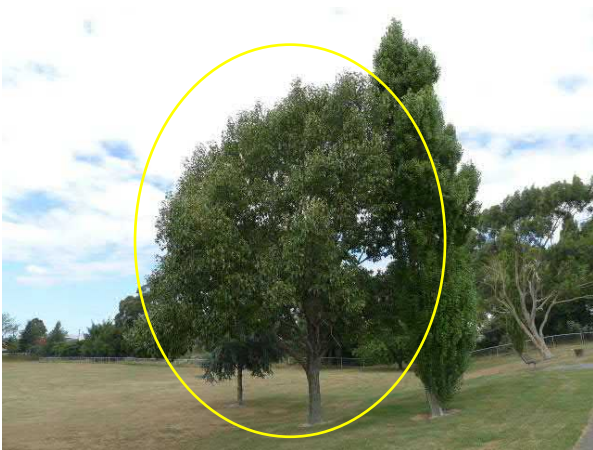
**59 - 93422**

Survey Number	Tree ID	Species	Common Name	Height	Canopy Spread	DBH	Tree Health	Tree Form	Overall Condition	Comments
59	93422	Populus yunnanensis	Chinese Poplar	11.0	12.0	0.35	3	3	3	Reasonably good foliage density slightly sparse crown, but less than 30% decline. Minor lateral suppression on the western side.
60	93415	Populus nigra	Black Poplar	10.0	11.0	0.25	4	4	4	Sparse crown, approximately 50% decline, and an old basal wound with decay.
61	93413	Populus nigra	Black Poplar	10.0	11.0	0.3	4	3	4	Sparse crown, approximately 50% decline.
62	93411	Cedrus atlantica	Atlas Cedar	7.0	7.0	0.25	2	3	3	Reasonably good foliage density. Multiple stems from ground level and multiple girdling roots. Slight lateral suppression from an adjacent tree, but no significant structural defects.
63	93410	Cedrus atlantica	Atlas Cedar	2.5	9.0	0.2	2	4	4	Reasonably good foliage density, crown to ground level. Central leader lost, and heavily suppressed under adjacent trees.

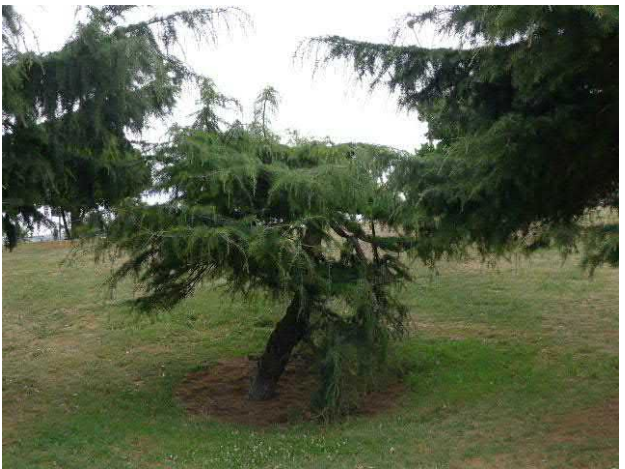
**65 - 93403**

64	93406	Cedrus atlantica	Atlas Cedar	7.0	10.0	0.35	2	3	3	Reasonably good foliage density. Multiple recent branch failures on the western side of the canopy.
65	93403	Cedrus atlantica	Atlas Cedar	3.5	5.0	0.2	3	4	4	Reasonably good foliage density. Central leader lost some time ago, and heavily suppressed by adjacent trees. Multiple previous branch failures.
66	93401	Cedrus atlantica	Atlas Cedar	6.0	8.0	0.4	2	3	3	Reasonably good foliage density. Asymmetrical form. No significant structural defects, but multiple branch failures in the lower crown.
67	67	Arbutus unedo	Irish Strawberry Tree	3.5	6.0	0.5	2	3	3	Reasonably good foliage density. Multiple stems from base, and canopy to near ground level. Broken branch stub on western side.

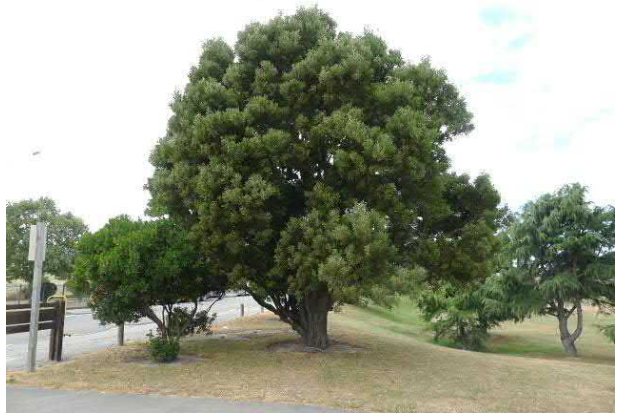
68 - 93408

Survey Number	Tree ID	Species	Common Name	Height	Canopy Spread	DBH	Tree Health	Tree Form	Overall Condition	Comments
68	93408	Acacia melanoxylon	Tasmanian Blackwood	8.0	8.0	0.6	3	4	4	Multiple stems from ground level, multiple included unions. Several delaminated branches.
69	93409	Arbutus unedo	Irish Strawberry Tree	3.0	3.0	0.2	3	4	4	Reasonably good foliage density. Multiple stems near base, and canopy to near ground level. Heavily suppressed by adjacent trees.
70	93405	Arbutus unedo	Irish Strawberry Tree	3.0	4.0	0.35	2	3	3	Reasonably good foliage density. Multiple stems near base, and canopy to near ground level.
71	93400	Arbutus unedo	Irish Strawberry Tree	2.5	4.0	0.25	2	4	4	Reasonably good foliage density. Multiple stems near base, and canopy to near ground level. Previous branch failures in the mid canopy.
72	93397	Arbutus unedo	Irish Strawberry Tree	4.0	7.0	0.4	2	3	3	Reasonably good foliage density. Multiple stems near base, and canopy to near ground level. Previous branch failures on the north-western side and mid canopy.
