Intrusive Investigation Report

Grand National (Public) Stand

Client: Canterbury Jockey Club

14-Apr-2015

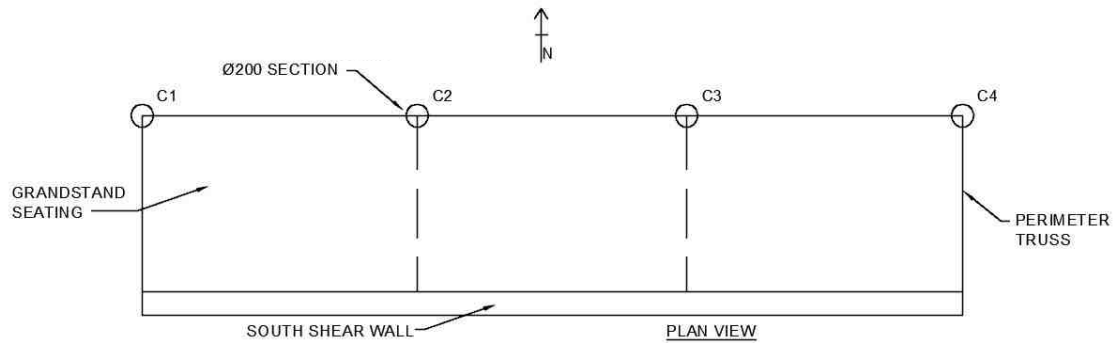
Figure 5: Layout of grandstand support columns

The main columns supporting the upper and lower stands are 200mm diameter concrete filled metal tubes. From a simple sounding test, these columns appear to be filled with concrete, although their exact specification is unknown. Column verticality measurements were taken with a digital spirit level on both the upper and lower stands. It was too bright to take measurements using a laser plumb and as such, more refined measurement will be required at the detailed investigation stage.

The position of the columns have been marked in Appendix B, on the initial observation plans B.001 to B.004, and are reproduced diagrammatically in Figure 5.

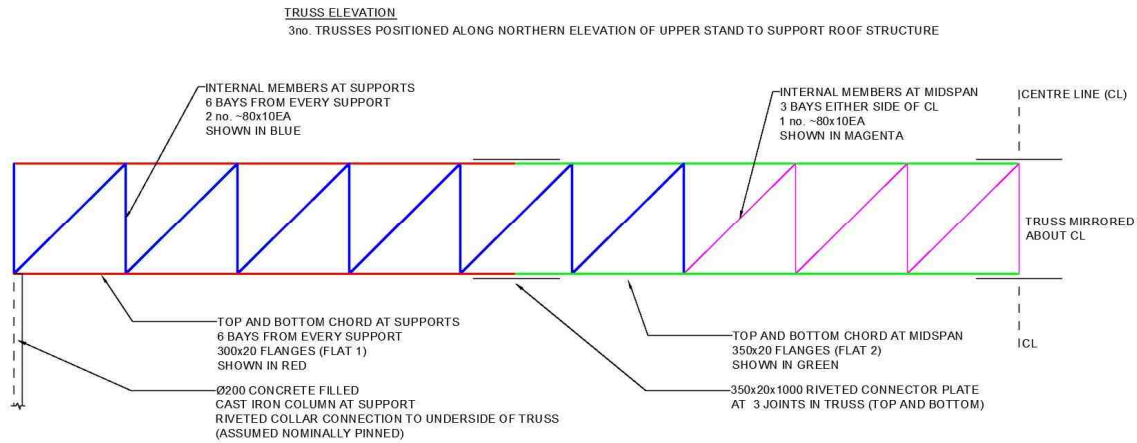
Figure 8: upper stand roof truss along northern elevation

Further commentary on the roofing system components is given in Table 4 and in Figures 8 to 12 respectively.

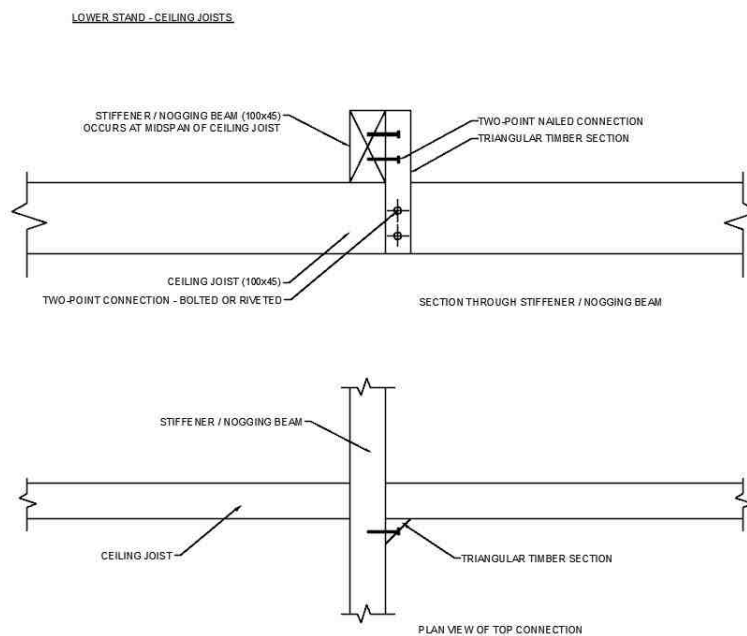
Figure 12: Ceiling joist stiffener connection

The ceiling joists are simply supported timber members spanning one bay between trusses (shown in magenta). At the mid-span of these ceiling joists there is a stiffener beam to prevent local buckling of the ceiling joists (seen in magenta, as a single member running perpendicular to joists). The ceiling joists are installed in-line with the bottom chord of the truss and serve as a support grillage for anti-bird mesh. There is secondary timber bracing running diagonally across the ceiling joists (shown in cyan) and these members serve to stabilize the truss and prevent local lateral torsional buckling of that member.
