24 March 2017  
File: 0294

## **OLD MUNICIPAL CHAMBERS REPAIR, RECONSTRUCTION & RESTORATION: DEVELOPED DESIGN**

### **ARCHITECT DESIGN REPORT CONSERVATION ARCHITECT HERITAGE ASSESSMENT REPORT**

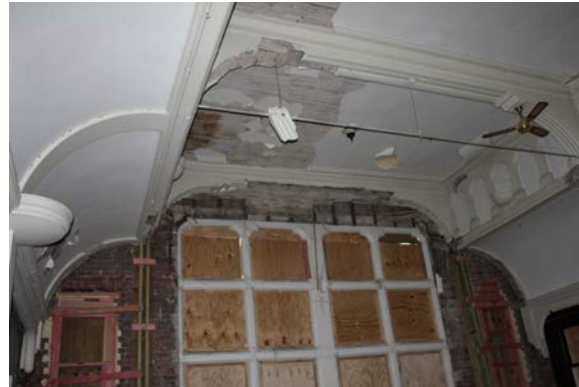
The Council Chamber, south window and wall. The inner wythe of brick collapsed exposing the rear of the figurines either side of the window and the plaster render collapsed off the wall in its entirety.

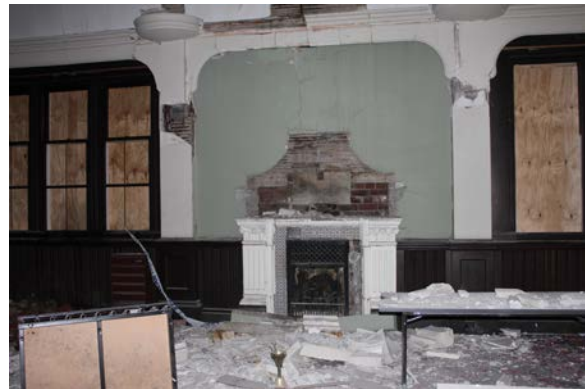
The partially collapsed fire surround and over mantle of the west fireplace in the Chamber following the February 2011 earthquake.

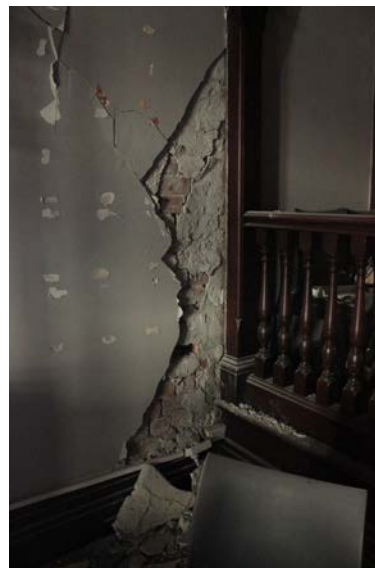
The damaged wall adjacent to the Library arcade balustrade.
