Old Municipal Chambers

Geotechnical Report

Old Municipal Chambers Geotechnical Report

PREPARED FOR: Christchurch City Council

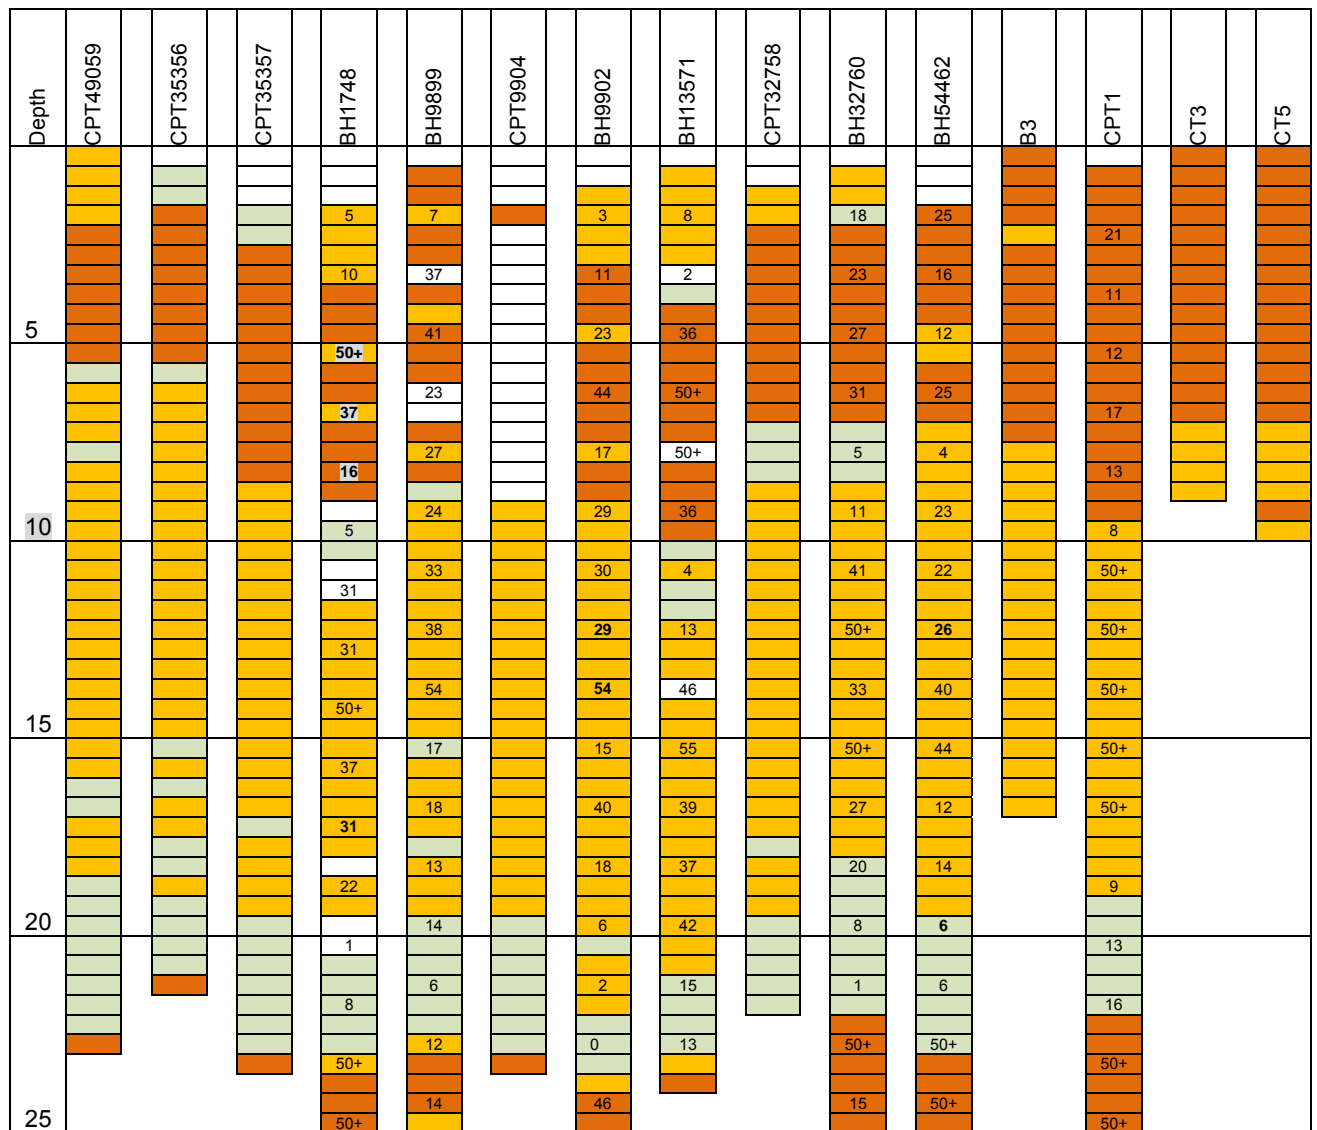
The surface soils (fill, basecourse or topsoil) overly predominantly silty sand with some silt and silt lenses, which in turn overlies sandy gravel. The depth to the gravel varies between about 0.6m and about 4m in the tests around the site. The gravel is closer to the ground surface on the east side of the river where the ground elevation is about 1m lower than Cambridge Terrace on the west side. The thickness of this gravel also varies considerably from less than 4m to over 7m.

The gravel extends to between about 5m and 10m depth, overlying predominantly sand soils which are often loose between the gravel and about 12m depth and then dense to very dense. Below about 18m there is a sequence of interbedded silt, sandy silt and sand. The Riccarton gravel was contacted at between 21m and 23m depth in the tests around the site; some of this variation will be due to changes in ground level.

Tests are in clockwise order starting from south of the site; refer Table 3.2
 Numbers in cells are SPT 'N' values (blows per 300mm penetration) uncorrected;

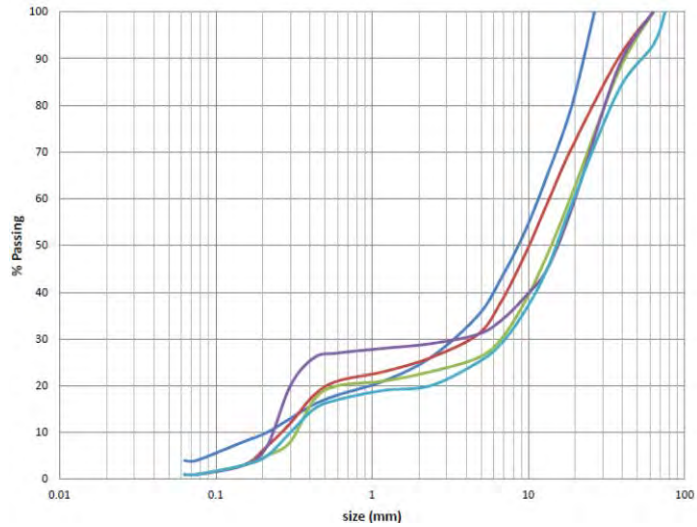
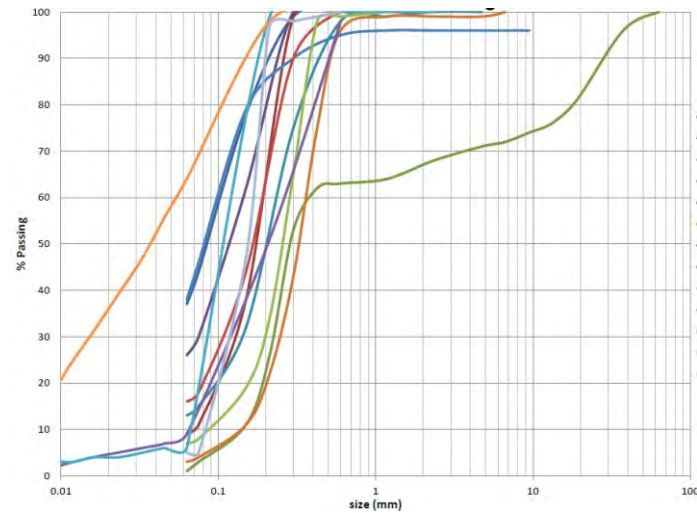
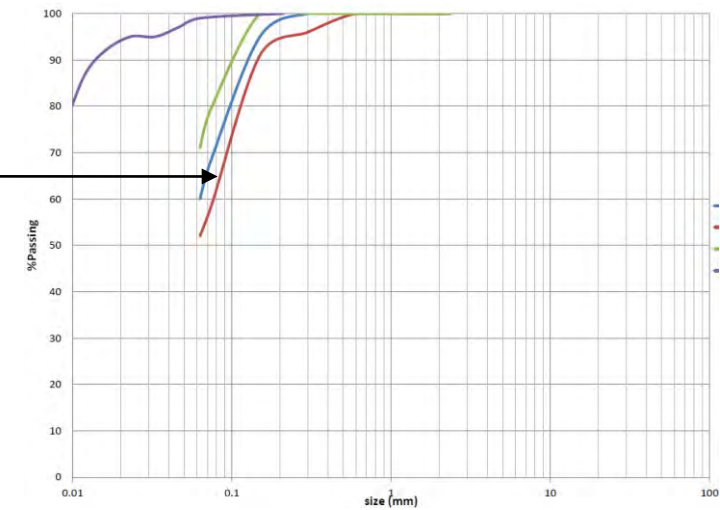
Figure 4.2 Grading curves for samples

The particle size distribution curves for the site to the south are plotted together in Figure 4.2, grouped for the shallow gravel, sands and deeper silty soils above the Riccarton gravel, to show the typical grading and range for each of the main strata. Figure 4.2(c) also shows the curve for a sample of the surface sandy silt. The gravel samples all show a surprisingly similar grading with a noticeable gap in particles between 0.5mm and 5mm size.

There is a wider range of grading in the sand soils. There is a trend in increasing fineness with depth. One sample (13m depth) has an appreciable (30%) gravel content, while a sample from 16m is similar to the soils below 18m depth.
