ROBERT MCDUGALL ART GALLERY

ROBERT MCDOUGALL ART GALLERY – DETAILED SEISMIC ASSESSMENT REPORT

Prepared For:
CHRISTCHURCH CITY COUNCIL

Date: 2 September 2013
Project No: 104653.02
Revision No: 1

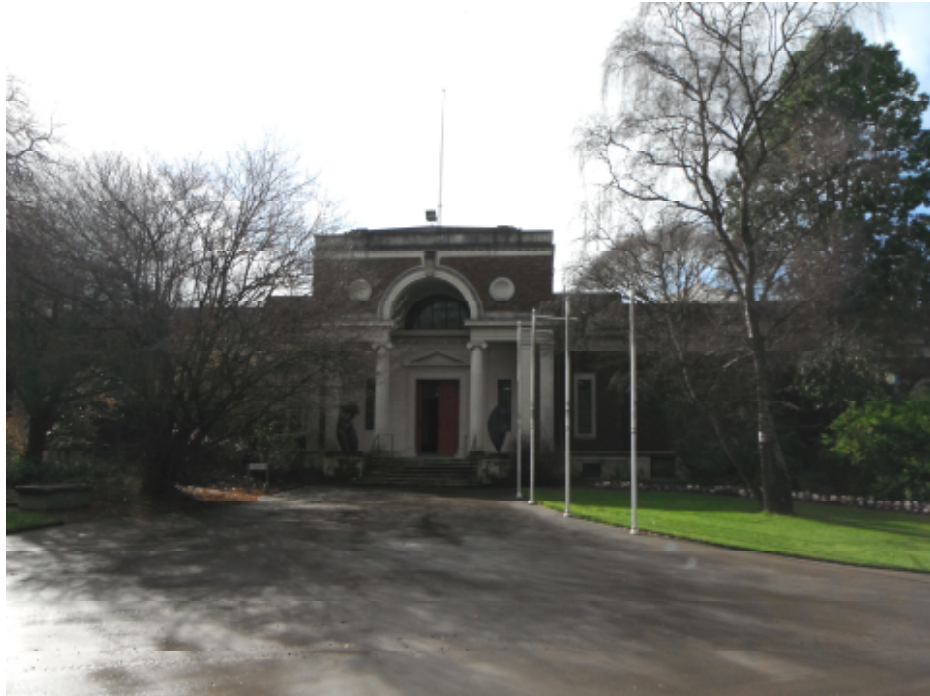
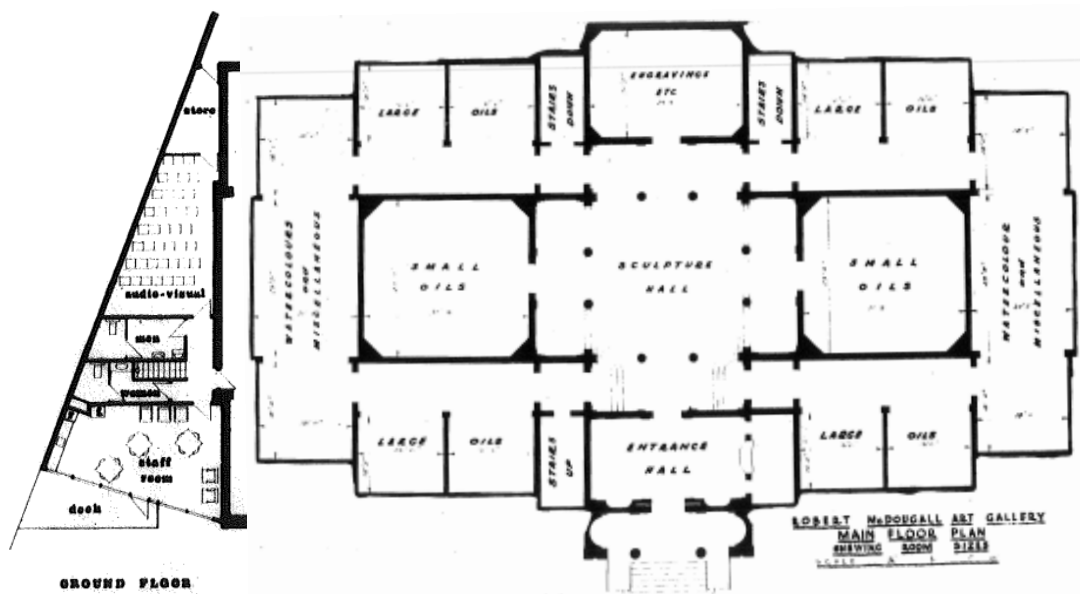
Figure 3-1: Robert McDougall Art Gallery

The McDougall Art Gallery was designed in 1930 and building opened in 1932. The original building is predominantly one storey with basement through approximately two thirds of the footprint (the original basement only extended on the east side of the building but was extended). Above the entrance hall there is a second floor with office space. The Canaday Wing attached to the north end of the gallery is a two storey addition constructed in 1983 (Figure 3-1).

The walls are generally tied together at their top by concrete (assumed to be lightly reinforced) roof slabs although these slabs are not complete plate elements due to the presence of central skylights. The main floor is an in-situ reinforced concrete slab on in-situ beams. The foundations are formed by strip footings beneath the basement wall lines (which correspond to the gallery walls above) and individual pad footings beneath the interior columns.

The Canaday Wing is constructed from a mixture of concrete block walls (assumed to be partially filled and reinforced), steel framing and timber flooring. Given the relatively new age of construction, it is expected that this will have had a level of seismic design carried out, commensurate with the building code requirements of that time (see Figure 3-2).

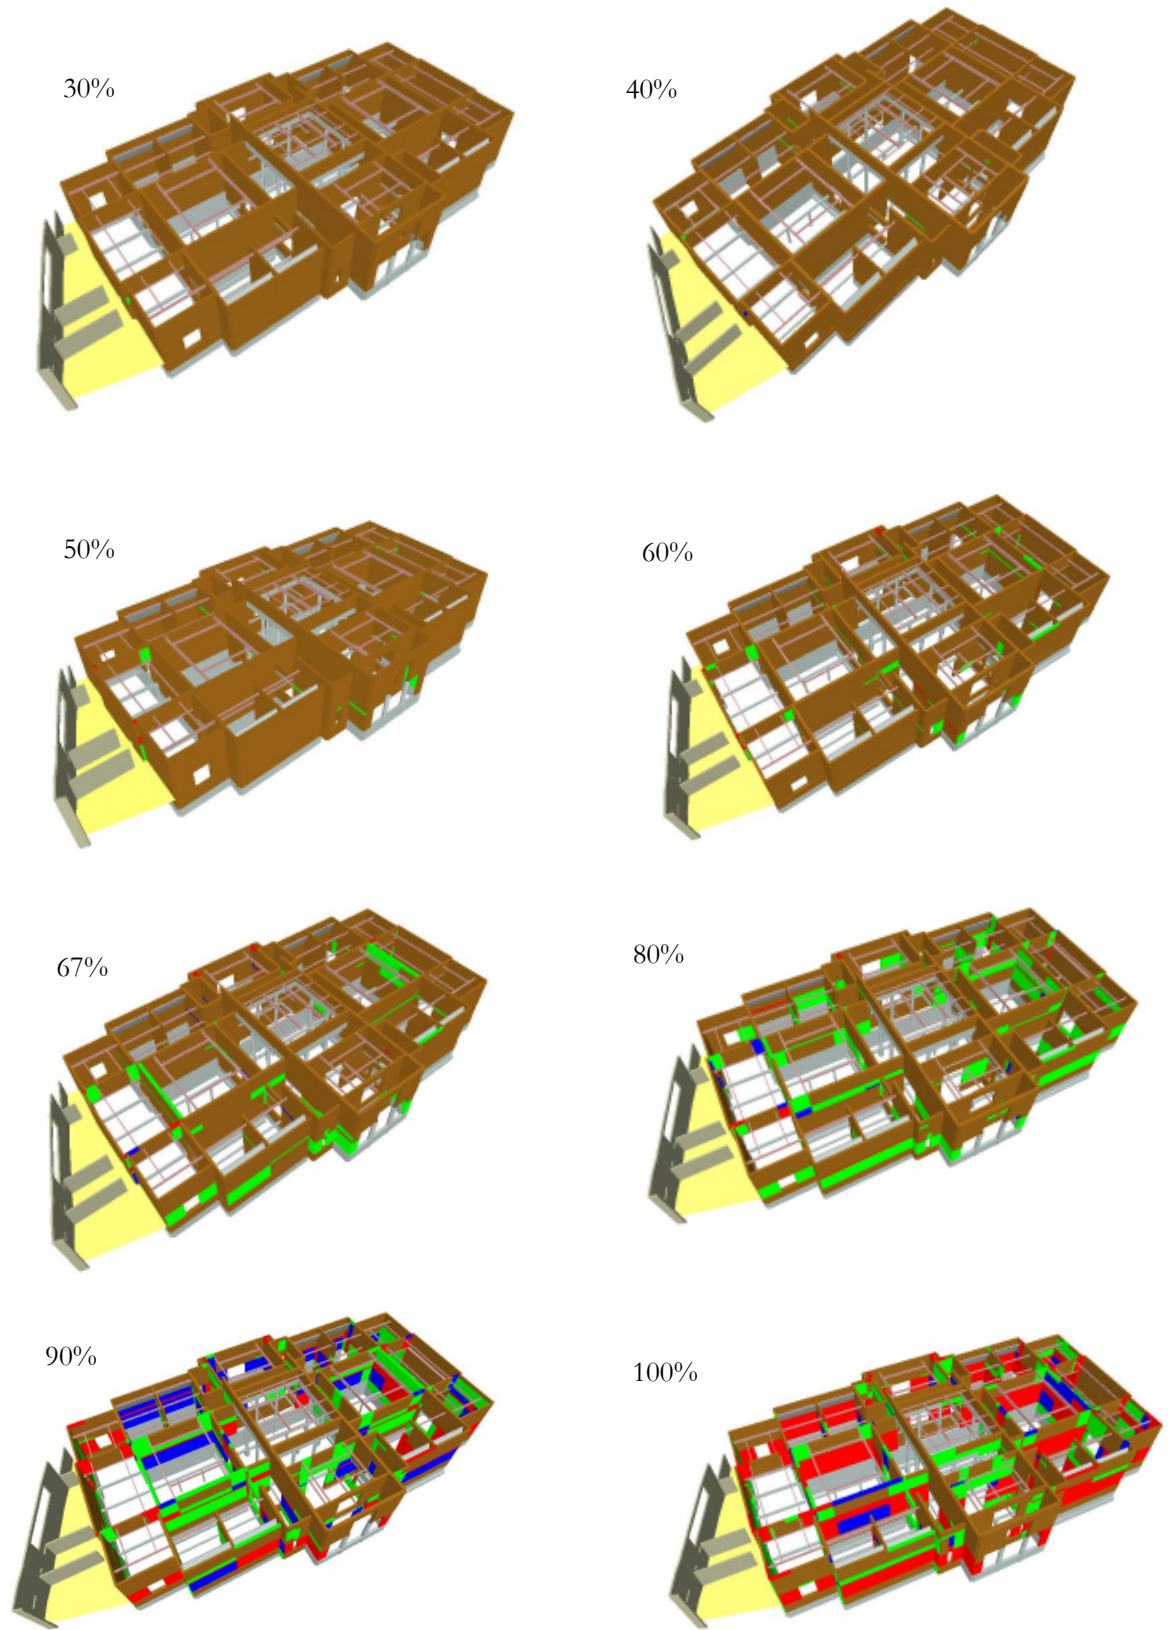
Figure 3-3: Comparison of damaged wall elements with increasing seismic intensity (% IL3 code demand). Green elements correspond to "Immediate Occupancy", Blue elements "Life Safety", Red elements "Collapse Prevention"

The non-linear time history assessment that was carried out utilised the numerical model shown in Figure 3-3 that was developed to run in the program ANSR. This model captures the inelastic behaviour of unreinforced masonry shear walls and therefore can be used to assess the development of damage in the walls and associated elements (lintel beams, foundation walls and pilasters). The analyses track the damage development at time intervals of 0.001 seconds through the course of each of three earthquake record pairs (i.e. both north-south and east-west recorded components of the earthquake). A full description of the analysis can be provided in an analysis specific report.

The suit of three real earthquake records, scaled according to Code specifications for this Christchurch site (allowing for soil type and proximity to a potential fault-line), were run at a range of intensities to identify the level of demand at which damage accumulation becomes critical to the buildings ability to sustain gravity loads. It was evident that this critical point occurred around 67% of current code demand for an IL3 building. Beyond this level of demand the wall elements rapidly lose their integrity and have an increased potential to collapse under gravity loads. The following Figure 3-3 provides a visual comparison the damage development with increasing seismic demand. The colouration of the elements corresponds to the damage limit state that has been exceeded by each element. The Life Safety limit state corresponds to current code Ultimate Limit State performance requirements, while Immediate Occupancy implies that the building can be occupied with minor repairs required.

Another way of viewing these results is that between 90% and 100% sufficient extents of wall reach their Collapse Limit State (CLS) to form a global failure mechanism for the building. While New Zealand design codes do not specifically refer to the CLS, if we assume a margin between Collapse and Ultimate Limit States (ULS) of 1.5x (which is approximately the margin for new buildings designed and constructed to current code) then $100\%/1.5 \sim 67\%$ which can be treated as the effective capacity as a percent of current code demand.

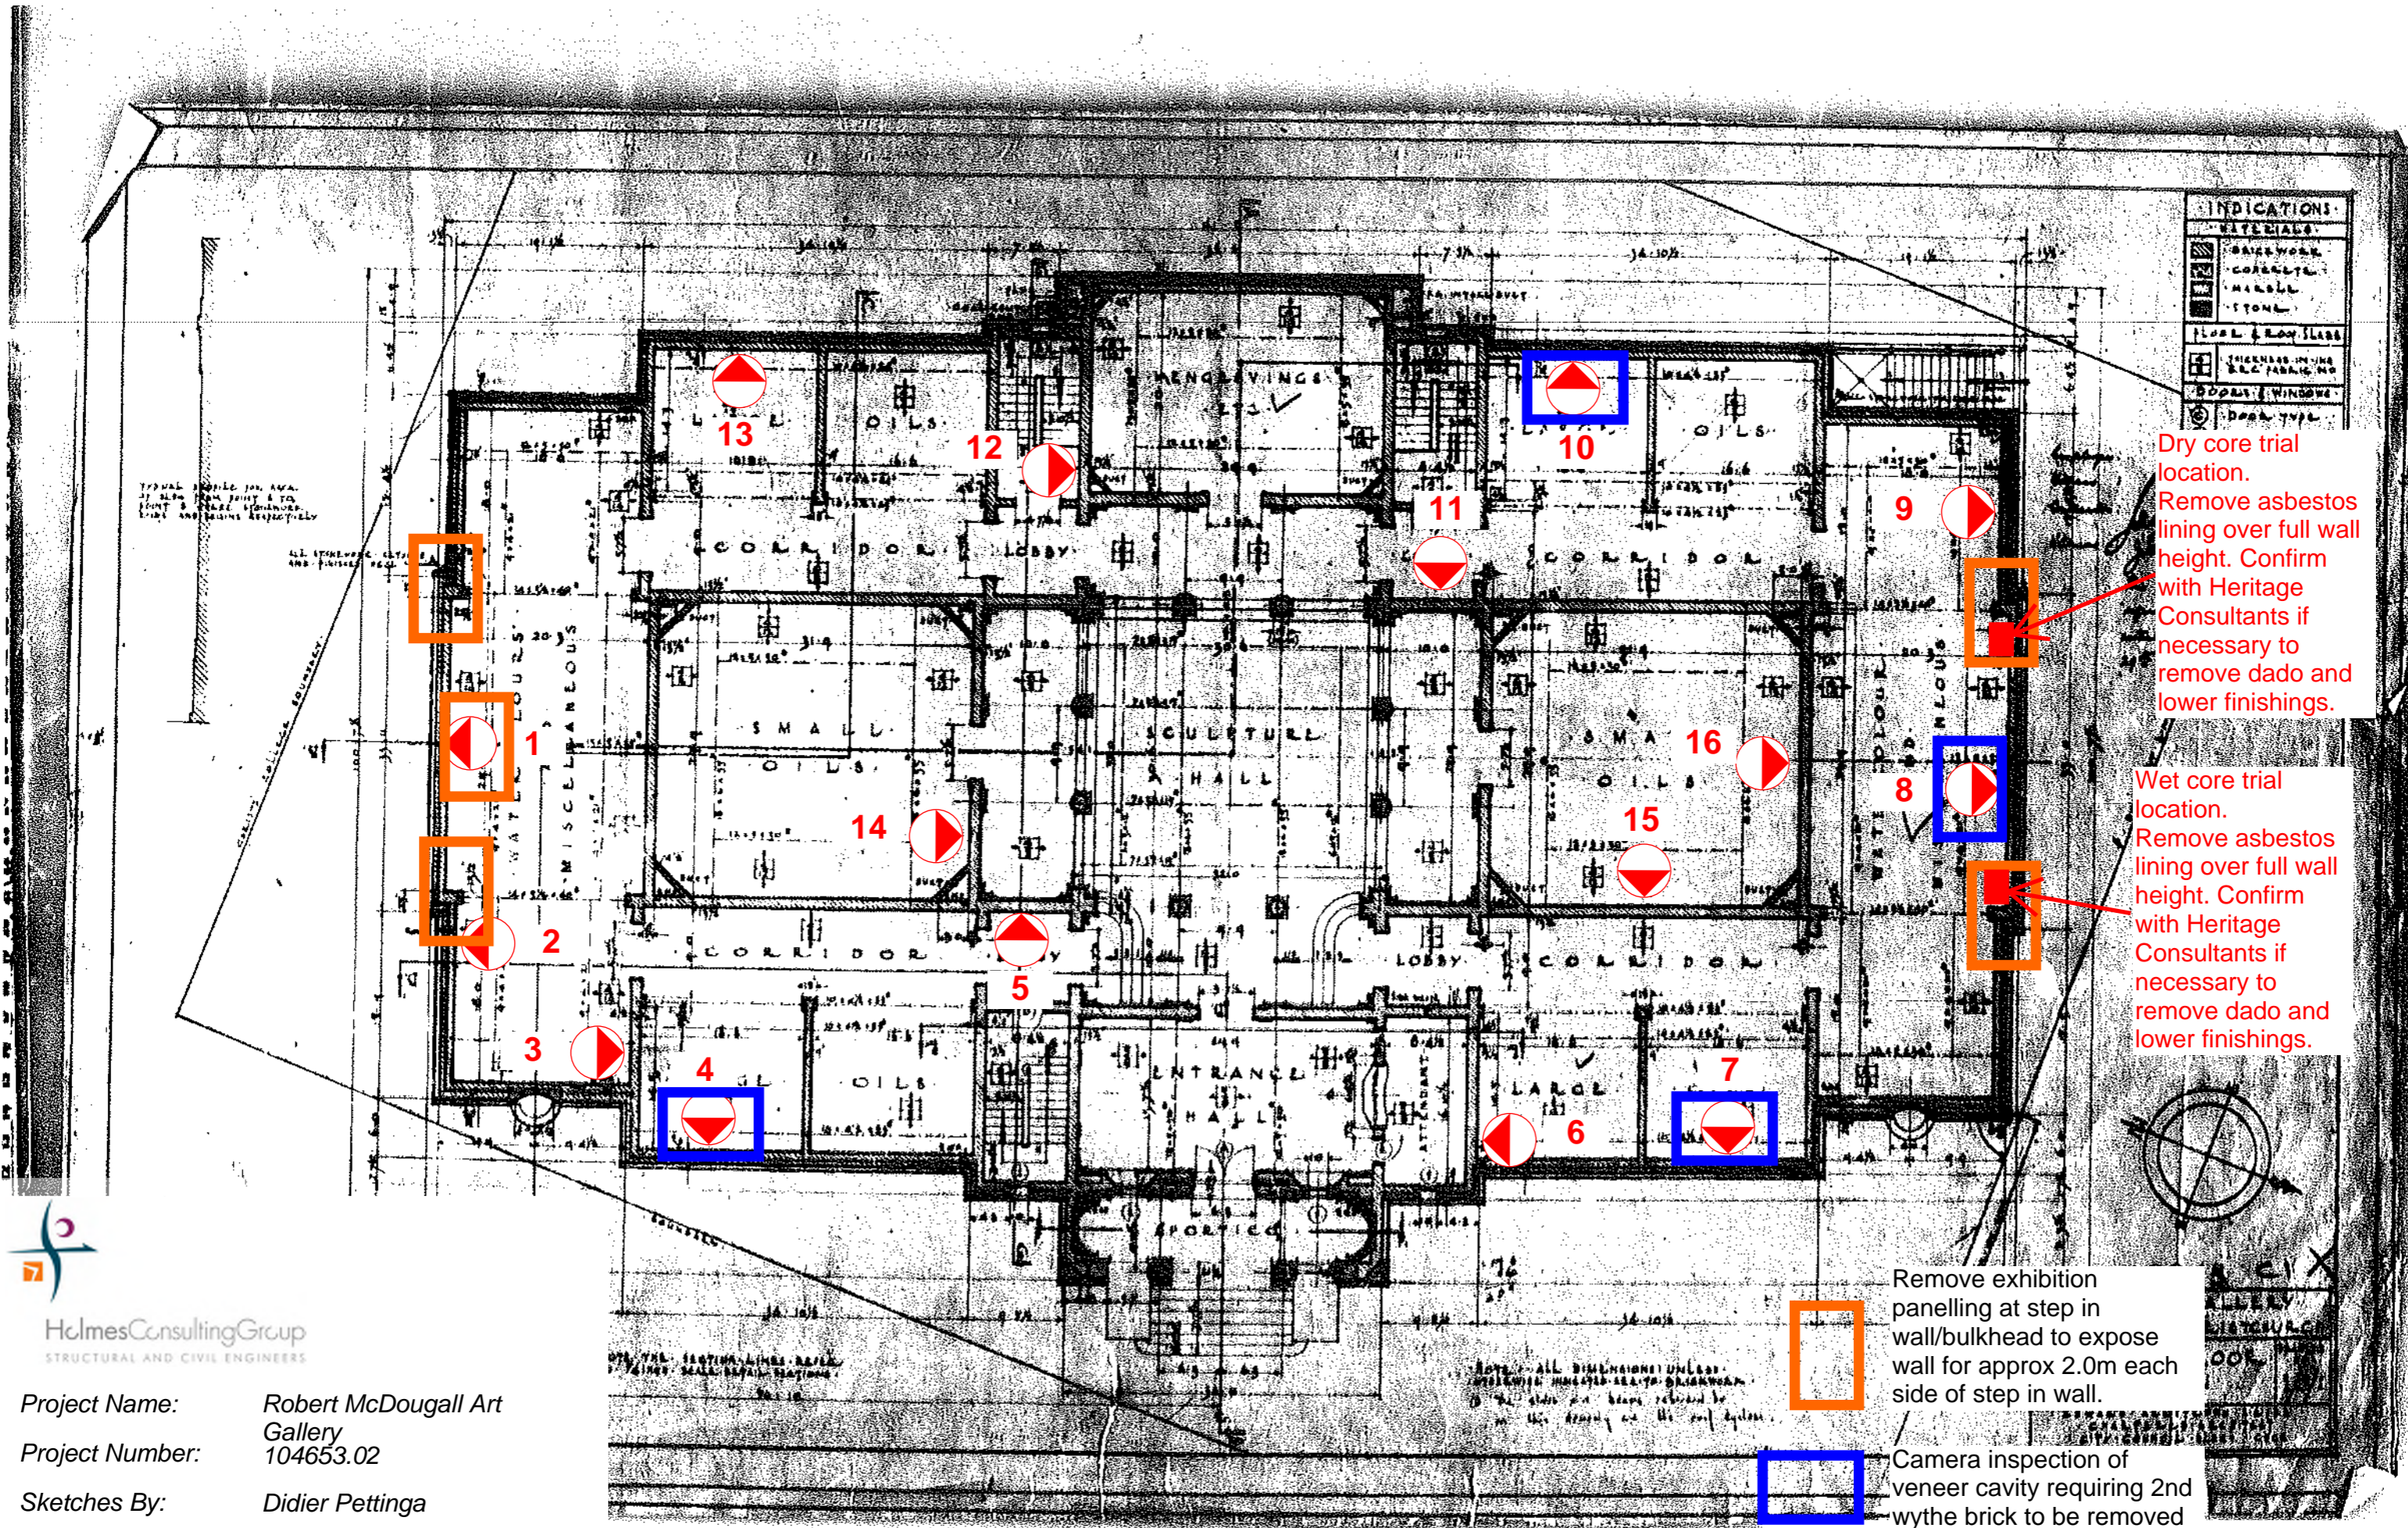
Dry core trial location.
Remove asbestos lining over full wall height. Confirm with Heritage Consultants if necessary to remove dado and lower finishings.
