**Canterbury Earthquakes 2010/11 Port Hills Slope
Stability: Earth/debris flow risk assessment for
Defender Lane**

**GNS Science Consultancy Report 2014/67
August 2014 FINAL**

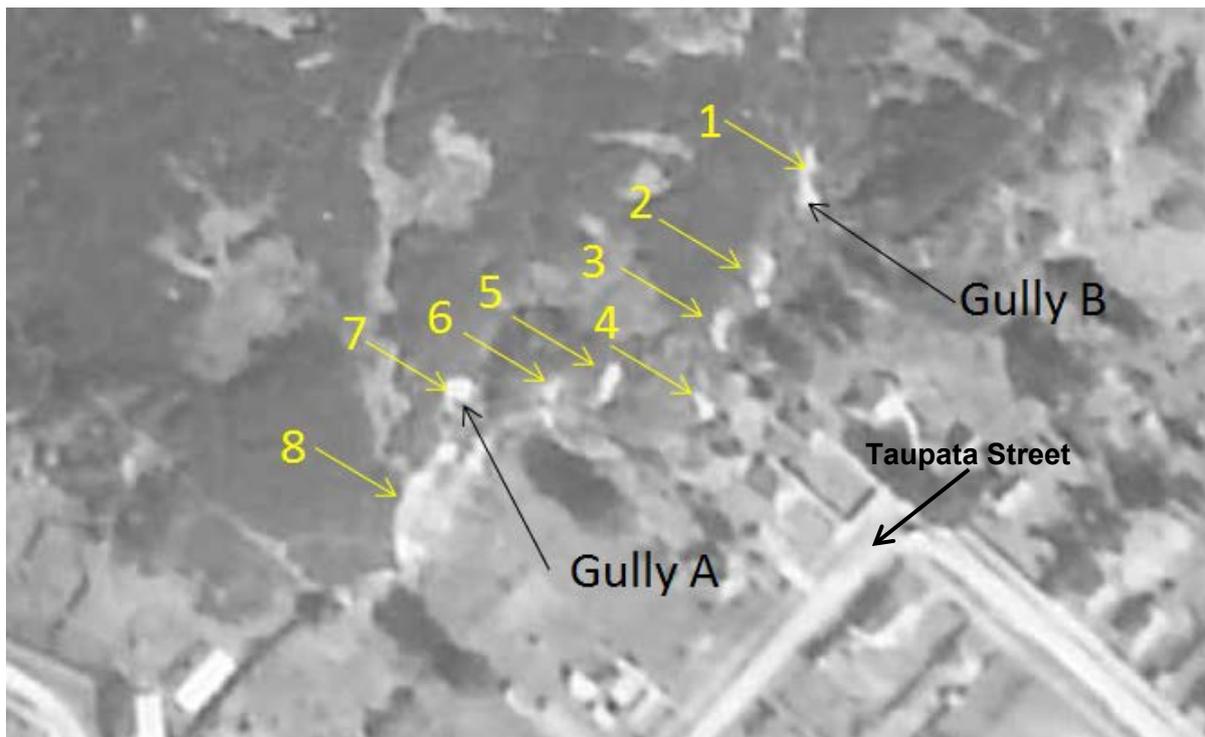
Date/scale of photo	Resolution	Comments
1940 1:10,000 (approx.)	Poor resolution	Eight small areas of bare ground (Areas 1–8 showing as white in Figure 5, are present along the slope facing towards the northeast appear to indicate eroded/unstable loess slope areas. No buildings are present on the slope, and the slope appears vegetated with trees or dense scrub. Several gullies are apparent in the surface of the slope. No buildings appear present immediately below the slope with only some present along 26–28 Taupata Street. Scouring along the gully A and B is apparent in Areas 1 and 7 (Figure 5). There appears to be a cleared track partly along what is now Egnot Heights.
1946 1:5,500 (approx.)	Good resolution	Several small possible landslide scars are apparent in the loess along the cliff crest, e.g., Areas 1, 5, 7 and 8 (Figure 6). Debris from Gully A is clearly visible. This debris has been later excavated for housing development. Scouring along Gullies A and B is visible. No housing development along cliff edge of Defender Lane or beneath the slope face has yet taken place.

Figure 5 1940 aerial photograph showing gullies A and B and several areas of bare ground/possible landslide scars numbered 1–8.

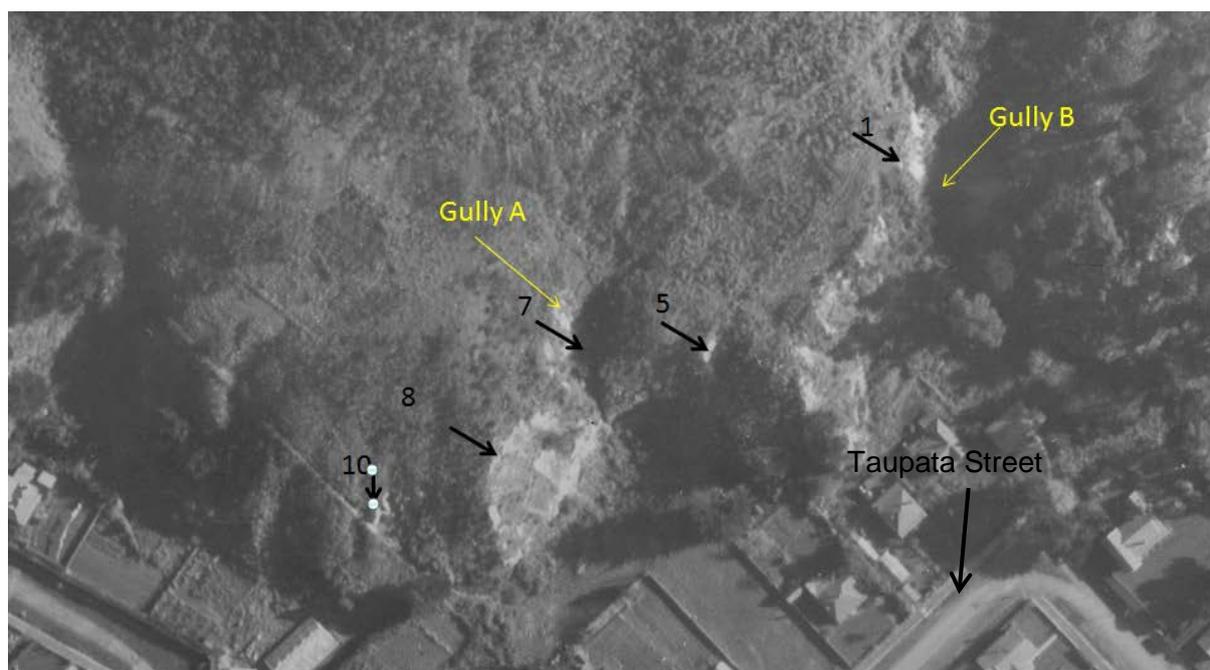
Figure 6 1946 aerial photograph, showing gullies A and B and several areas of bare ground/possible landslide scars (numbered).

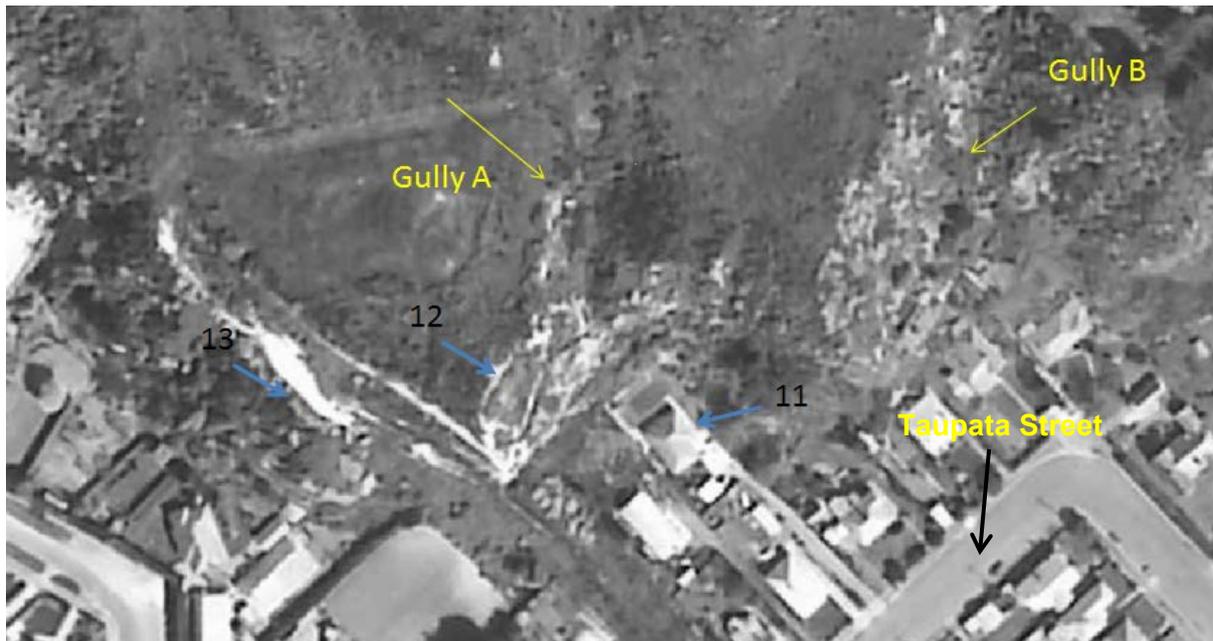
1973 1:10,000 (approx.)	Poor resolution	Most of the buildings currently present along the front on Taupata Street appear to have been constructed. Some scouring is apparent along the slope face south of Gully A, Area 12, (Figure 7). Development has occurred along Egnot Heights, Area 13 (Figure 7). No housing development has yet occurred along the slope crest of Defender Lane or beneath the slope face.
1984, 1:6,000 (approx.)	Good resolution	No housing development has yet occurred along the slope crest of Defender Lane or beneath the slope face. Land modification and clearing appears to have commenced beneath the south facing slope of what is now Egnot Heights, Area 21 (Figure 8). Some scouring is apparent on the northern flank of Gully A, Area 20, (Figure 8).
2003	Google Earth Historical Imagery	Houses have now been constructed along the slope crest of Defender Lane. Gully A has been partially backfilled for housing development of 24 Egnot Heights.

Figure 7 1973 aerial photograph, showing gullies A and B and several areas of bare ground/possible landslide scars (numbered).

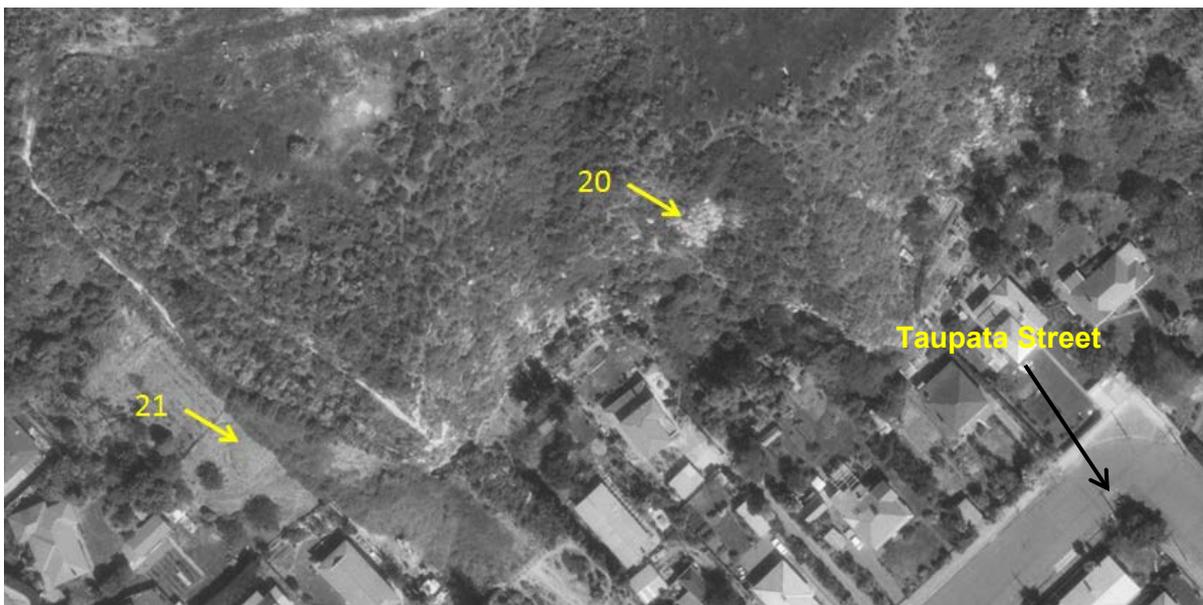
Figure 8 1984 aerial photograph, showing gullies A and B and several areas of bare ground/possible landslide scars (numbered).

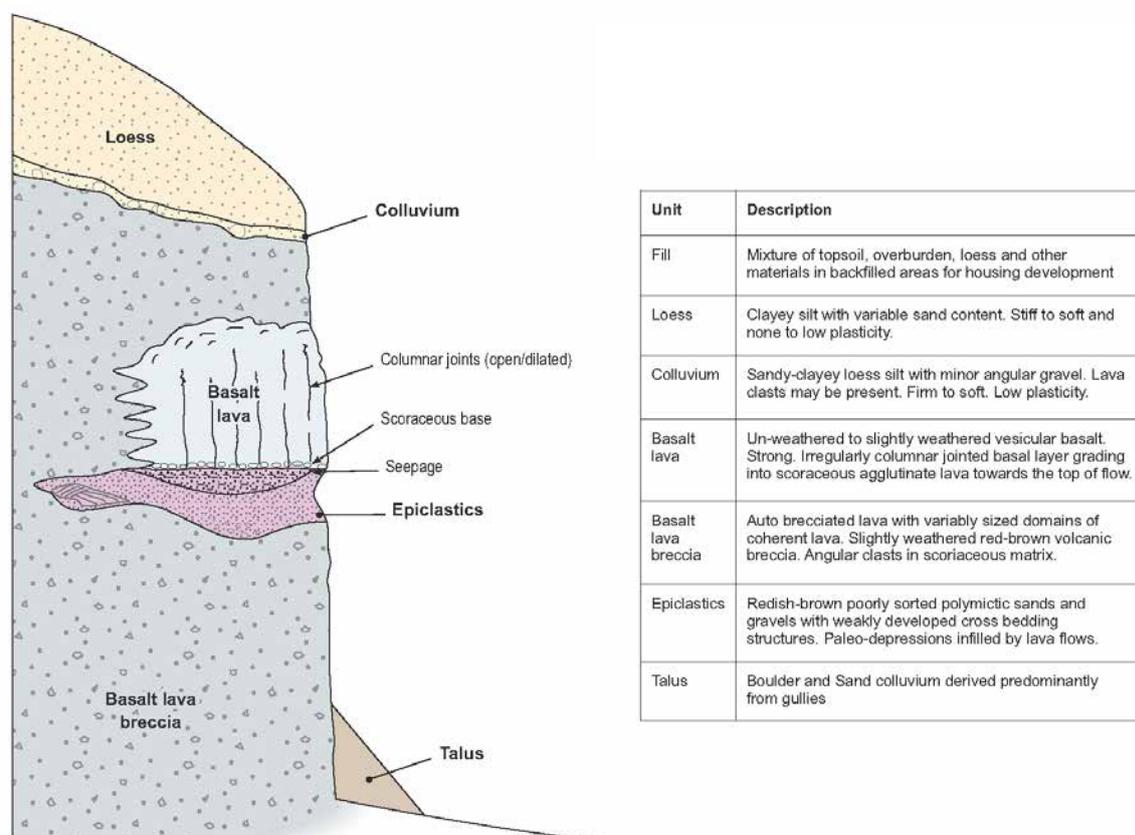
The cliff face comprises shallow (flat to locally 25°), easterly-dipping, highly variable (both laterally and vertically) basaltic lava flows with blocky irregular basal columnar-joints. Joint spacings are highly variable from less than a meter to many meters. A variable auto-brecciated scoria/lava (basalt lava breccia) forms the lower most exposed unit at the base of the cliff line. The schematic cross-section (Figure 14) shows where the scoria and lava flows units are separated by an epiclastic layer.

Figure 14 Schematic lithological summary of the materials at the Defender Lane mass movement.

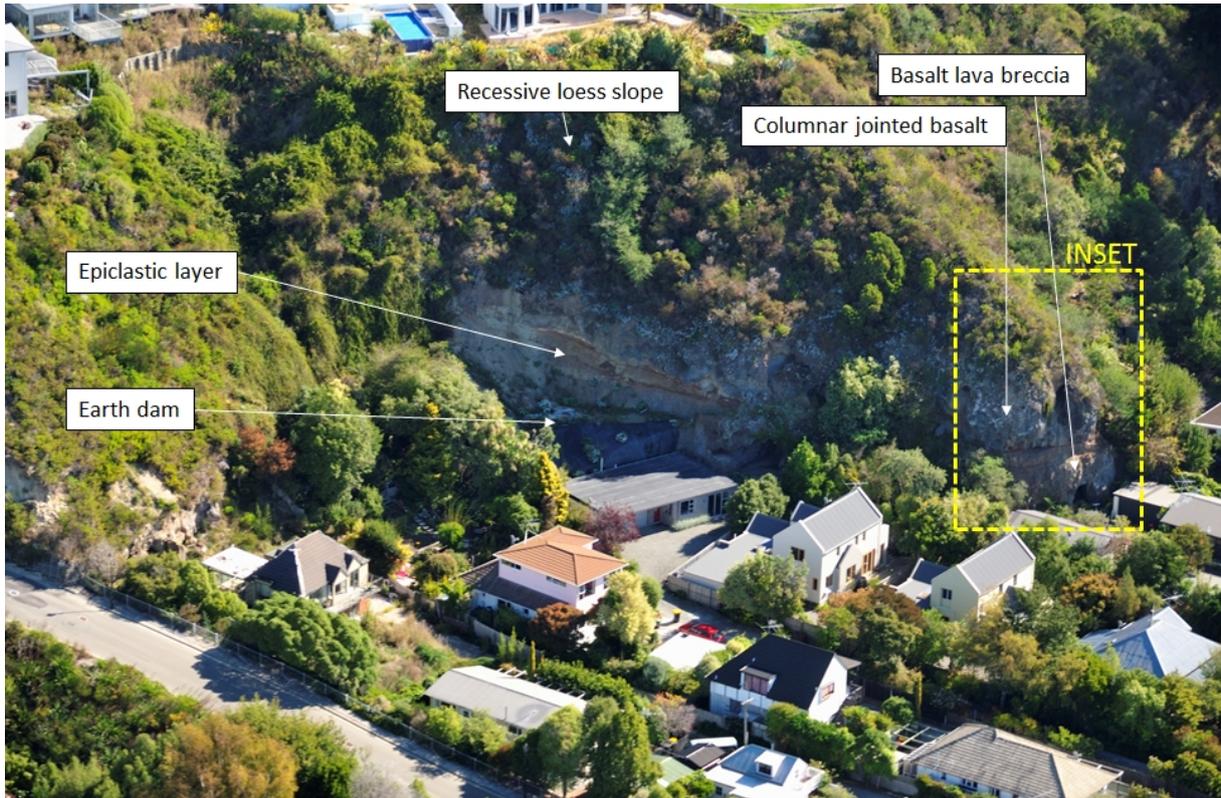
This unit underlies conformably the columnar jointed basalt flow. It forms reddish-brown poorly sorted polymictic sands and angular gravels with weakly developed cross bedding structures. In some locations this unit appears to comprise fine-grained silts and clays. These materials are highly variable both laterally and vertically. Good exposures occur along the cliff face behind 30B Taupata Street where the paleo-depressions are infilled by columnar jointed lava flows (Figure 15 and Figure 16).

Figure 15 Key lithologic units at the Defender Lane mass movement.

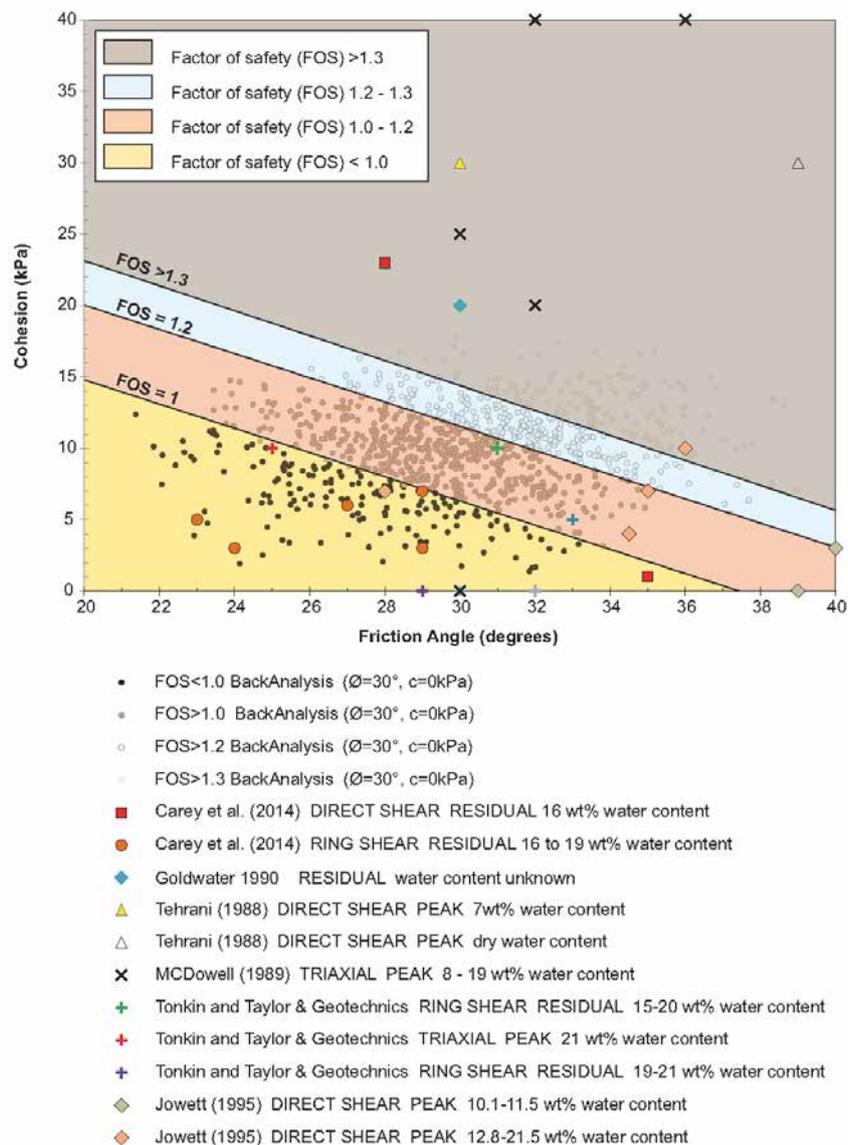
- As previously established in Section 3.3.2.2, the shear strength of the loess, particularly the cohesion, is very sensitive to changes in water content. Figure 22 shows that the factor of the safety of the slope is fundamentally linked to the shear strength of the loess. For example at a friction angle of 30°, a drop in cohesion from 10 to 5 kPa represents a decrease in factor of safety from greater than 1.1 to less than 1.

The sensitivity of the loess slope at the Defender Lane mass movement to changing water contents was addressed in this study by adopting a range of strength parameters for the stability assessments (friction (ϕ): 25–35° and cohesion (c): 5–30 kPa).

Figure 22 Sensitivity assessment of the loess slope bulk shear strength parameters of friction and cohesion from limit equilibrium modelling. Datapoints shown as diamonds represent modelled slide surfaces with factors of safety >1. Data points shown as crosses represent modelled slide surfaces with a factors of safety <1. The larger circles represent the shear strength of the samples tested in the laboratory.

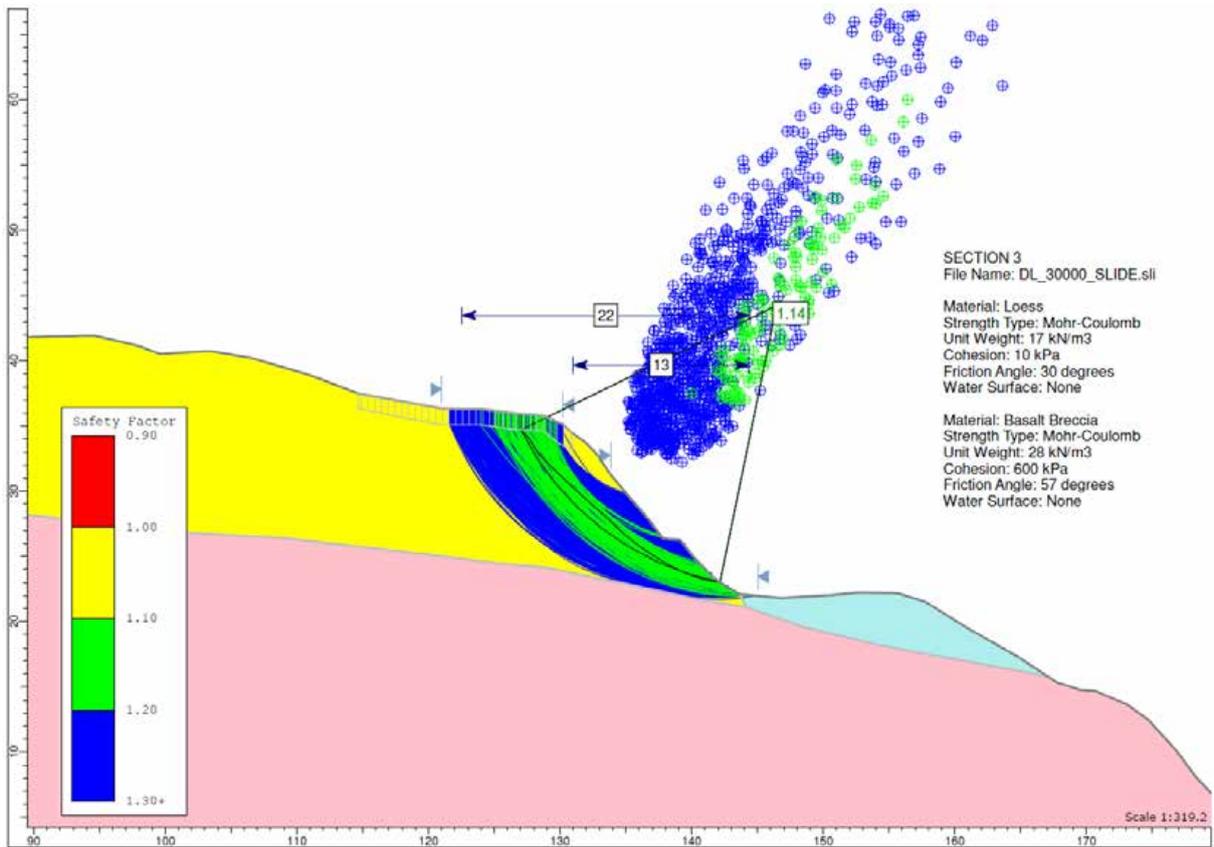
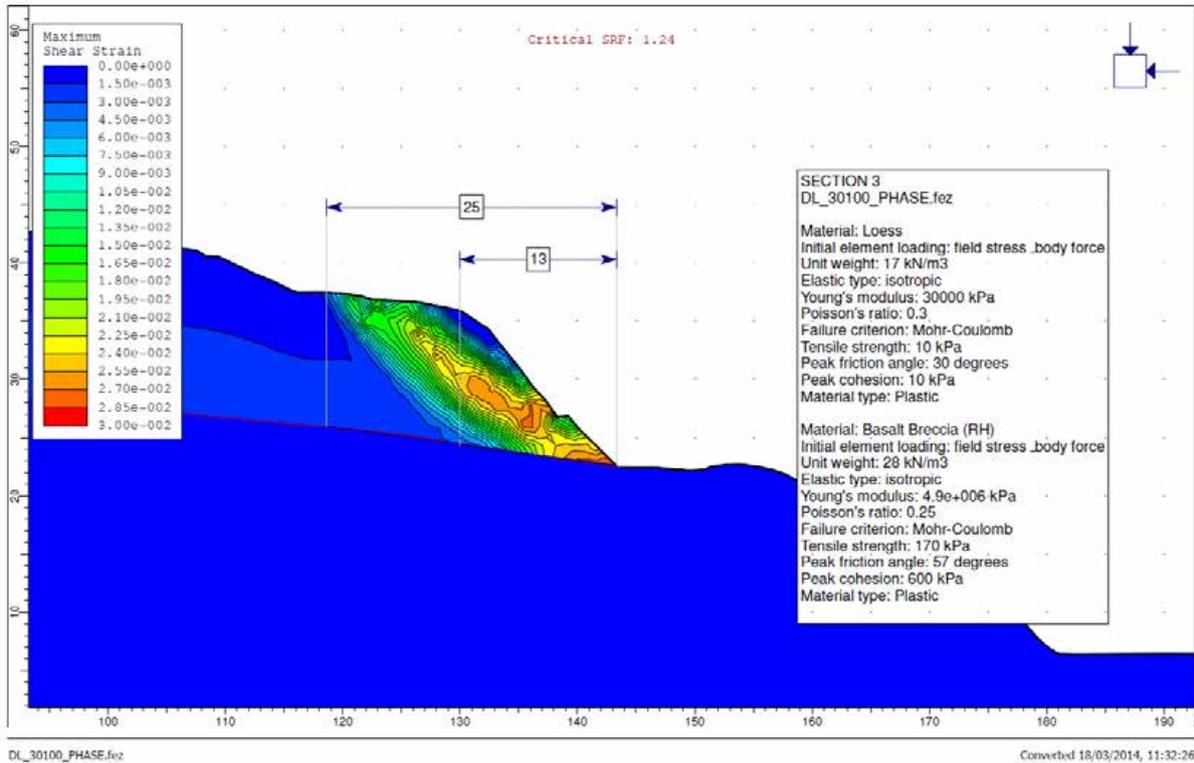
Figure 29 Mechanism 1. Limit equilibrium and finite element modelling assessment results for cross-section 3, adopting friction (ϕ) = 30°, and cohesion (c) = 10 kPa.

If a slope has a static factor of safety of one, then the slope is assessed as being marginally stable. Slopes relating to structures designed for civil engineering purposes are typically designed to achieve a long-term factor of safety of 1.5 under drained conditions, as set out in the New Zealand Building Code. Results from the stability assessment indicate that if the loess shear strength parameters that are typically used in the Port Hills (M. Yetton, Geotech Consulting Ltd., personal communication 2013) are adopted (friction (ϕ) = 30° and cohesion (c) = 10 kPa), then the factors of safety of the assessed cross-sections 1, 2, 3, 5 and 6 are generally less than 1.3. The exception is cross-section 7, where the factor of safety is greater than 2. Results from the stability assessment, adopting loess shear strength parameters of friction (ϕ) of 35° and cohesion (c) of 30 kPa, indicate the factors of safety for the sections assessed range from 1.7 to 2.3.

If the lower shear strength parameters are representative of the *in situ* loess within the Defender Lane assessment area, then it is likely that failure of the assessed slide surfaces could occur under static (rain) conditions.

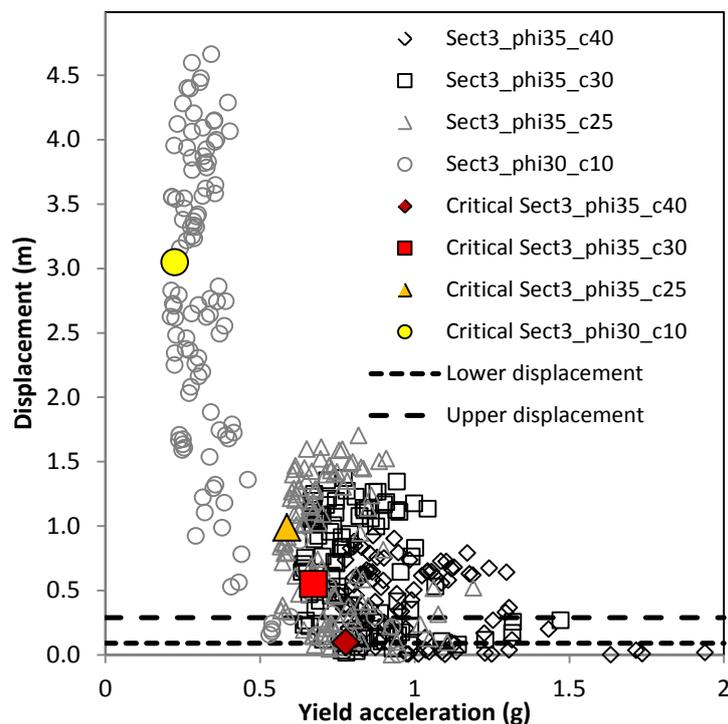
Figure 33 Modelled Slope/W decoupled displacements for cross-section 3 Defender Lane, adopting variable estimates of the loess material strength, for failure mechanism 1. Each data point represents a modelled slide surface and the corresponding estimate of its displacement as a result of the 22 February 2011 earthquake – adopting the synthetic free-field rock outcrop earthquake acceleration time histories. Critical slide surfaces are those with the lowest yield accelerations for the given material strength parameters. The dashed lines represent the total recorded coseismic displacement (Upper displacement) and displacement with horizontal and vertical components only (Lower displacement) for the cross-section.

Results from the assessment show that for failure mechanism 1, the modelled slide surfaces have lower yield accelerations and larger calculated permanent displacements, than those modelled adopting failure mechanism 2. For failure mechanism 1, the “best” correlation between the inferred permanent coseismic displacements and modelled displacements is for modelled slide surfaces adopting loess material strength parameters of friction (ϕ) of 35° and cohesion of 30–40 kPa. The range of recorded displacements shown on Figure 33 and Figure 34 are those inferred: 1) only from crack apertures of the slope crest where both horizontal and vertical displacements had been recorded for the 22 February 2011 earthquake, referred to as “Lower displacement”; and 2) from all mapped and measured crack apertures, referred to as “Upper displacement”.

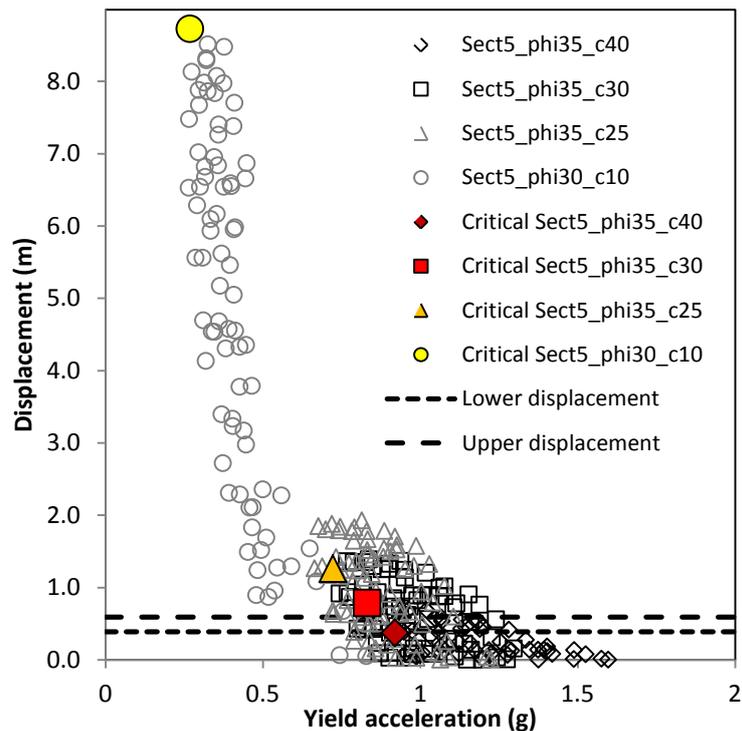
Figure 34 Modelled Slope/W decoupled displacements for cross-section 5 Defender Lane, adopting variable estimates of the loess material strength, for failure mechanism 1. Each data point represents a modelled slide surface and the corresponding estimate of its displacement as a result of the 22 February 2011 earthquake – adopting the synthetic free-field rock outcrop earthquake acceleration time histories. Critical slide surfaces are those with the lowest yield accelerations for the given material strength parameters. The dashed lines represent the total recorded coseismic displacement (Upper displacement) and displacement with horizontal and vertical components only (Lower displacement) for the cross-section.

Results from the assessment adopting the 13 June 2011 synthetic earthquake motions, and loess material strength parameters of friction (ϕ) = 30° and 35° and cohesion (c) = 10 and 30 kPa, are shown in Figure 34. The loess parameters of friction (ϕ) = 30° and cohesion (c) = 10 kPa were adopted as lower strength estimates as they represent the “typical” loess strength parameters used by engineering consultants working in the Port Hills. The loess parameters of friction (ϕ) = 35° and cohesion (c) = 30 kPa were adopted as “average” parameters as these gave the best correlation between recorded and modelled permanent coseismic slope displacements in response to the 22 February 2011 earthquake.

Results show that the magnitude of the modelled permanent displacements adopting the “average” loess strength parameters are within the range of recorded displacements. However, estimated permanent displacements adopting the “lower” strength estimates suggest displacements should have been much larger than those actually recorded,

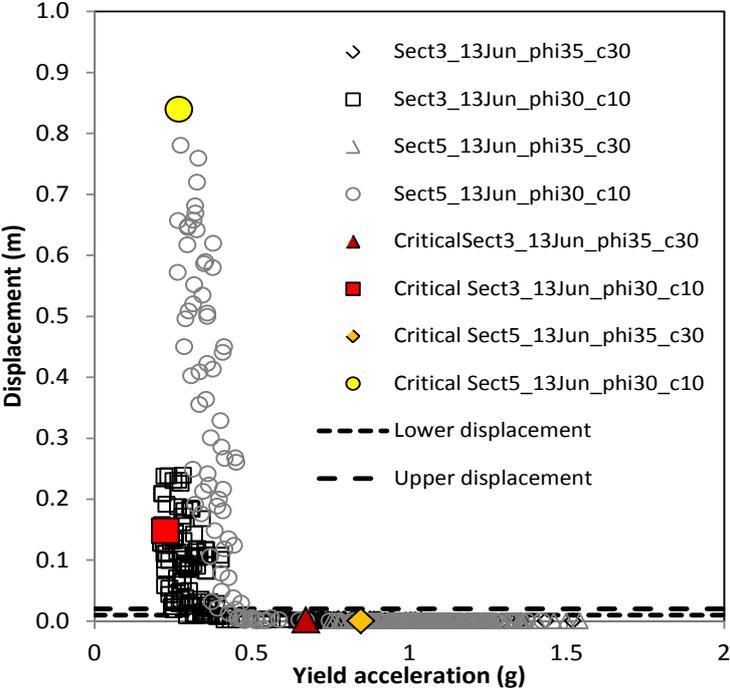
indicating the parameters are not representative of the loess at the time of the earthquake. The locations of the slope where recorded permanent displacements were both horizontal and vertical correspond well with the location of the modelled slide masses with the lowest yield accelerations (Figure 35).

Figure 35 Modelled Slope/W decoupled displacements for cross-sections 3 and 5 Defender Lane, adopting variable estimates of the loess material strength, for failure mechanism 1. Each data point represents a modelled slide surface and the corresponding estimate of its displacement as a result of the 13 June 2011 earthquake – adopting the synthetic free-field rock outcrop earthquake acceleration time histories. Critical slide surfaces are those with the lowest yield accelerations for the given material strength parameters. The dashed lines represent the total recorded coseismic displacement (Upper displacement) and displacement with horizontal and vertical components only (Lower displacement) for the cross-section.

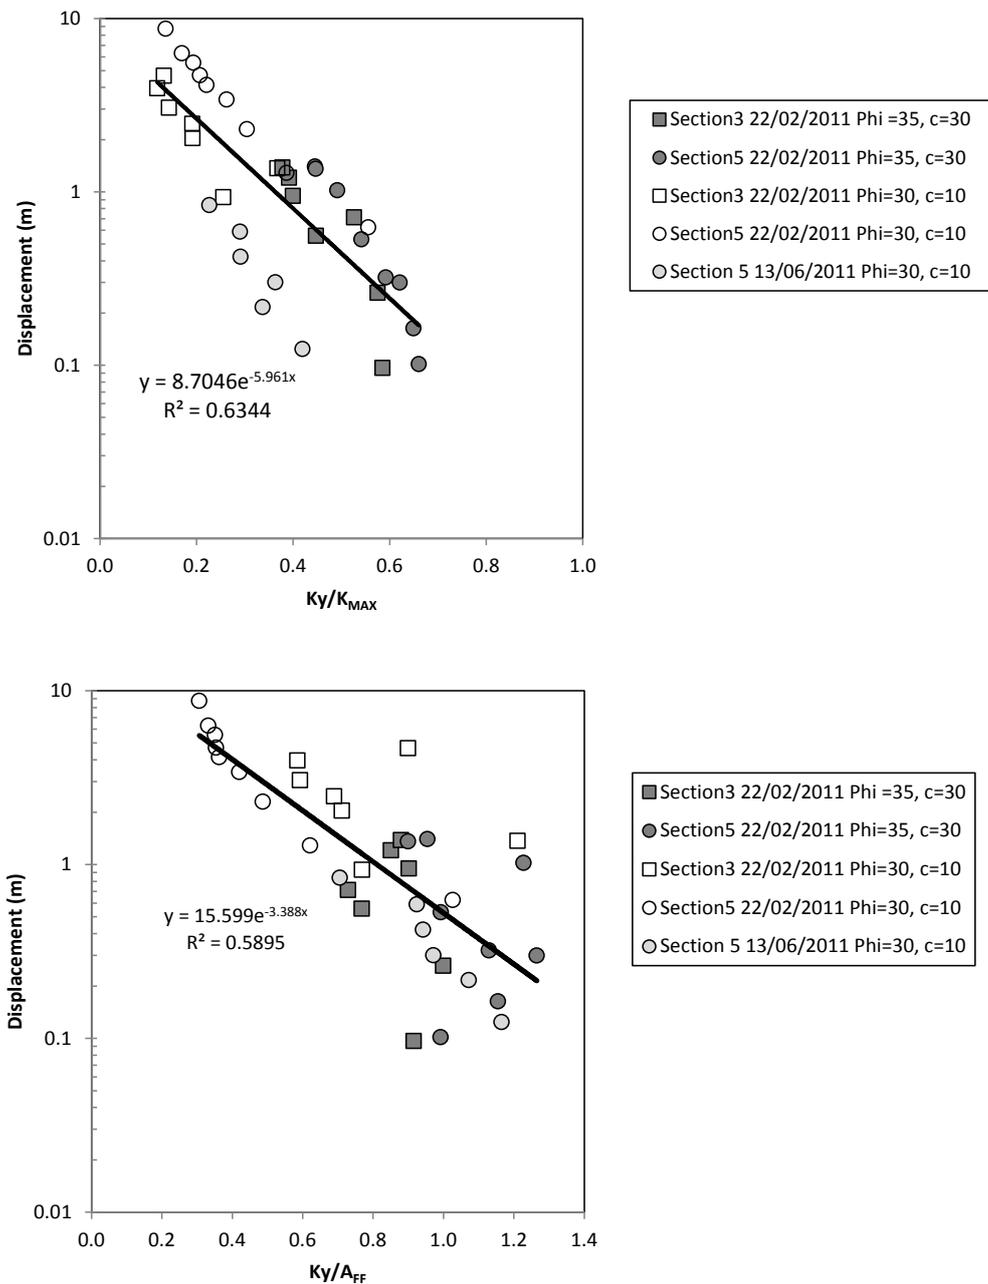
Figure 36 Cross-sections 3 and 5, decoupled Slope/W displacements calculated for different ratios of yield acceleration to maximum average acceleration of the mass (Ky/K_{MAX}) and the maximum acceleration of the input motion (Ky/A_{FF}), for selected slide-surface geometries. The results shown adopt the “average” loess strength parameters of friction (ϕ) = 35° and cohesion (c) = 30 kPa; and the “lower” estimates of ϕ = 30° and c = 10 kPa. Synthetic rock outcrop time acceleration histories for the 22 February and 13 June 2011 earthquakes were used as inputs for the assessment. (N = 39). The black dashed lines are exponential trend line fitted to the semi-log data. The formula and the coefficient of determination (R^2) for the trend lines are shown.

The results show that between K_y/K_{MAX} values of 0.2–0.8 and K_y/A_{FF} values of 0.2–1.2, the data are well fitted to a straight line (exponential trend line) in semi-log space. The coefficient of determination (R^2) is 0.7 for K_y/K_{MAX} and 0.6 for K_y/A_{FF} , and includes all of the plotted data ($N = 39$). The gradients of the fitted lines are different, with the K_y/K_{MAX} line having a steeper gradient, indicating, as expected, that for the same magnitude of displacement the ratio of K_y/K_{MAX} is lower than the corresponding K_y/A_{FF} ratio. The poorer coefficient of determination for ratios of K_y/A_{FF} is also not unusual as Newmark (1965) displacements are highly sensitive to the high frequency components of the input motions, which can vary from event to event. By comparison, K_{MAX} “filters” the higher frequency components, and thus is less sensitive to the input motion characteristics. For ratios of K_y/A_{FF} in Figure 36, the estimated magnitudes of displacement are consistent with those reported by Jibson (2007), where these data plot between the ranges for earthquakes of M6.5–7.5 as reported by Makdisi and Seed (1978) and plotted by Jibson (2007).

The peak ground acceleration of the input motion (A_{FF}) does not take into account amplification effects caused by the slope geometry, and at this site, the material contrasts within the slope, between the loess/volcanic colluvium and the underlying rock (Appendix 4). From the data in Figure 36, the mean ratio of K_{MAX} to A_{FF} for cross-section 1 is 2.1 (mean plus one standard deviation), meaning that K_{MAX} is 2.1 times greater than the peak horizontal ground acceleration of the input motion, if assuming the mean plus one standard deviation of the mean.

The relationship in Figure 36 is based on past performance of the slope, however, the slope moved about 0.6 m during the 2010/11 Canterbury earthquakes. It is now possible that catastrophic failure of the slope could occur at further permanent slope displacements of less than 0.6 m. At free-field peak ground accelerations of greater than 1.0 g the amount of permanent displacement could lead to catastrophic failure and runout of debris, as performance of the slope at these levels of ground acceleration is unknown. At these ratios of K_y/K_{MAX} (less than 0.1) the magnitude of displacement tends to increase rapidly with only relatively small changes in the K_y/K_{MAX} ratio.

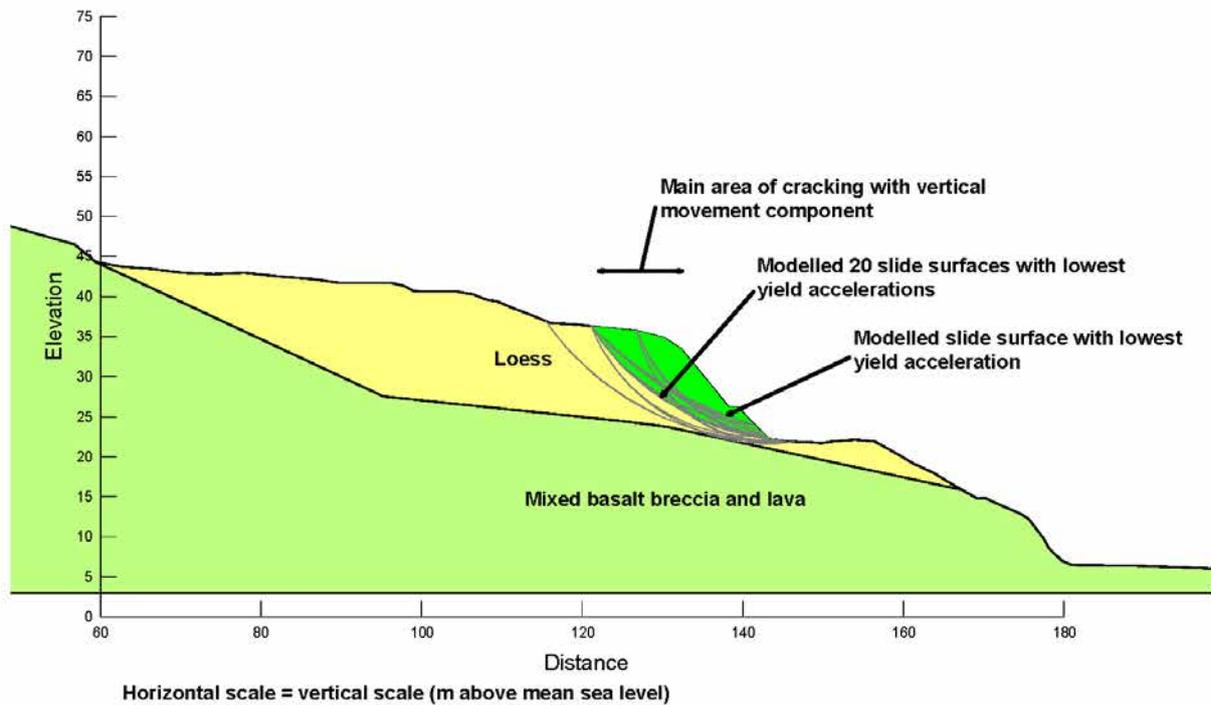
Figure 37 Cross-section 3 seismic slope stability assessment for the 22 February 2011 earthquake (loess parameters of friction (ϕ) of 35 and cohesion (c) of 30 kPa).

The selected slide-surface geometries shown in Figure 37 and Figure 38 show that their shapes are consistent with the results from the field mapping of cracks, where the location of the modelled slide masses with the lowest yield accelerations correspond to the locations where vertical and horizontal permanent displacements were recorded.

The results show that the modelled slide surfaces concentrate behind the slope crest (Figure 37 and Figure 38), with very few extending further back up slope. As expected, those shallow slide surfaces nearest the cliff edge have lower factors of safety, and therefore lower yield accelerations (K_y), compared to those deeper slide surfaces further back from the cliff edge. The assessment using the 22 February 2011 synthetic earthquake shows that even when the lower loess strength parameters are adopted, displacement of the entire loess mass (corresponding to the main area of mapped cracks) is not likely to occur as a result of landslide processes. It is therefore possible that many of the mapped cracks, up-slope and away from the slope crest – where only horizontal displacements were recorded – formed in response to the inelastic behaviour of the loess during shaking, rather than large-scale landslide processes.
