**Canterbury Earthquakes 2010/11 Port Hills Slope
Stability: Earth/debris flow risk assessment for
Defender Lane**

**GNS Science Consultancy Report 2014/67
August 2014 FINAL**

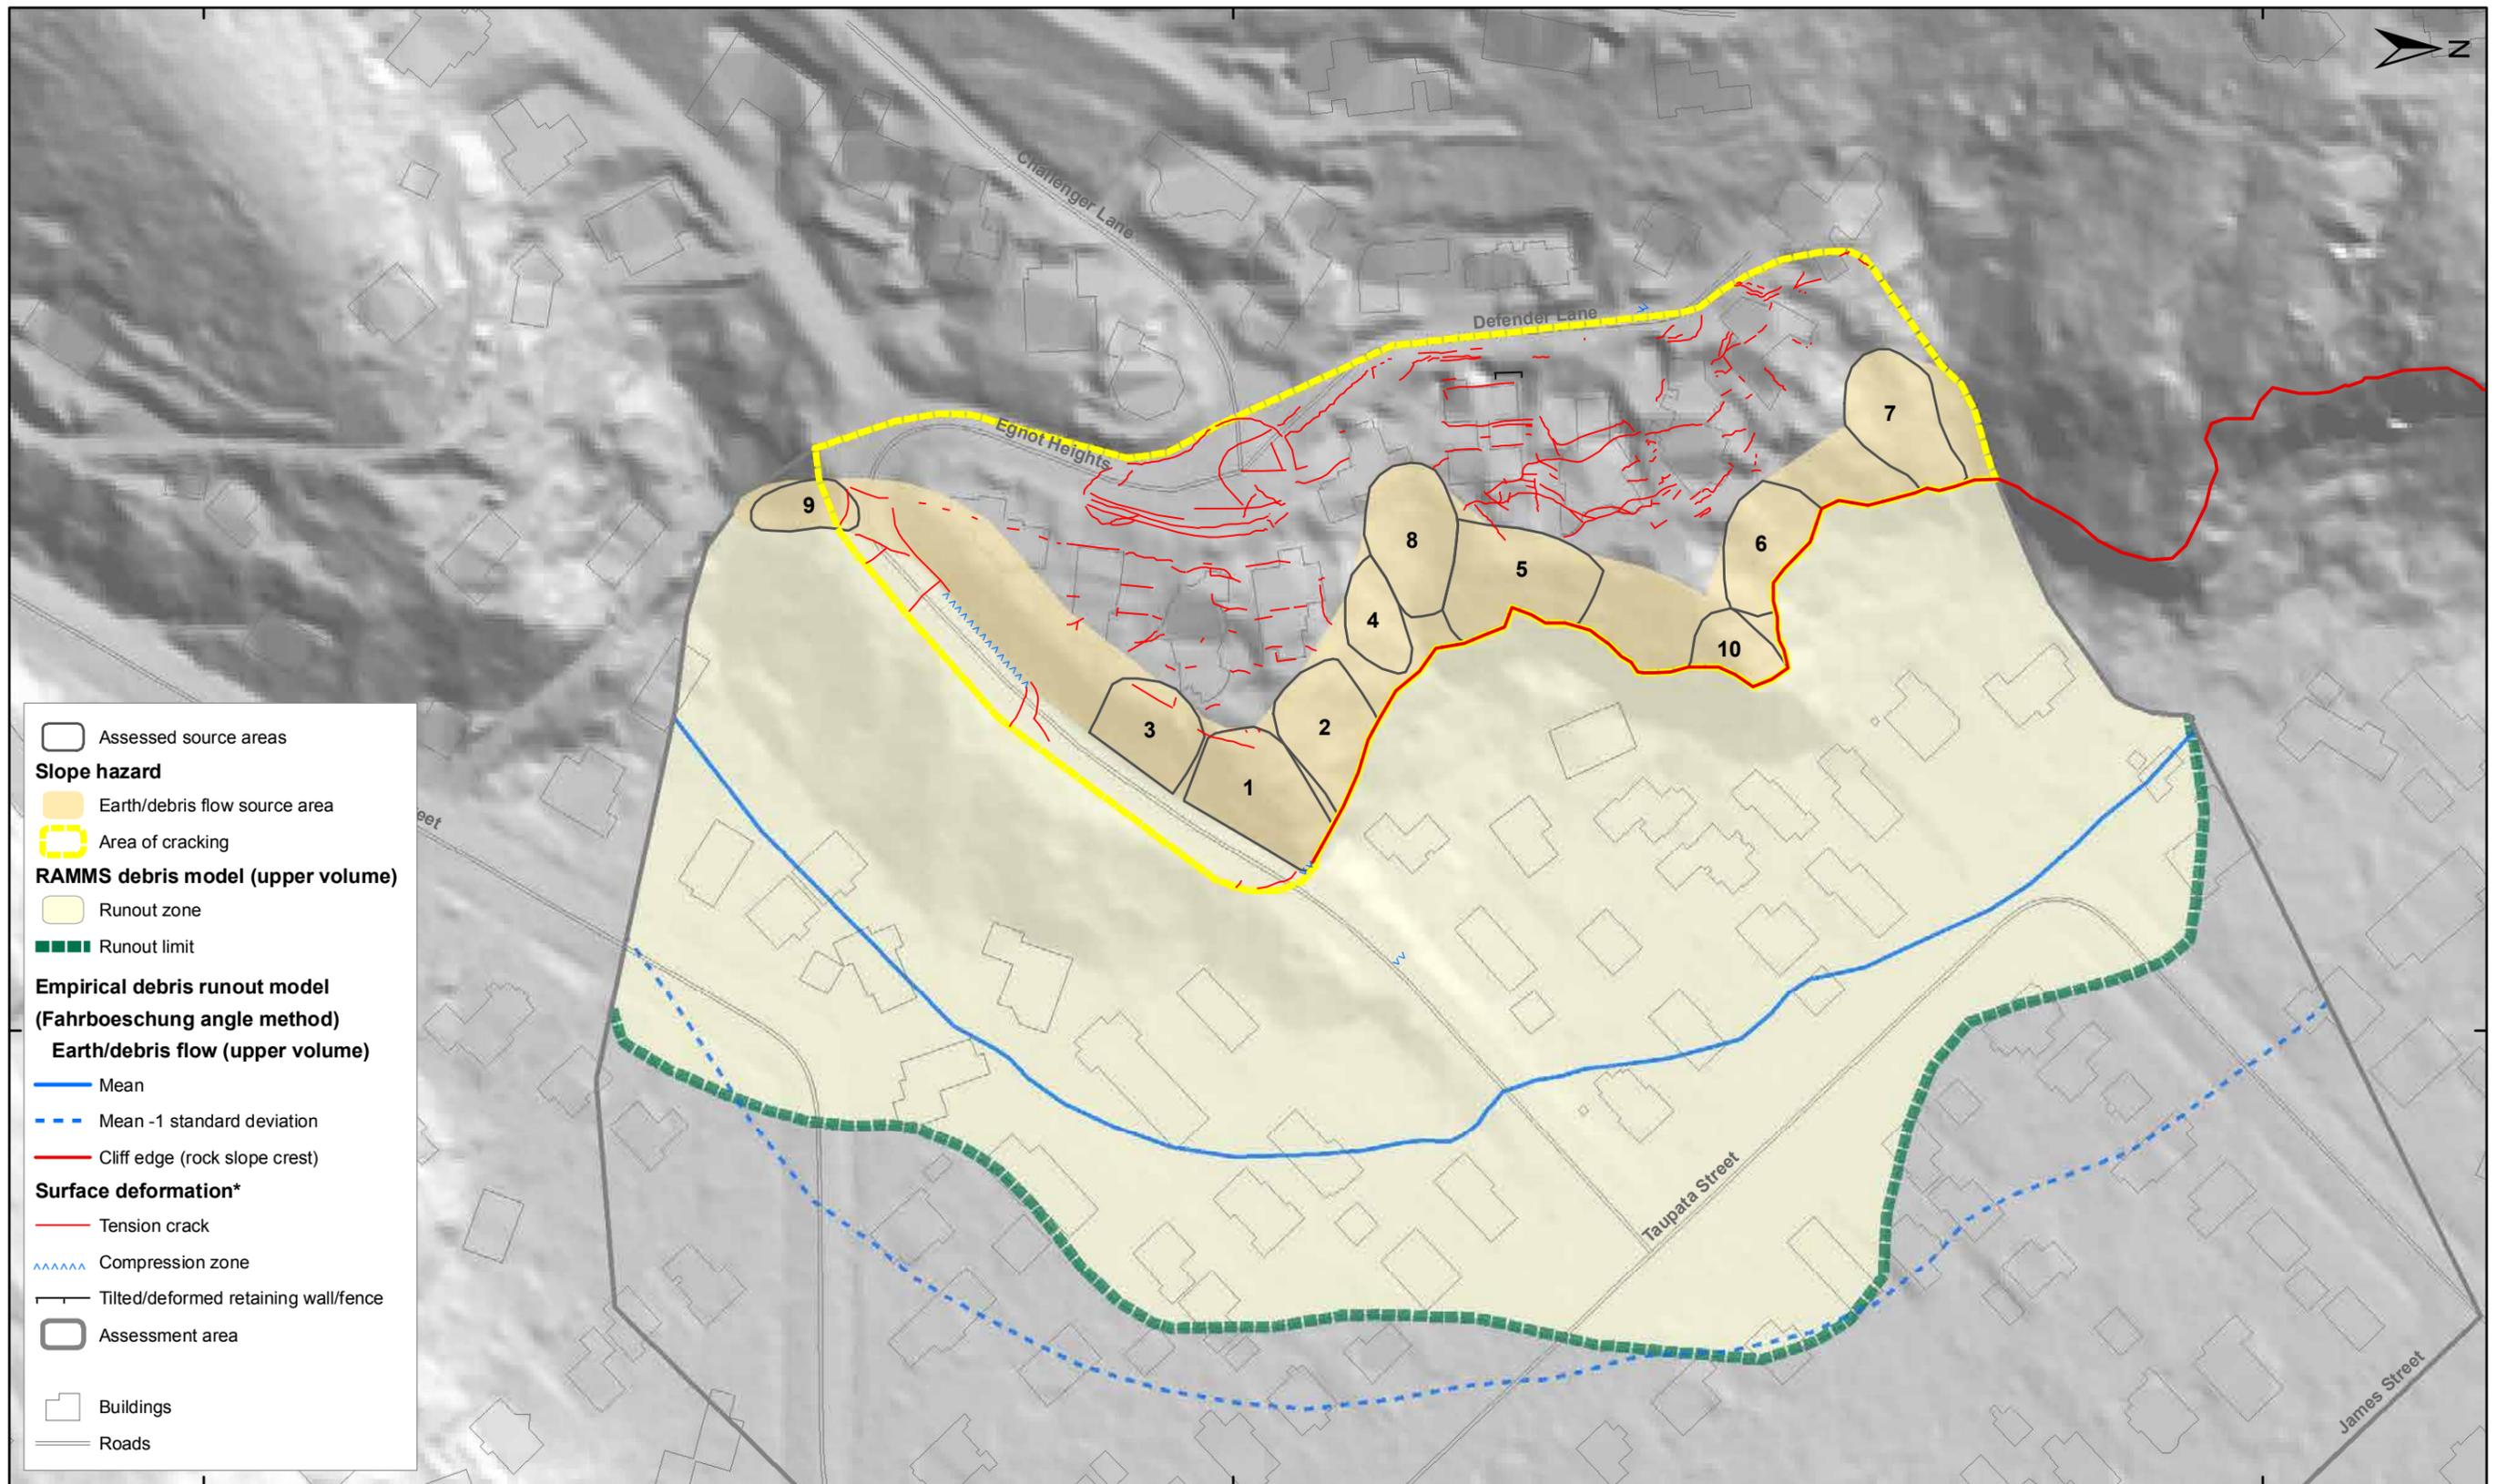
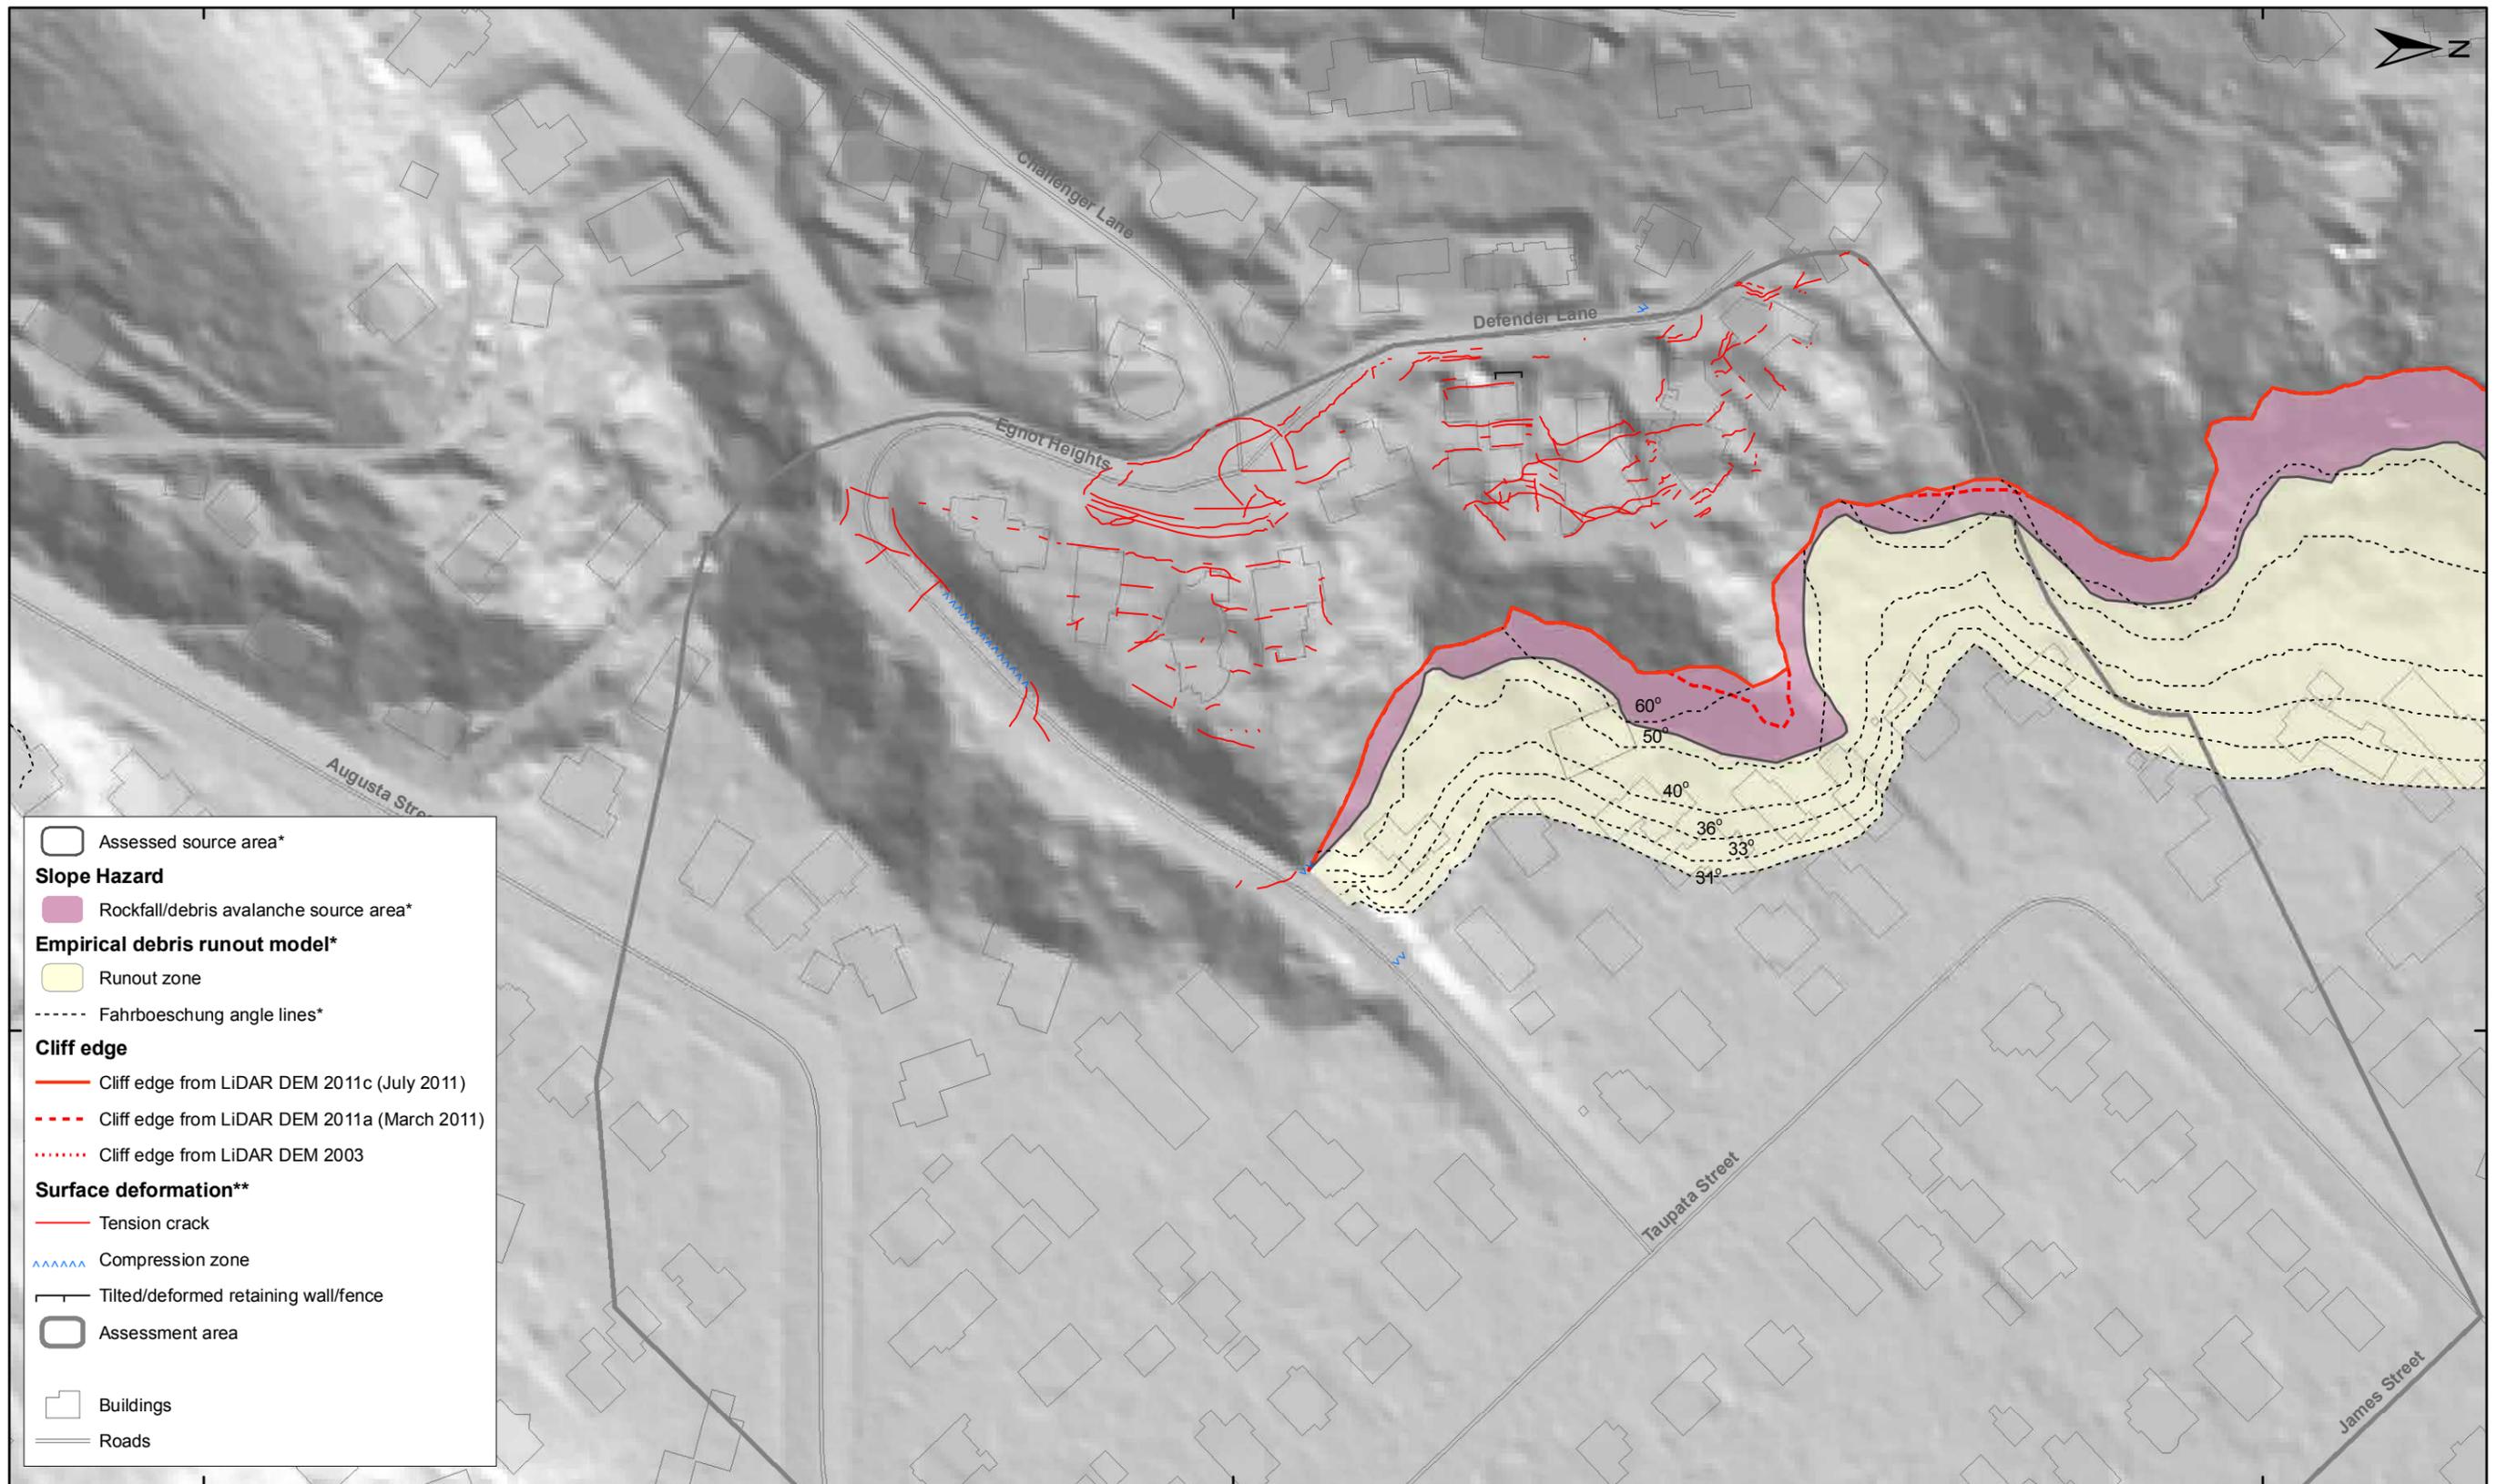
FIGURE 44

The mean and mean minus one standard deviation fahrboeschung angles for each potential source area (1–10), are shown in Figure 44. The empirically derived fahrboeschung runout lines are based on combining the runout lines from each of the source areas for the upper source volume estimates only. The estimated runout distances from RAMMS are shown in Appendix 5 (debris height) and Appendix 6 (debris velocity), for source areas 1–10 using the middle source volume estimates, along with the corresponding mean and mean minus one standard deviation fahrboeschung angles.

Figure 44, Map 2, shows a hazard map for debris avalanches (cliff collapse hazard), modified from Massey et al. (2012), which illustrates the fahrboeschung angles and runout limits of debris avalanches. Note that the runout limits assessed for the earth/debris flow hazards (Figure 44, Map 1) are much further out from the toe of the slope, than the runout limit of the debris avalanches. This reflects the more fluid and mobile nature of the earth/debris flows.

The estimated magnitude of permanent slope displacement, in the assessed sources and area of cracking (Figure 44), in a future earthquake, was based on the decoupled assessment results for failure mechanism 1. The permanent displacement at a given level of

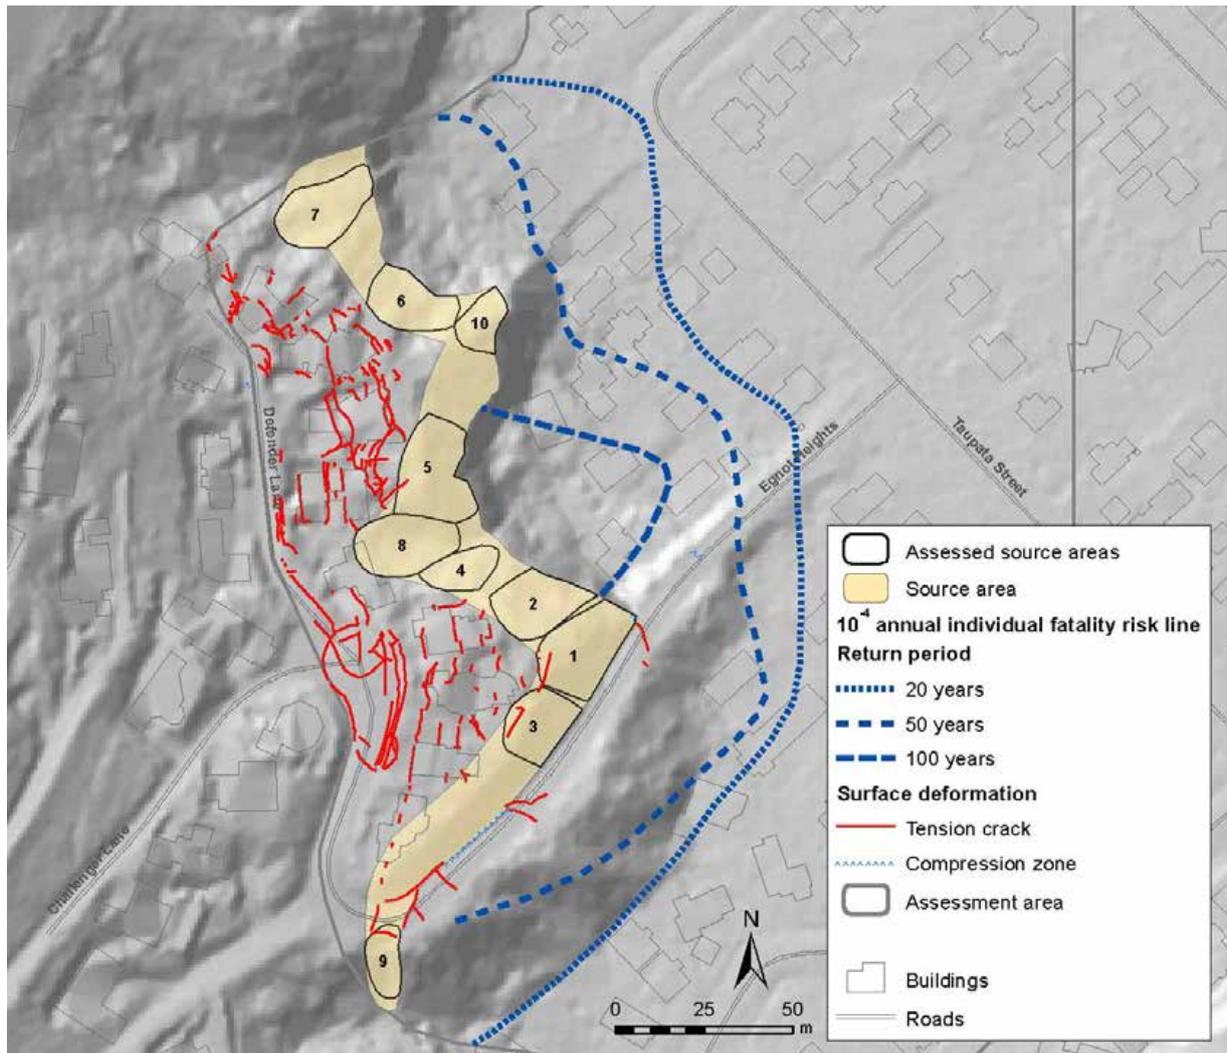
Figure 46 Sensitivity of the risk estimates, upper volume estimates, for triggering event return periods of 20, 50, 100 and 200 years.

The return period of the event that could initiate failure is unknown. The sensitivity of the risk estimates for the assessed source areas to different event return periods has been assessed. This was done by plotting the location of the 10^{-4} annual individual fatality risk contour, for the upper source volume estimates only, adopting return periods of 20, 50 and 100 years for the triggering event. The results are plotted for in Figure 46. The risks adopting the 200 year triggering event frequency are all less than 10^{-4} and cannot therefore be plotted in Figure 46.

The results show that area within the 10^{-4} risk contour reduces between the 20 and 100 year return periods. This is because the volume of the failure, and therefore runout distance of the debris, remains fixed, but the return period of the event increases, leading to a reduction in the risk at the longer return periods.

For the assessed source areas, for the 20–100 year return periods, the changing risk has little impact on the numbers of dwellings within the 10^{-4} annual individual fatality risk contour. Therefore the 50-year return period adopted for the risk estimates shown in Figure 45 is considered reasonable.

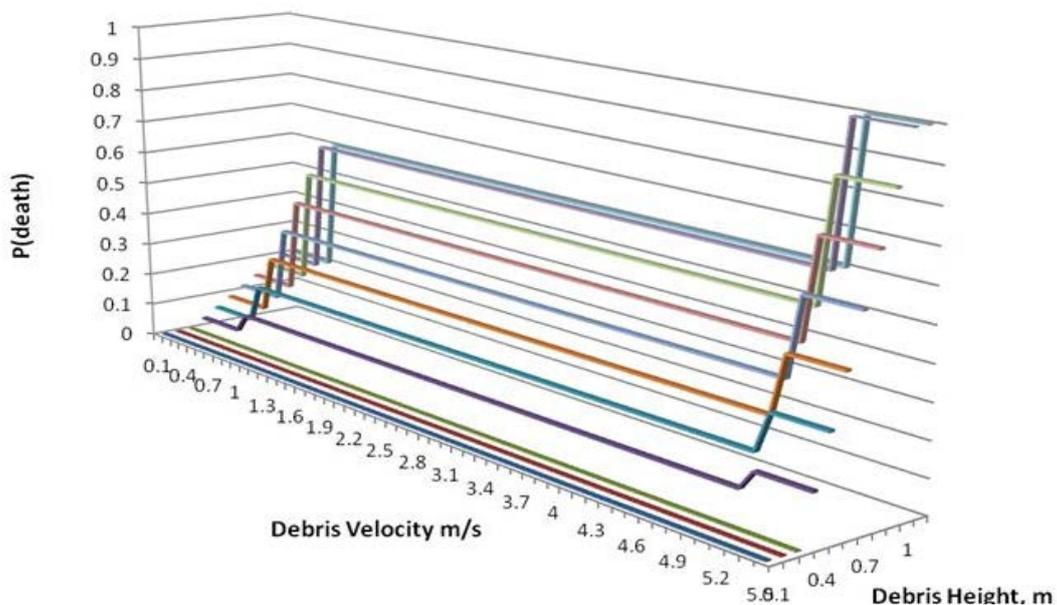
Figure 47 Probability of death as a function of debris velocity and height.

4. Figure 47 shows the probability of depth as a function of debris height and velocity. The risk assessment may not adequately take into account the sheltering effect of buildings. Variable vulnerabilities have been adopted linked to debris velocity. However, the vulnerability of a person in a dwelling is related to the nature of the structure, for which there is no data available for use in the risk assessment.

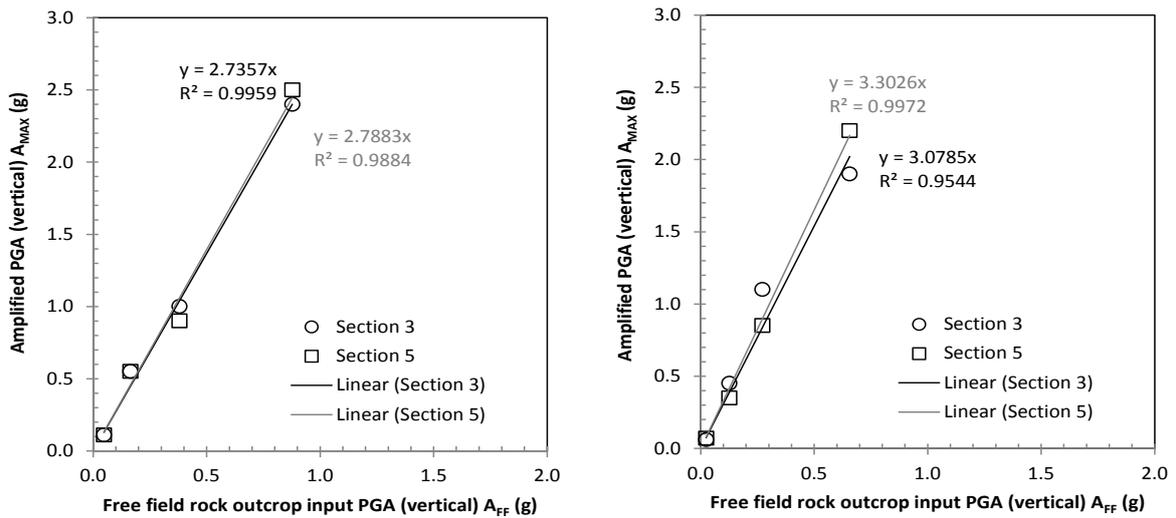
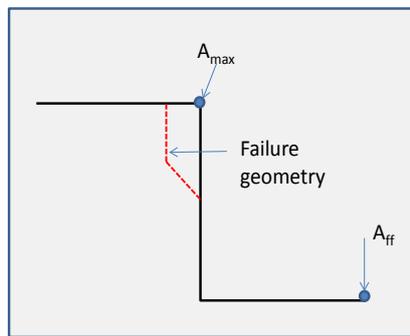
Figure A4.1 Amplification relationship between the synthetic free field rock outcrop input motions (A_{FF}) and the modelled cliff crest maximum accelerations (A_{MAX}) for cross-sections 3 and 5. A schematic diagram showing the locations of the various recorded accelerations is shown.

Results from this assessment have shown that the relationship between the peak ground acceleration of the free field input motion and the corresponding modelled peak acceleration at the slope crest (A_{MAX}) is generally linear. In the range of modelled peak horizontal accelerations, the horizontal amplification factor (S_T) is typically in the order of about 2.8 times the input free field peak horizontal acceleration.

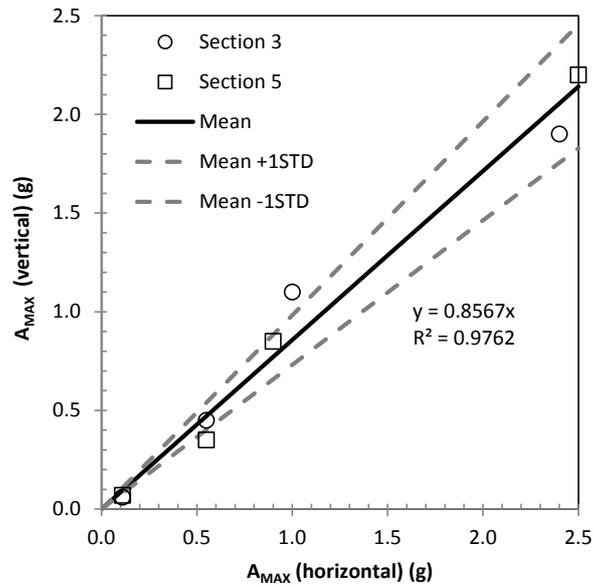
The relationship between the modelled vertical and horizontal peak ground accelerations recorded at the slope crest (A_{MAX}) is shown in Figure A4.2. The gradient of the linear fit (all data, cross-sections 3 and 5) is $0.86 (\pm 0.03)$ – errors at one standard deviation, with a gradient of 0.92 being the mean plus two standard deviations. The relationship between horizontal and vertical peak ground accelerations appears linear to a horizontal peak ground acceleration of 1 g, but then appears to become non-linear at higher horizontal peak ground accelerations.
