OPEN WATERWAY CONDITION ASSESSMENT

DATA SUMMARY REPORT

Land Drainage Recovery Programme

January 2017

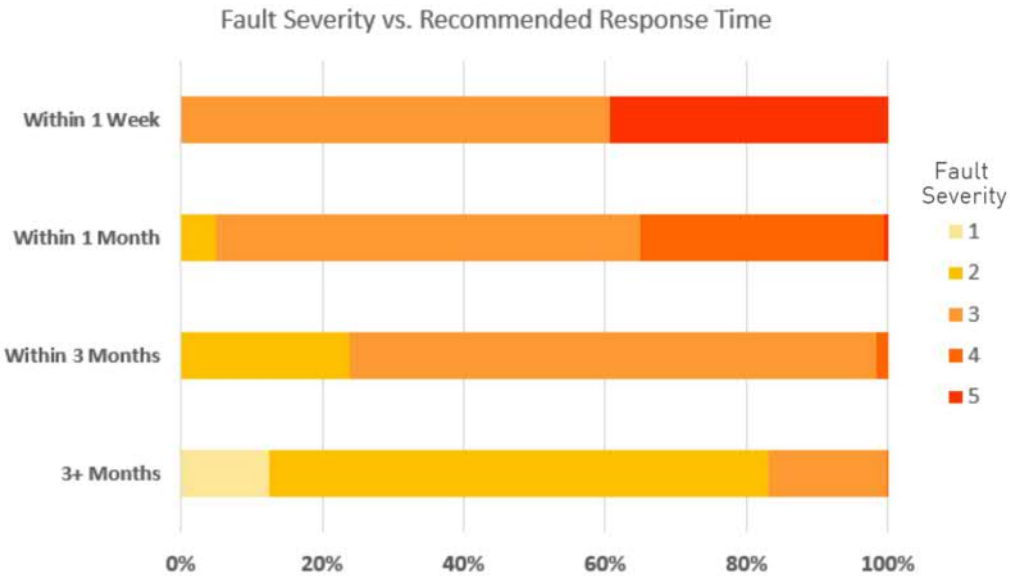
FIGURE 09 - FAULT SEVERITY AND RECOMMENDED RESPONSE TIME

Figure 09 shows fault severity combined with recommended response time. It can be seen that faults that were considered to be urgent (Within 1 Week) generally also had higher severity. Correspondingly, less urgent faults have a higher proportion of lower severity faults.

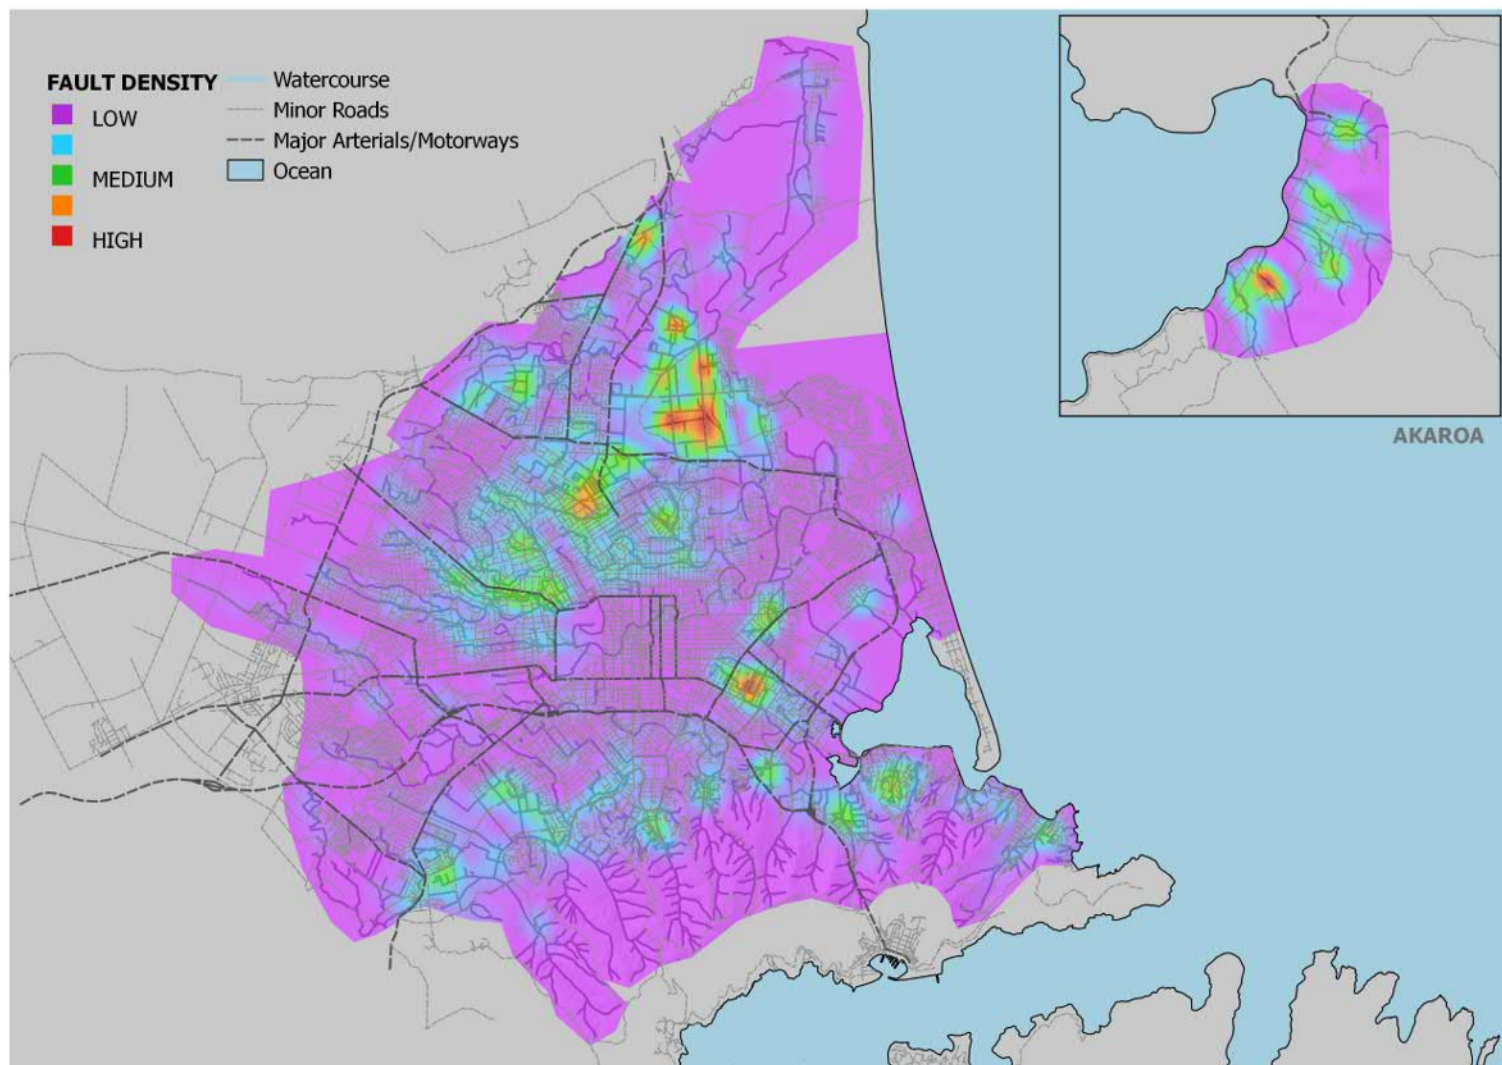
FIGURE 10 - DENSITY OF FAULTS IDENTIFIED ON WATERWAYS

The relative density of faults is shown in Figure 10. The density of faults will be influenced by the number of waterways in the area, however the density map exhibits trends that correlate with general expectations. Firstly, faults are more common in areas of the city that were generally worse affected by the earthquakes, such as the north-eastern suburbs. In addition to this, the areas of higher fault density generally occur where there is a higher proportion of lined drains versus unlined channels. This is described further below.

The suggestion that the density of faults is higher on lined channels is supported by analysis of the data. The dataset shows that 56% of the faults were logged on the lined drains, however lined drains only account for 20% of the total length of waterways surveyed. This shows that proportionally a large number of faults exist on the timber and concrete lined waterways.

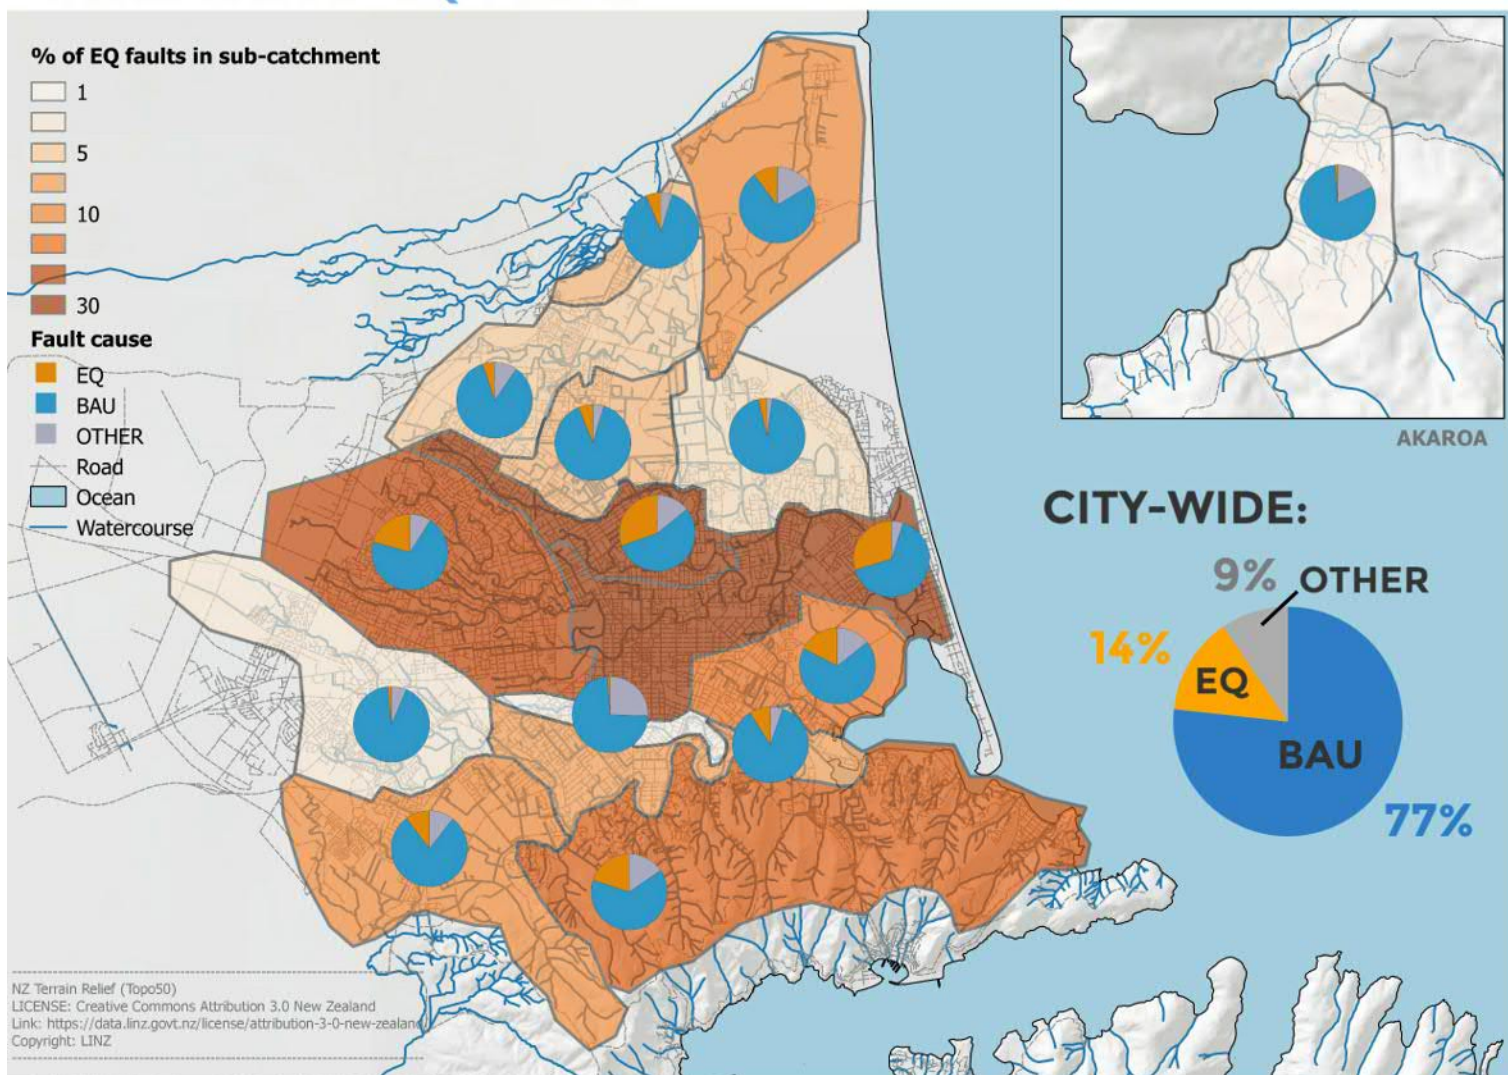
FIGURE 11 - DISTRIBUTION OF EQ VS BAU FAULTS

The assessment of faults included an evaluation of what the fundamental cause of the fault was; either earthquake (EQ) or Business-as-Usual (BAU). Fault cause 'Other' was used for scenarios where neither of the two other categories were applicable. This category related mostly to human interference with the waterways such as potential compliance issues including private fences crossing the channel and stock pugging the banks due to lack of fencing. Figure 11 shows an overview of EQ vs. BAU faults across the city.

Regardless of the difficulties, the data gives some insight into the overall cause of faults on the waterways. Overall, the data shows the distribution as 77% BAU, 14% EQ and 9% 'Other'. This indicates that although the earthquakes have had an effect on the condition of the waterways, the majority of faults relate to general deterioration and highlights the need for continuous maintenance.

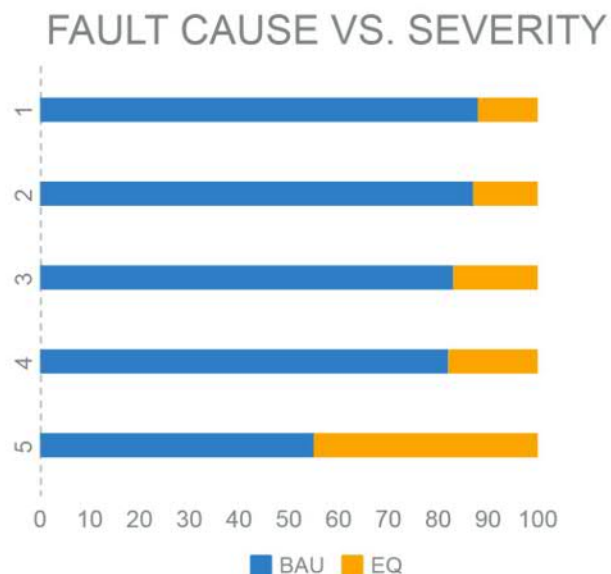
FIGURE 12 - EQ DAMAGE GENERALLY RESULTS IN HIGHER FAULT SEVERITY

One interesting insight, as shown in Figure 12, is that the EQ-related faults often result in more severe damage. This applies in particular to category 5 (Catastrophic) faults where the split between BAU and EQ is close to 50/50 (versus average 85/15 for the lower severity ratings).

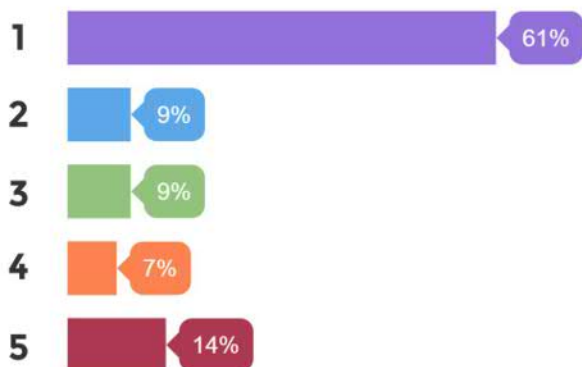
FIGURE 15 - CCTV MEAN SCORES FOR SURVEYED ASSETS

Figure 15 and Figure 16 show a summary of mean and peak structural grades for the 70 km of pipes and culverts that have had CCTV surveys undertaken.

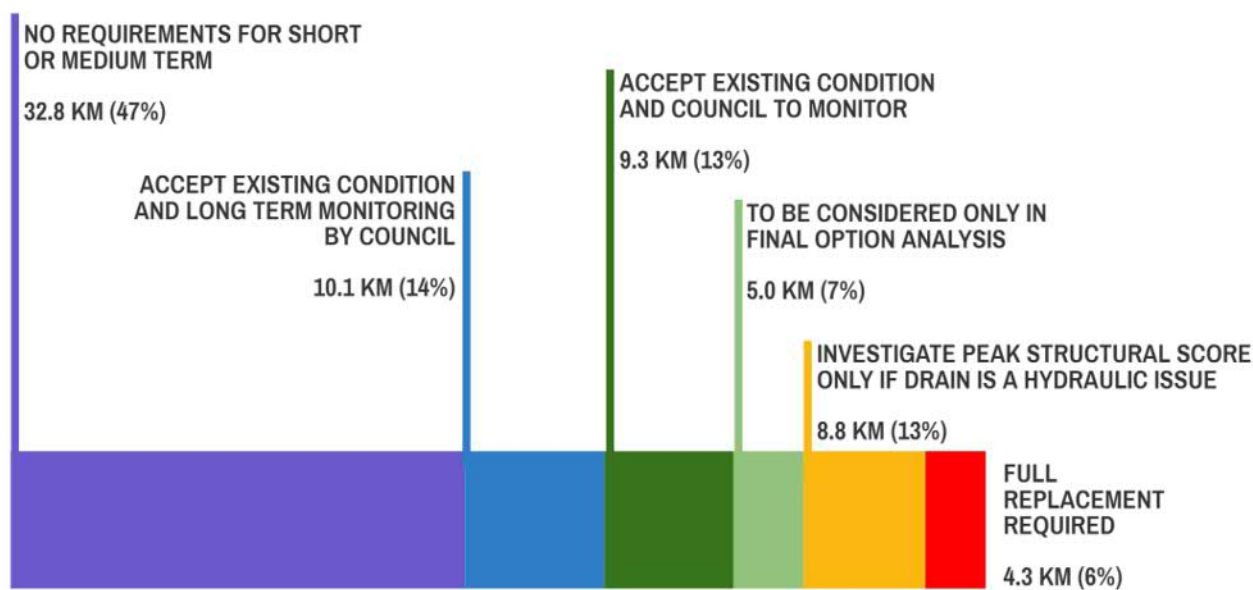
FIGURE 18 - RESULTS OF CCTV ACTION ANALYSIS

The results of running the analysis on the 70 km of surveyed pipes and culverts is shown in Figure 18.

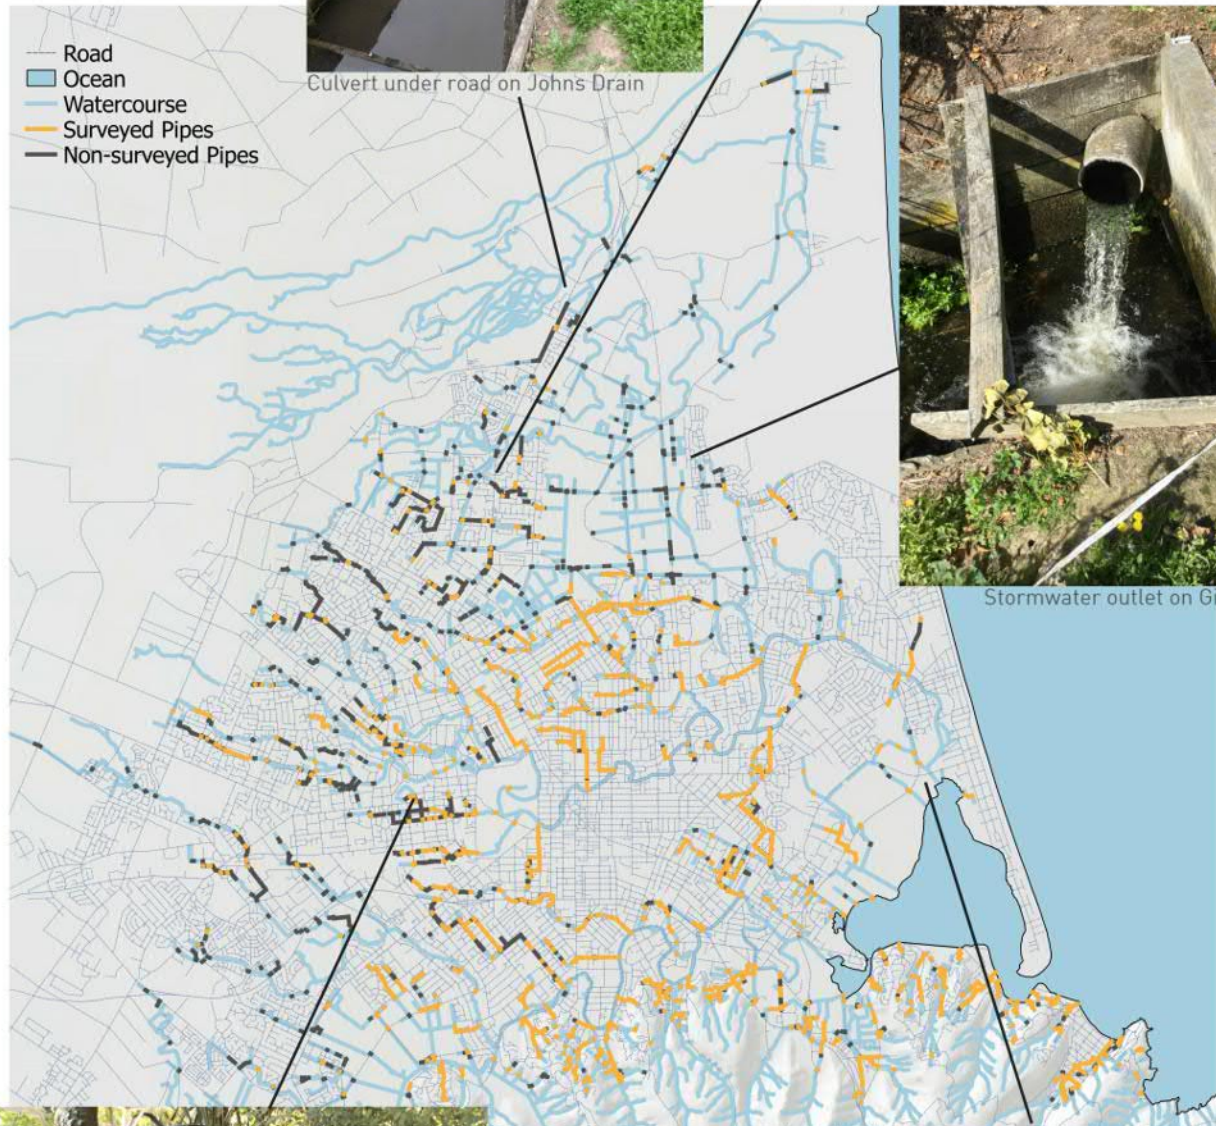
Stormwater outlet on Gibsons Drain
