REPORT **ST ASAPH STREET** POST CONSTRUCTION ROAD SAFETY AUDIT

Prepared for Christchurch City Council 13 March 2017

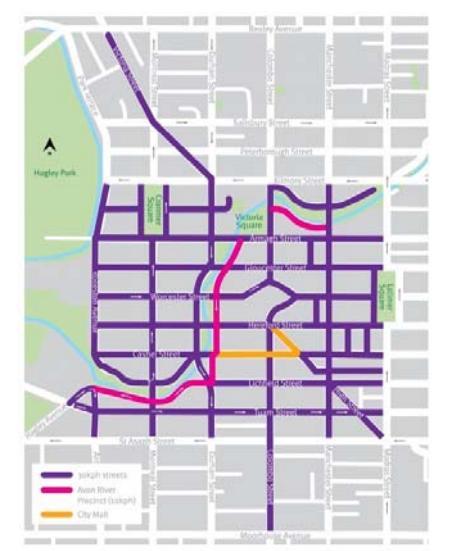
Figure 2: Current Central City 30 km/h speed limit area.

St Asaph Street is on the southern boundary of the central city 30 km/h cordon area (Refer to Figure 2). It is noted that Colombo Street has a 30 km/h speed limit southward to Moorhouse Avenue.

Given that the normal day progression speed is around 30 km/h, the SAT recommends that the legal speed limit be lowered to 30 km/h to better reflect the speed environment, and match the actual operating speed.

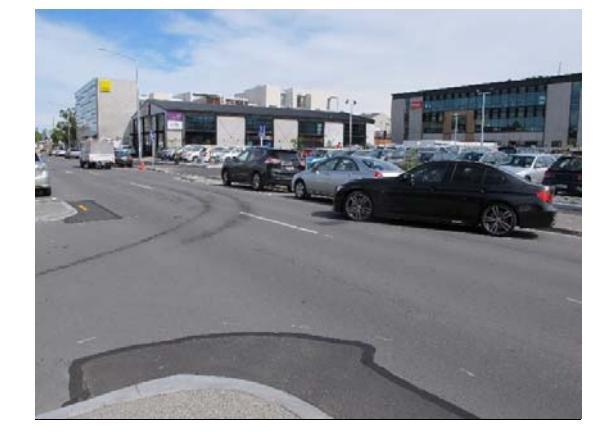
The planters installed generally have a sloped face (in respect to the traffic direction of travel) that assists drivers with entry and exit movements. The provision of perpendicular ends results in an impeded ability to easily enter and exit the parking space.

Photo 3: Example of new planter – north side. Note lack of plants installed to define vertical element.

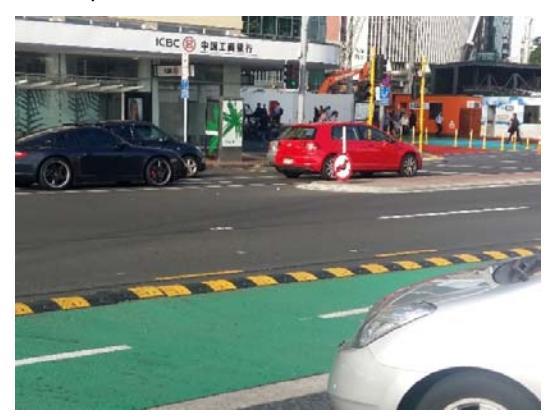
The SAT consider that there may be opportunity to explore a solid barrier line on the traffic side of the cycleway green markings to highlight that the driver is crossing over a separated facility. In some locations throughout NZ, this barrier line is formed through the use of a low profile black and yellow raised separator.

Photo 7: Example of low profile raised separator at access – Bi-directional facility, Quay Street, Auckland

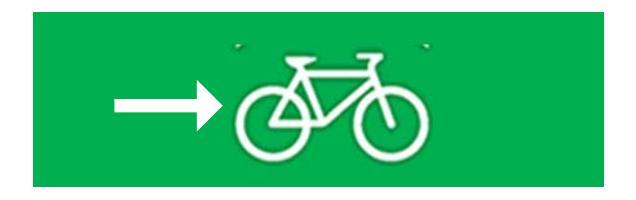
A recent study of the St Vincent Street separated facility in Nelson has demonstrated that the orientation of the cycle symbols to the entering / exiting driver, along with an arrow for the direction that the cyclist is approaching from, offers a suitable solution. Furthermore – there is no signage applied warning the driver that there is a risk of a cyclist approaching from behind them (masked by the parked vehicles). While signs at every access may not be appropriate, at key locations they may offer the best solution.

Photo 8: Example of cycle marking for access points

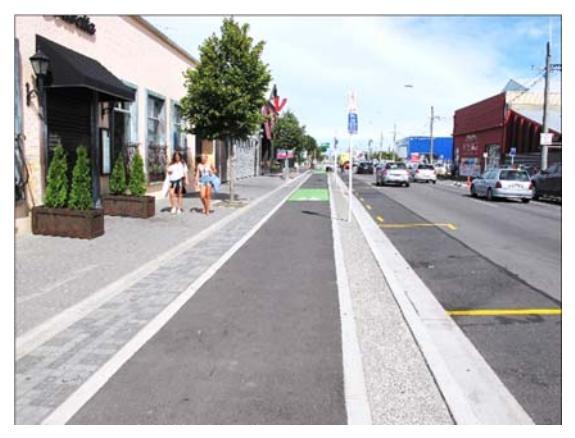
Photo 12: Example of cycle facility raised to footpath level, with concrete edge treatments to define path.

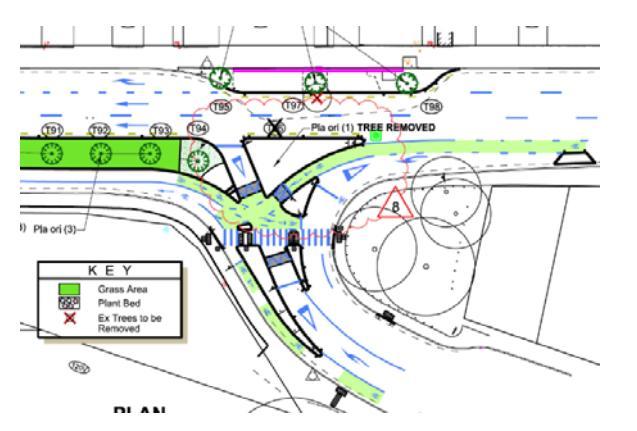
Figure 2-3: Design Drawing of intersection.

A review of the supplied plans indicate that the Detailed Design approved (refer to Figure 2-3) has the westbound (St Asaph) cyclist having to give way to the eastbound cyclist movement.

Cyclists are approaching the intersection at generally 20km/h to 30km/h, however the markings (and signage) is reasonably complex and difficult to interpret when travelling at these speeds, especially when changing direction, and potentially giving way to other cyclists, motorists and pedestrians.

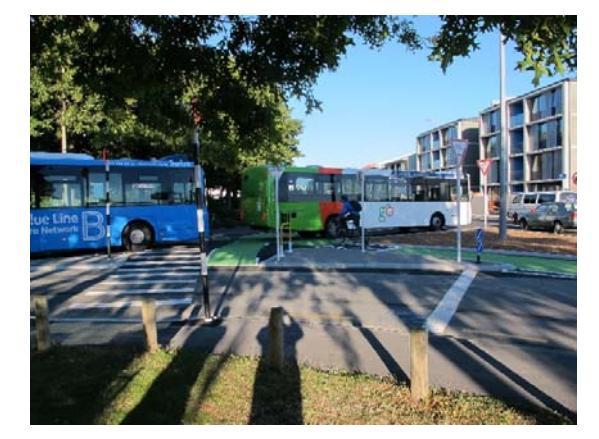
select from the list

Photo 27: Current design requires an exiting bus to

Refer also to the recommendation in Section 2.2.3.
