Toilets Abberley Park
PRK 0610 BLDG 004 EQ2
Detailed Engineering Evaluation
Qualitative Report
Version Final

15 Abberley Crescent, St Albans

Christchurch City Council

Date
11 March 2013

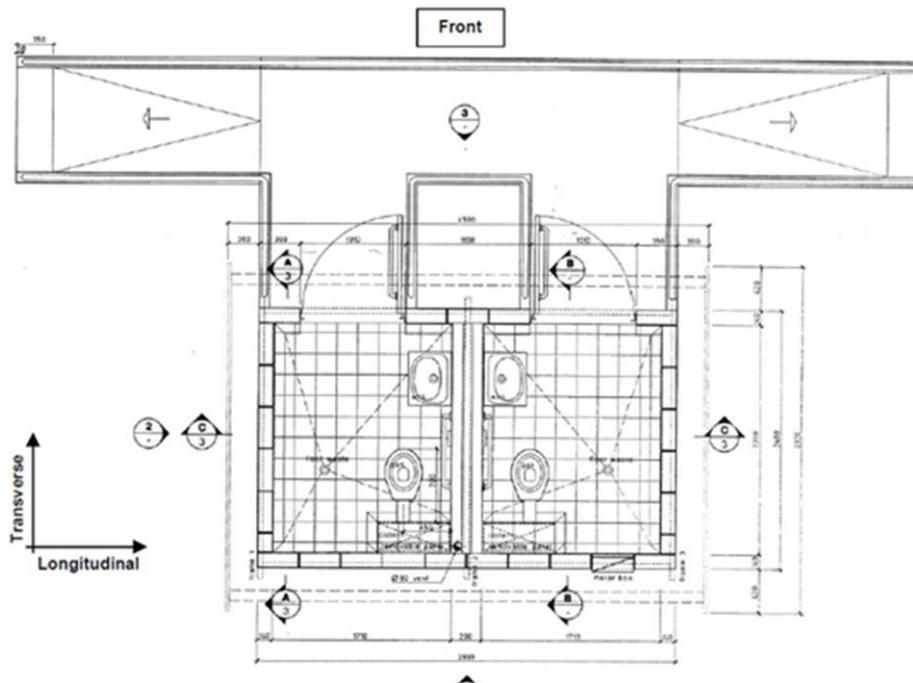
Figure 2 Plan Sketch Showing Key Structural Elements

Filled reinforced 15 series concrete masonry walls form the external perimeter walls. The internal partition walls are constructed from 100x50 timber framing with timber diagonal bracings. Internally all walls are clad with ceramic tiles.

The building's foundation is a raft slab on grade.

Note: All plans were taken from an identical structure built on Styx Mill Reserve in 1996.
