Akaroa Court House PRO 3635-005

**Detailed Engineering Evaluation
Quantitative Assessment Report**

71 Rue Lavaud, Akaroa

Jan Stanway Senior Structural Engineer CPEng 222291	Date: March 2014 Reference: 6-QUCCC.78 Status: Final V2

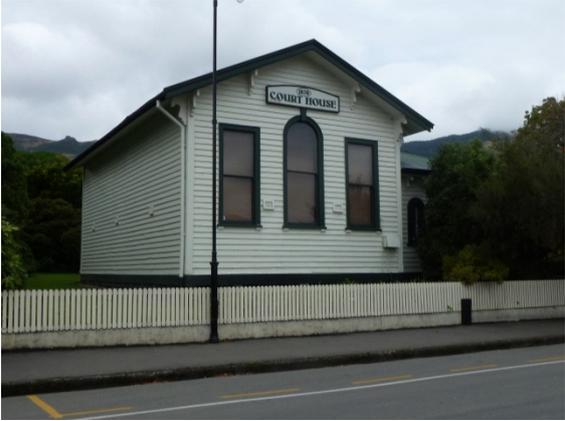
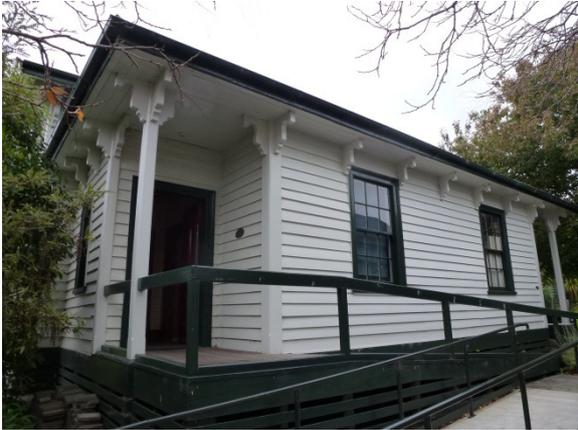
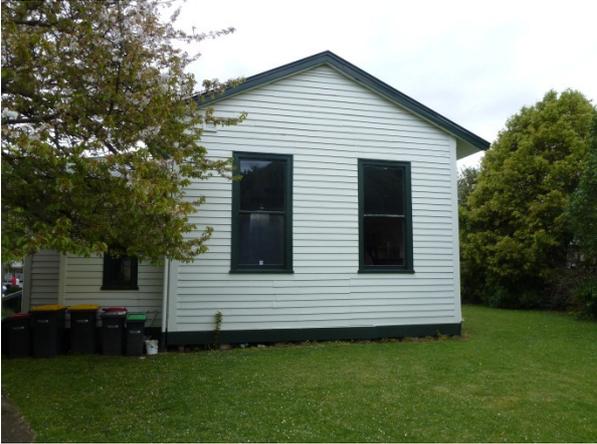
No.	Item description	Photo
1.	<p>General building elevations</p> <p>North West elevation</p> <p>South elevation</p> <p>East elevation</p>
