**Alma Place
Housing Complex
PRO 0715**

**Detailed Engineering Evaluation
Quantitative Assessment Report**

1 - 25 Alma Place, Shirley, Christchurch

Date: November 2013
Reference: 6-QC305.00
Status: Final

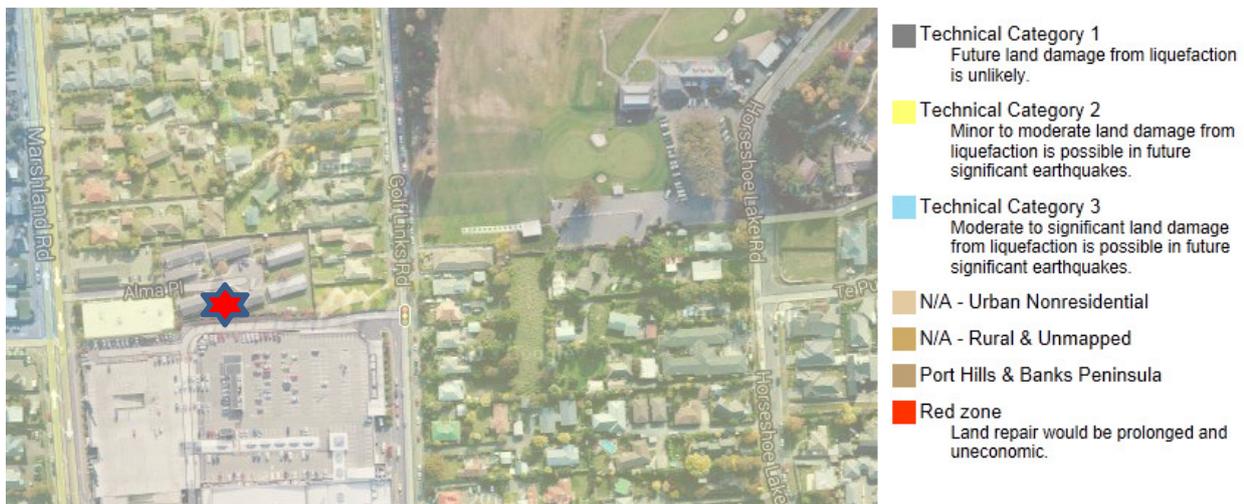
Figure 8: TC2 zoning for Alma Place Housing Complex.

CERA indicates that Alma Place Housing Complex is located in a TC2 zone (as shown in Figure 8). This classification suggests future significant earthquakes will cause minor to moderate land damage due to liquefaction and settlement.

There is no evidence to suggest that further geotechnical investigation is warranted for this site.
