Christchurch City Council BE 1119 EQ2 Andrews Crescent

QUANTITATIVE ASSESSMENT REPORT FINAL

- Rev B
- 04 June 2013

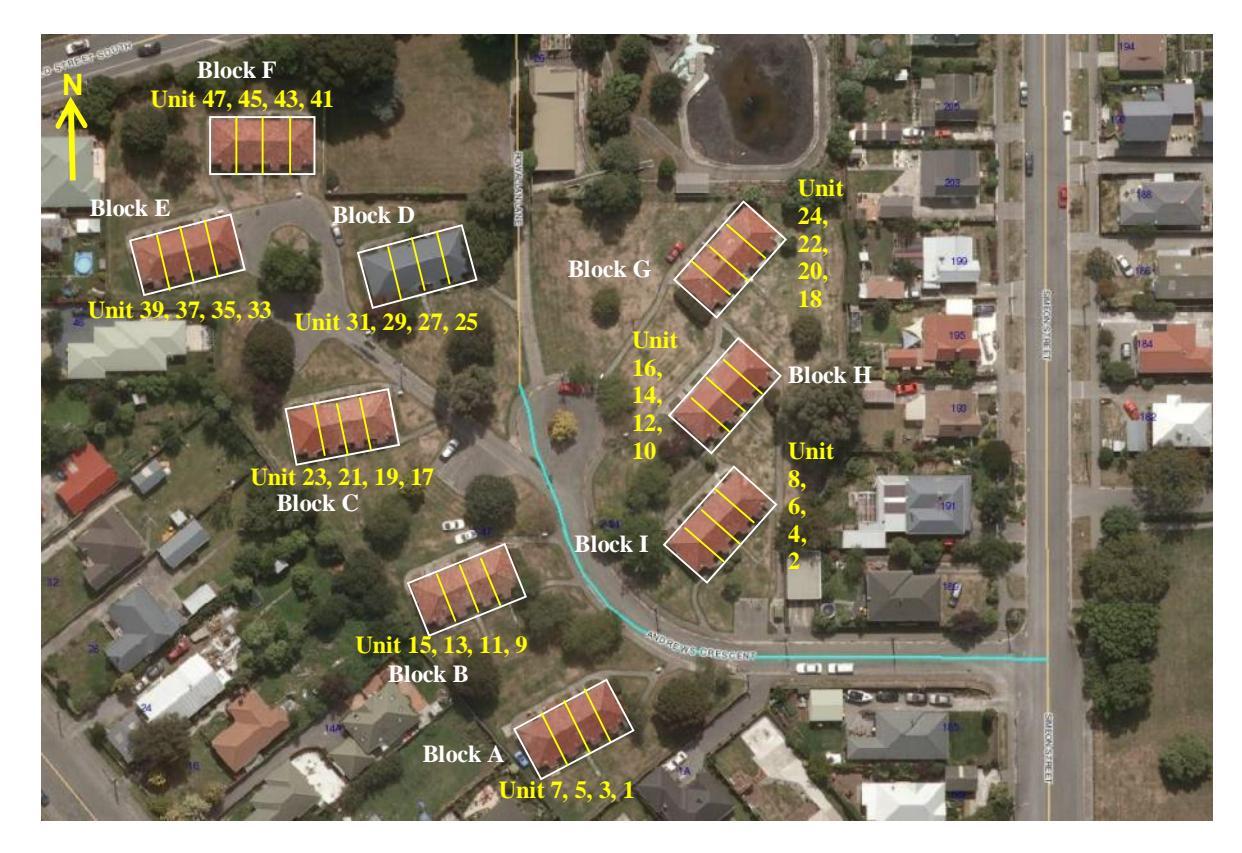
Figure 1 Aerial Photograph of Andrews Crescent

A Quantitative Assessment was carried out on the housing complex located at Andrews Crescent. The site comprises of nine buildings, with each building housing 4 separate living units, in total there are 36 livings units. An aerial photograph illustrating these areas is shown below in Figure 1. Detailed descriptions outlining the buildings age and construction type is given in Section 5 of this report.

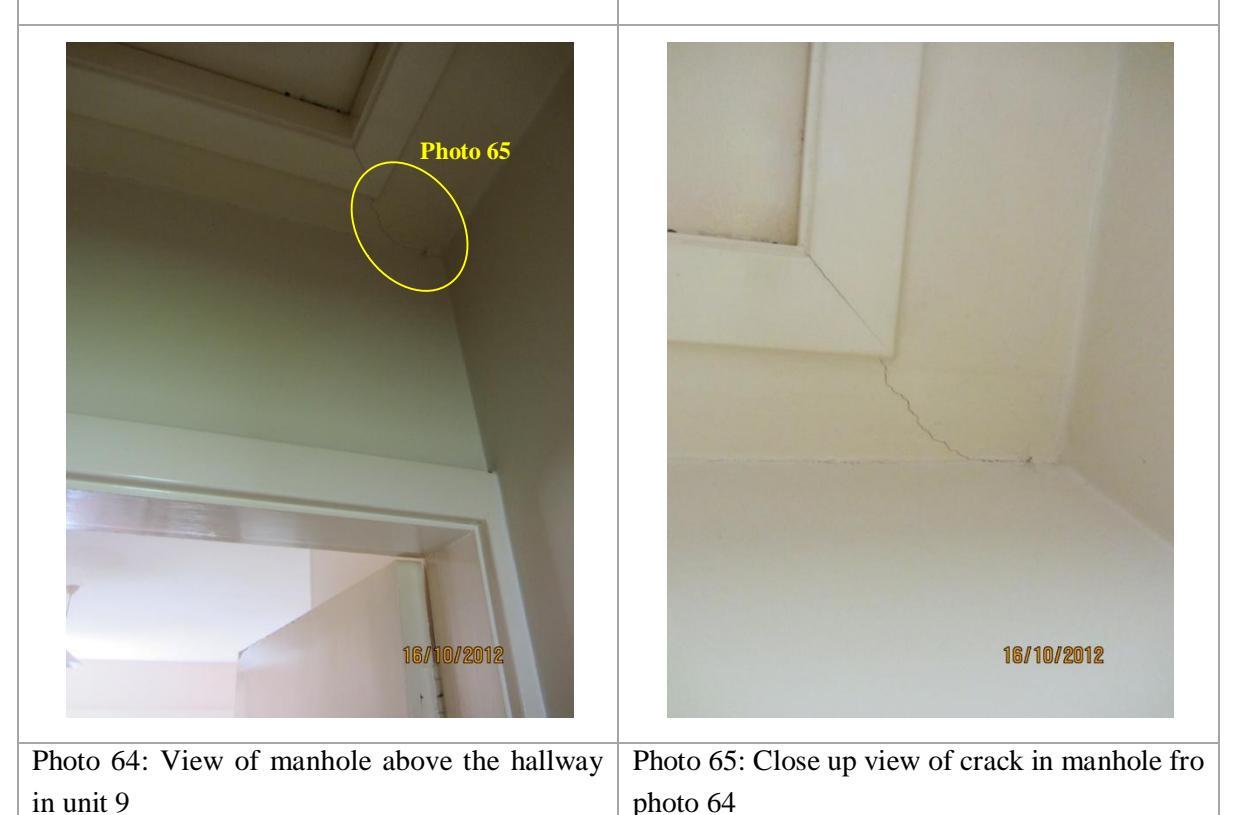
- Unit 9 has vertical cracks between the door frame junctions (see photo 62, 63)
- Unit 9 has diagonal crack beside the manhole in the hallway (see photo 65)
- Unit 11 has cracks in the lounge area above the doorway and also in the ceiling (see photo 67, 68)
- Unit 11 has a crack above the electrical meter box in the kitchen (see photo 70)
- Unit 11 has a crack above the back entrance doorway in the kitchen (see photo 71)
- Unit 15 has a crack above the doorway in the lounge area (see photo 76)
- Unit 15 has a diagonal crack beside the manhole in the hallway crack (see photo 78)

Photo 62: Kitchen and lounge doorway junctionPhoto 63: Bathroom and kitchen doorwayshowing crackjunction showing crack

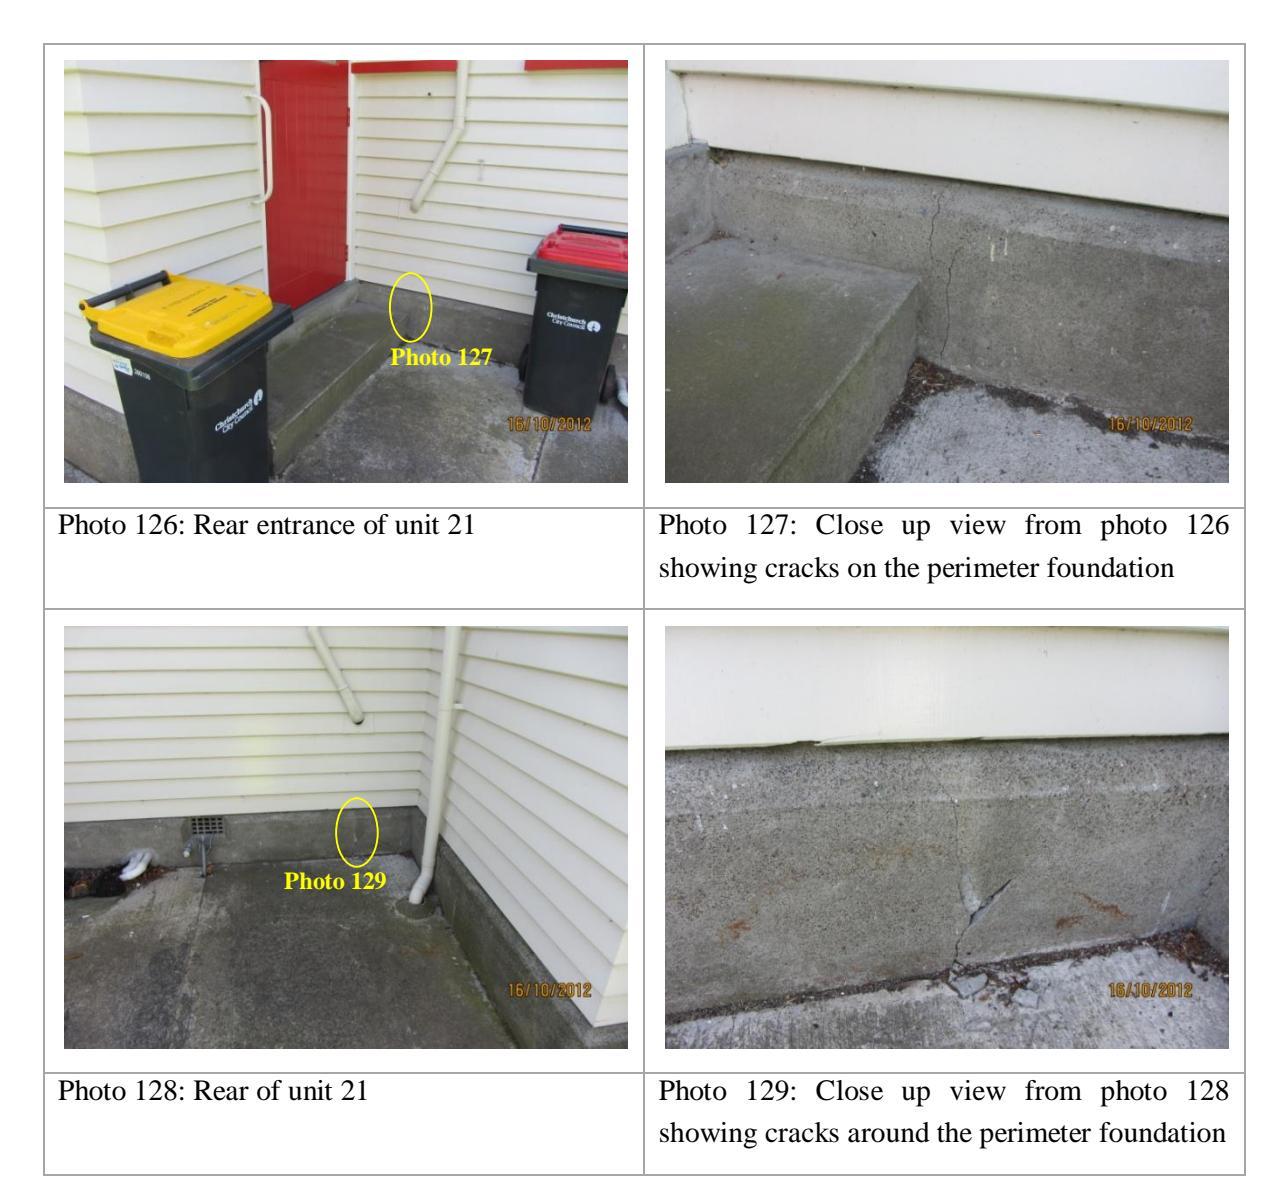
- Cracks were found around the perimeter foundation. (see photo 124, 127, 129, 132, 136)
- Concrete has spalled from the concrete perimeter foundation, exposing rusted reinforcing at the rear entrance of unit 23 (see photo 124). This damage does not appear to have come as a direct result of the earthquakes
- Concrete render has been displaced from the concrete perimeter foundation at the rear corner of unit 23 (see photo 119)
- Concrete steps leading up to the entrances of units 19 and 17 have cracked 2.5mm and 1mm respectively (see photo 121, 134)

Photo 124: Close up view from photo 123,
damage does not appear to be due to the
earthquakePhoto 125: Rear entrances of units 23 and 21
respectively

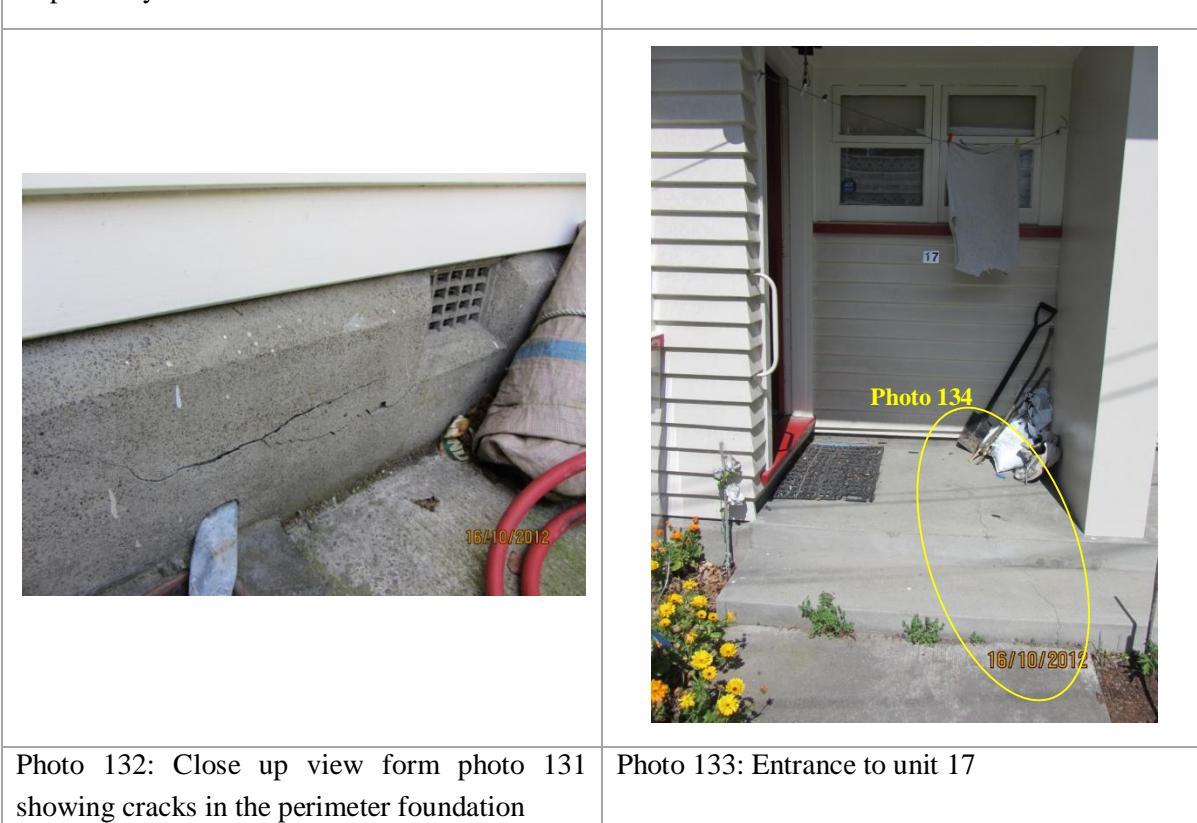
Photo 130: Rear entrance to unit 19 and 17 Photo 131: View of rear entrance to unit 19 respectively
