Angus Courts Housing Complex PRO 1144

**Detailed Engineering Evaluation
Quantitative Assessment Report**

Angus Courts Housing Complex Quantitative Assessment Report

Date: February 2014
Reference: 6-QC307.00
Status: Final

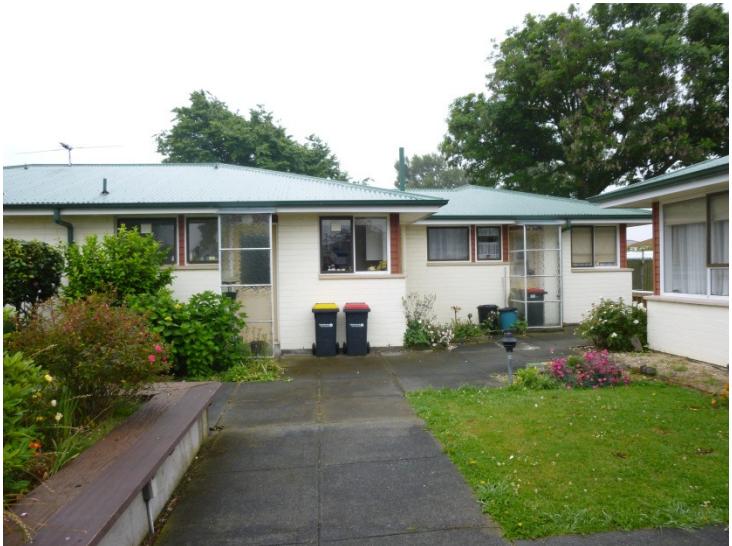
A photograph showing the front elevation of a single-story residential unit. The unit has a light green corrugated metal roof and white horizontal siding. There are several windows with white frames and dark shutters. A small front porch with a red door is visible. The unit is surrounded by a green lawn and a concrete driveway.
2.	Typical joining between units
