Men's Toilet Avonhead Cemetery  
PRK 0217 BLDG 003  
Detailed Engineering Evaluation  
Qualitative Report  
Version Final

140 Hawthornden Road

Christchurch City Council

**Date**  
20<sup>th</sup> May 2013

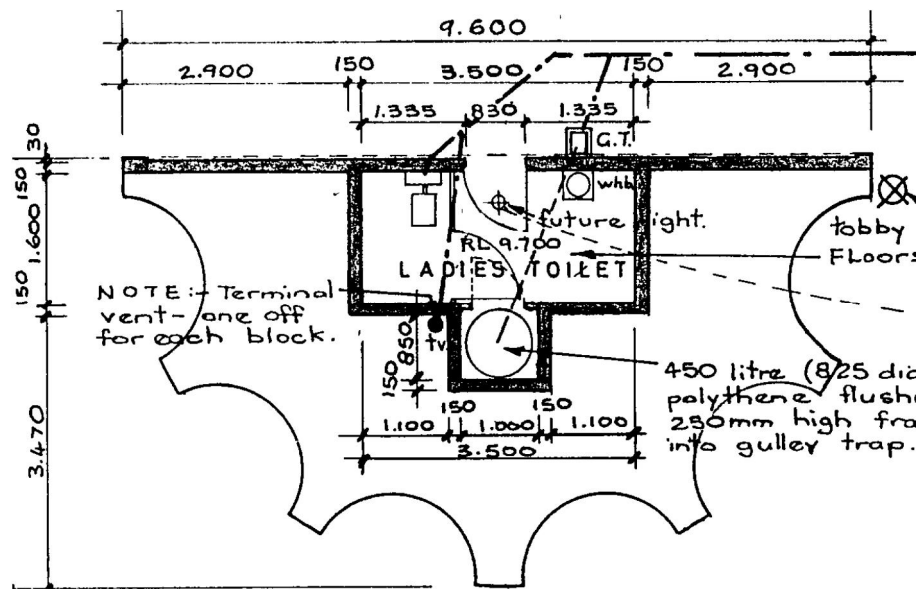
Figure 2 Plan

The building is constructed entirely from un-plastered reinforced in-situ concrete and takes the shape of half a concave cone. A 150mm thick wall forms the vertical face at the rear of the half cone and the curved external surface is formed from a 100mm roof slab sloping from the apex to the ground. There are also 150mm walls internally from ground to the underside of the roof slab. Strip footings form the foundations.

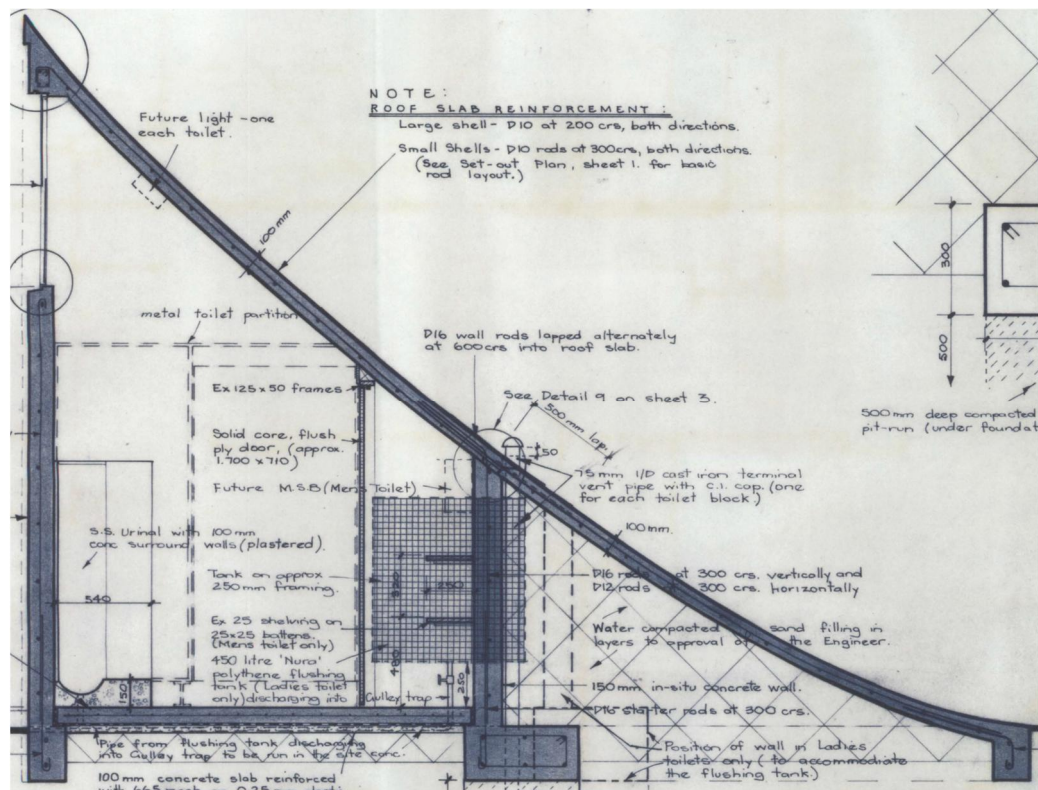
**Figure 4 Section along centreline of building**

The building's footprint is a semi-circle with an approximate radius of 4.8m and it has an overall height of 3.8m. The building is one of three buildings of similar construction and layout, the nearest being approximately 3m away. The flat site is approximately 150m south of an unnamed stream.
