Avonheath Courts BE 1401 EQ2

**Detailed Engineering Evaluation
Quantitative Assessment Report**

**86 Beachville Road, Redcliffs,
Christchurch 8081**

Date: December 2012
Reference: 6-QUCC1.93
Status: Final

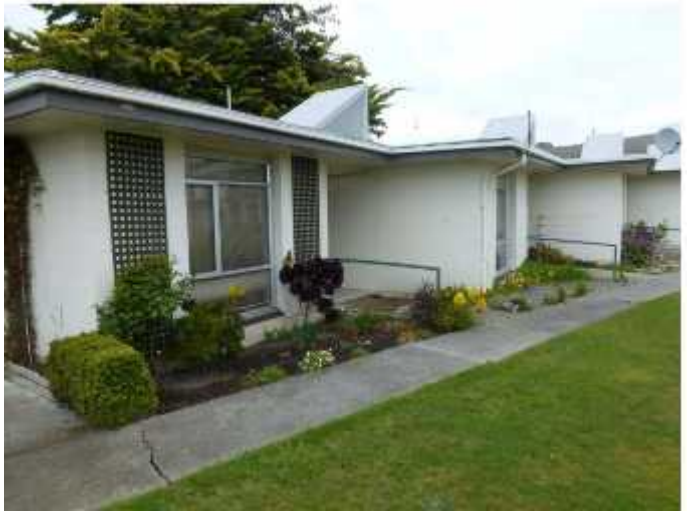
Block C		
9.	Block C – South (street) elevation	 
10.	Block C – North (Courtyard) elevation	 
11.	Block C - Timber truss roof

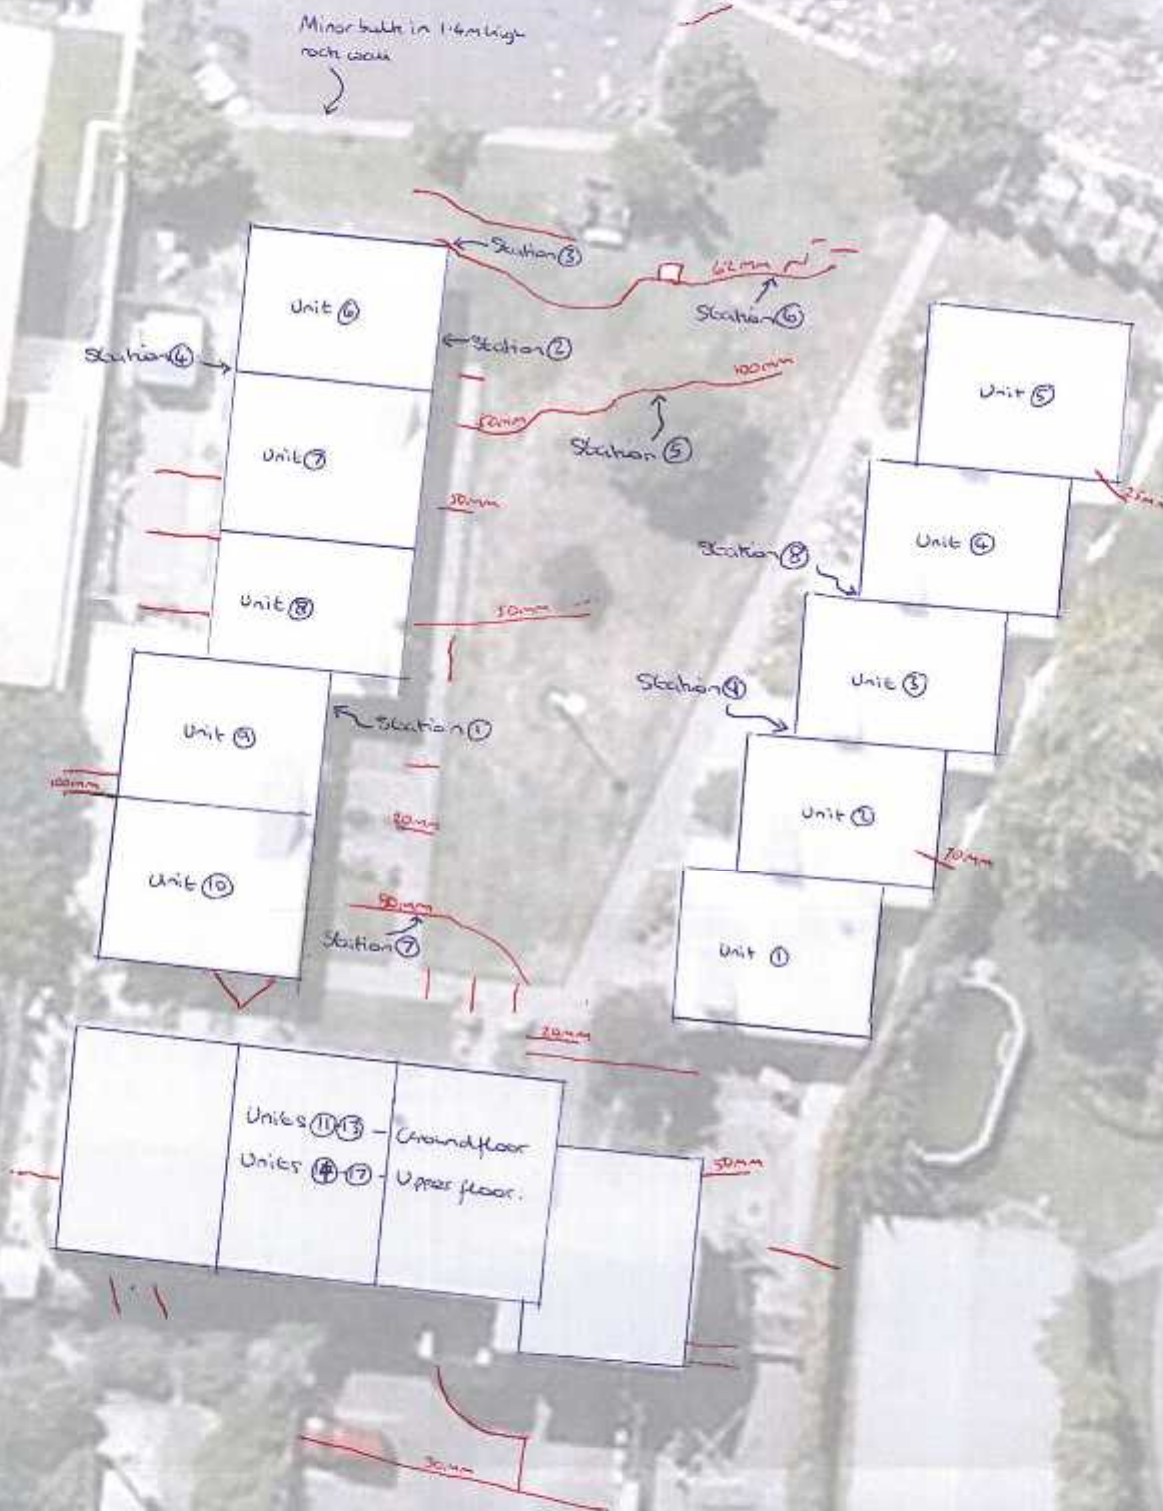
50mm = Approximate Crack Location and aperture width. (where recorded).
