Bower Park Pavilion/Toilet
PRK 1307 BLDG 001

Detailed Engineering Evaluation
Quantitative Report
Version FINAL

479 New Brighton Road, Christchurch

Christchurch City Council

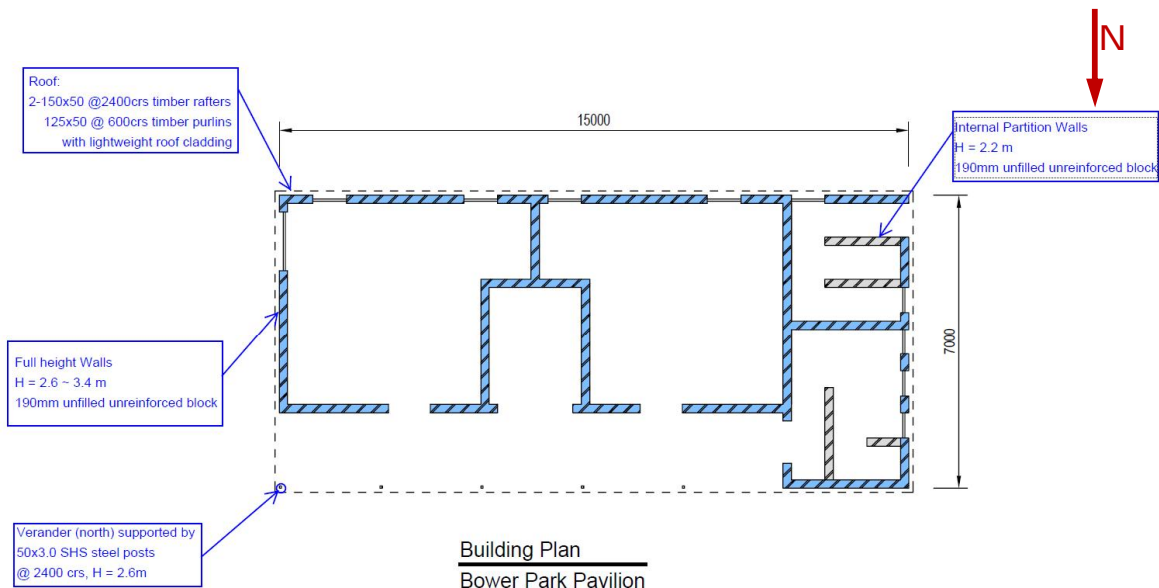
Figure 2: Plan Sketch Showing Key Structural Elements

The overall seismic capacity for the Bower Park Pavilion building assessed in accordance with NZSEE guidelines is **19% NBS**. The rate of 19% NBS represents the out-of-plane seismic capacity of the cantilevered partition walls (as outlined in grey in Figure 2). The in-plane seismic capacity of the building has been assessed as 52% NBS in the along direction and 58% NBS in the across direction. The out-of-plane seismic capacity of the simply supported walls (as outlined in blue in Figure 2) has been assessed as 60% NBS.

The building measures approximately 15 m long by 7 m wide by 3.4 m high. It is rectangular in plan, with a gross floor area of approximately 105 m². The veranda along the northern side extends 1.8 m out from the building, as shown in Figure 2.

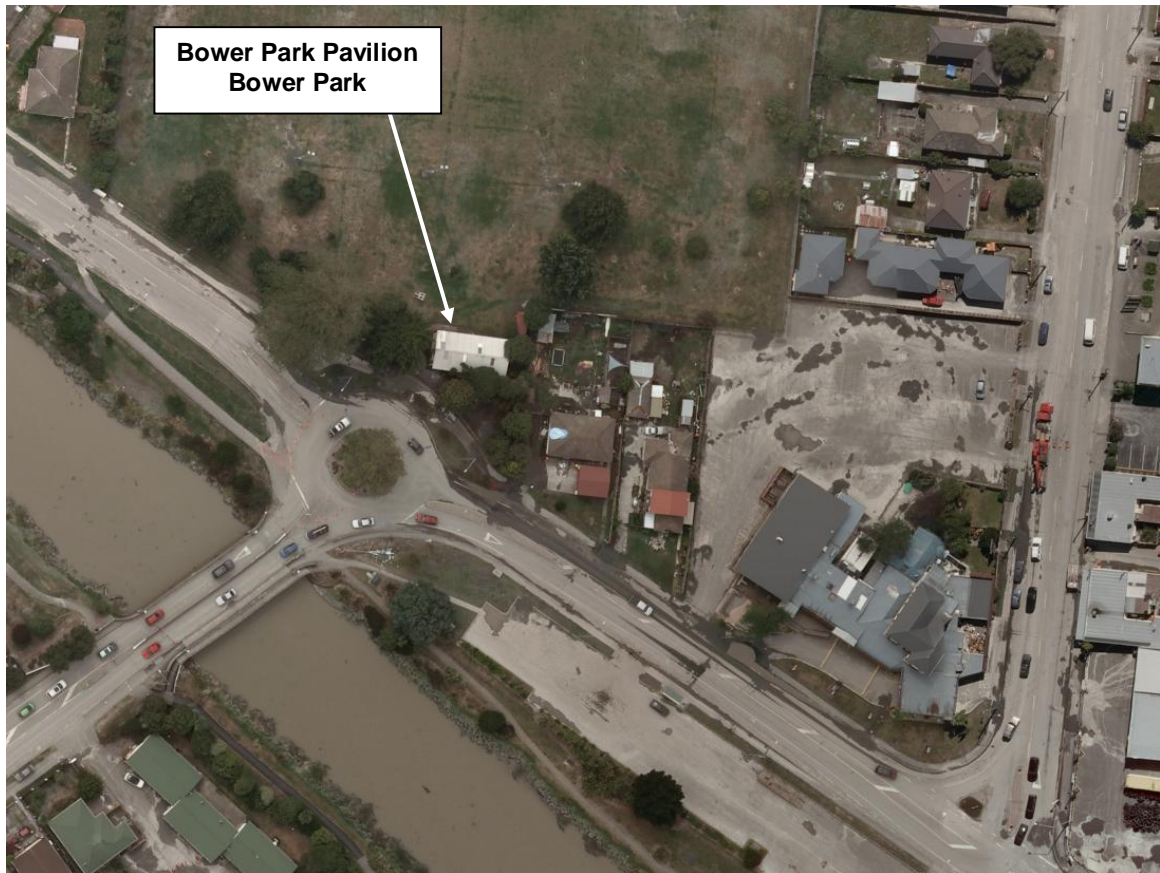
Figure 3 Post February 2011 Earthquake Aerial Photography

Aerial photography⁸ taken following the 22 February 2011 earthquake shows moderate signs of liquefaction in Bower Park, in the carpark adjacent to the site, and on nearby streets, as shown in Figure 3. No new signs of liquefaction occurred following the 13 June 2011 and the 23 December 2011 earthquakes. Aerial photography taken following the 4 September 2010 earthquake shows minor signs of liquefaction in the adjacent carpark to the east.
