Broad Park Toilets and Changing Rooms PRK 0121 BLDG 001 EQ2

Detailed Engineering Evaluation Quantitative Report Version FINAL Rev 1

7a Broadpark Road, Waimairi Beach

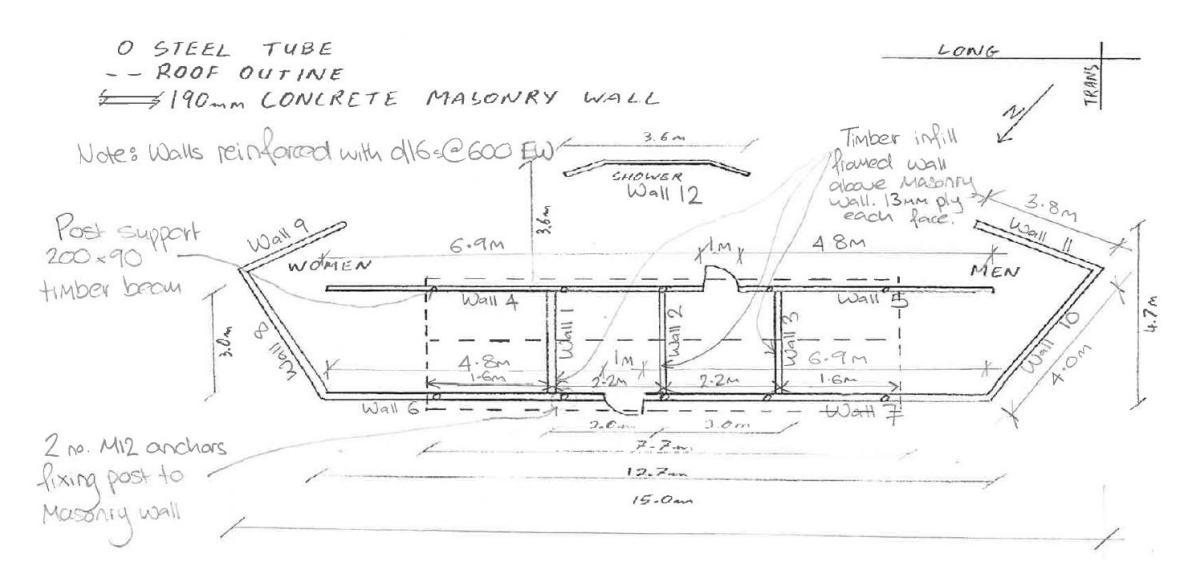
Figure 4.1 Plan of public toilets and changing rooms

Figures 4.1 and 4.2 show the construction details. No drawings of the building were available.

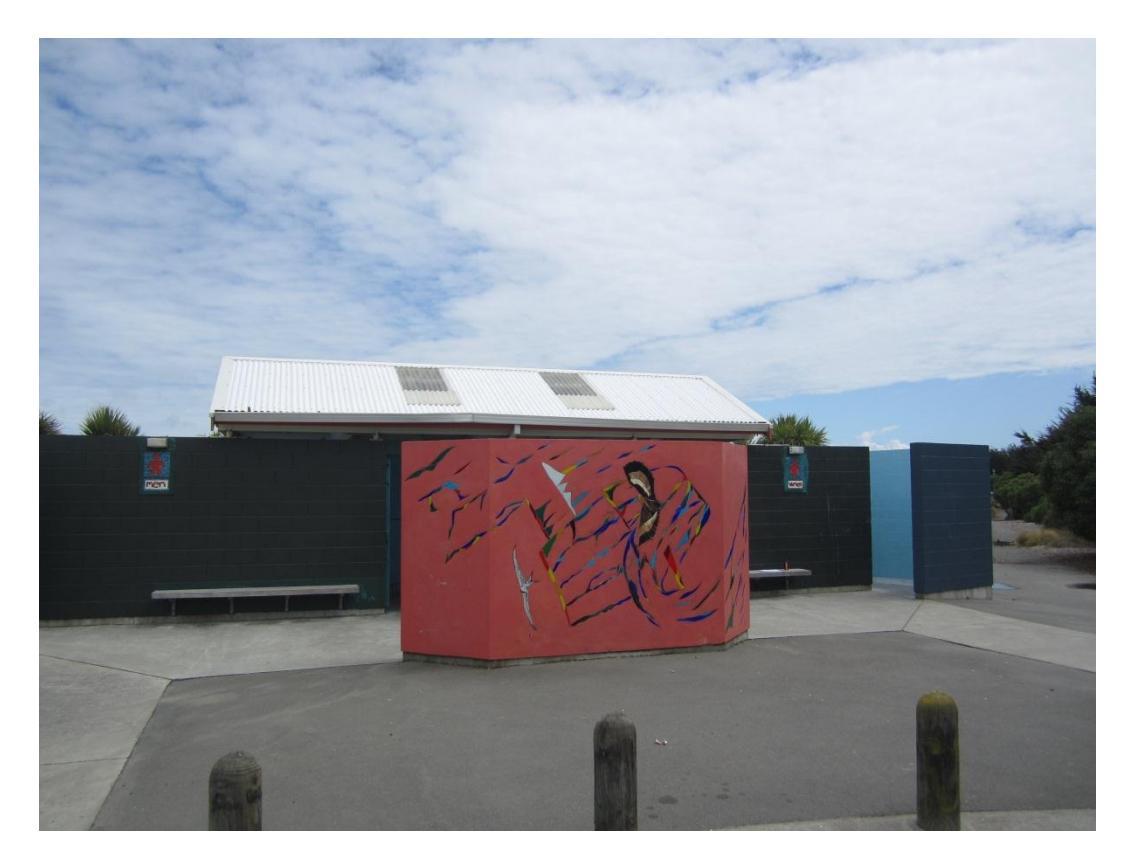
Photograph 1 View of the building from the north

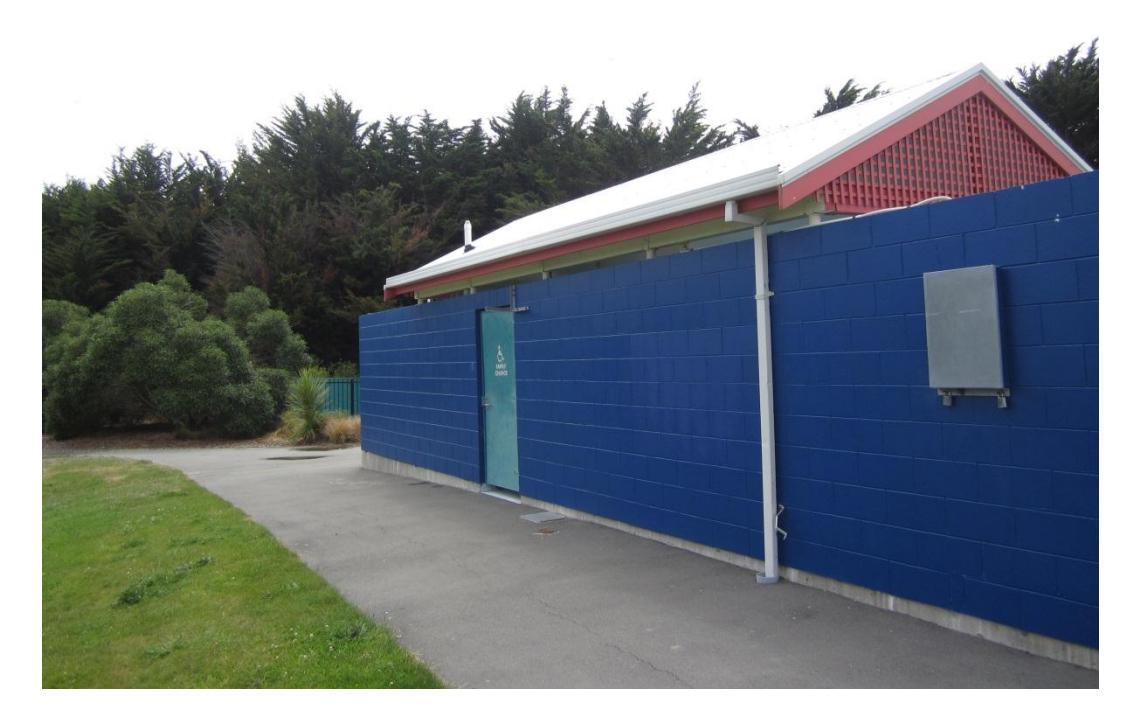
Photograph 2 View of the rear wall

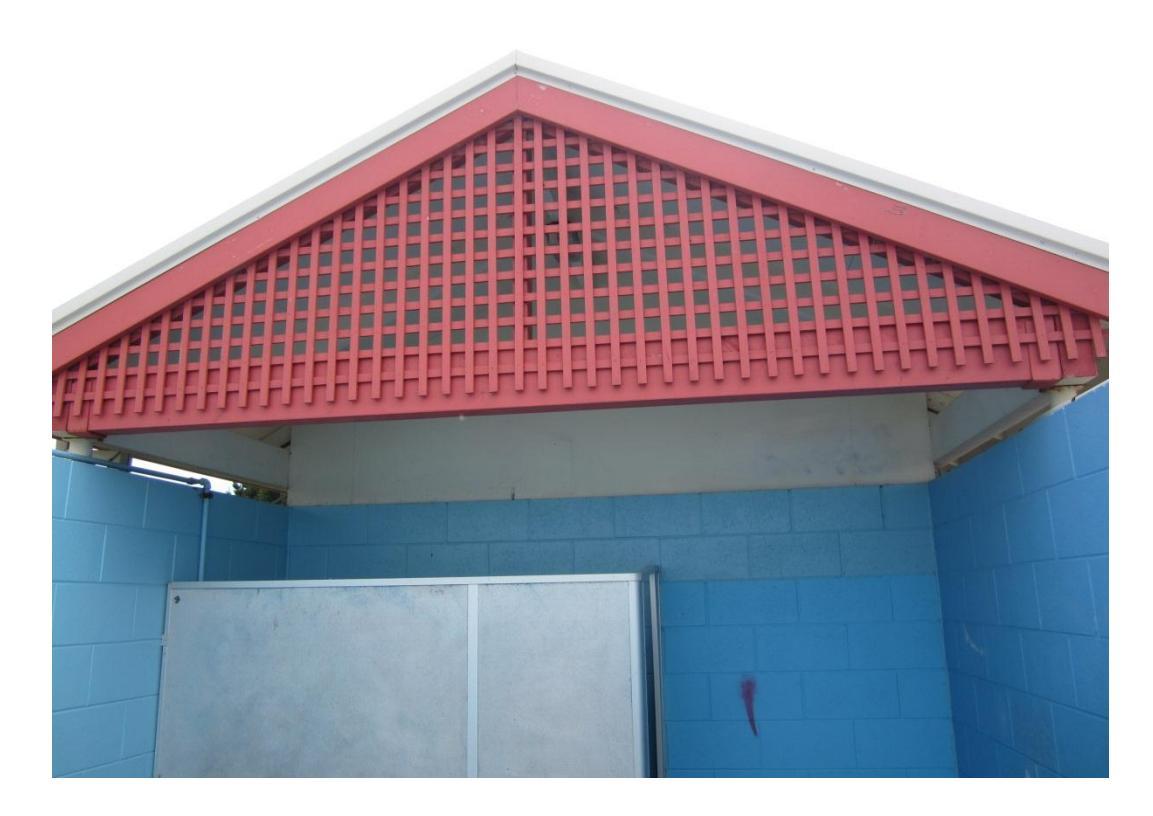
A number of concrete masonry panels with minimal lateral restraint at the top were noted in the structure. The shower area wall is one such panel and is shown in Photograph 6. These walls are restrained against lateral loading by their connection to the reinforced concrete floor slab.

Photograph 6 Unrestrained wall forming public showers
