**Burwood / Pegasus Community  
Boardroom  
BU 2637-001 EQ2**  
Detailed Engineering Evaluation  
Quantitative Report  
Version FINAL

5 Union St (133 Brighton Mall)  
New Brighton

Christchurch City Council

**Date**  
30 October 2012

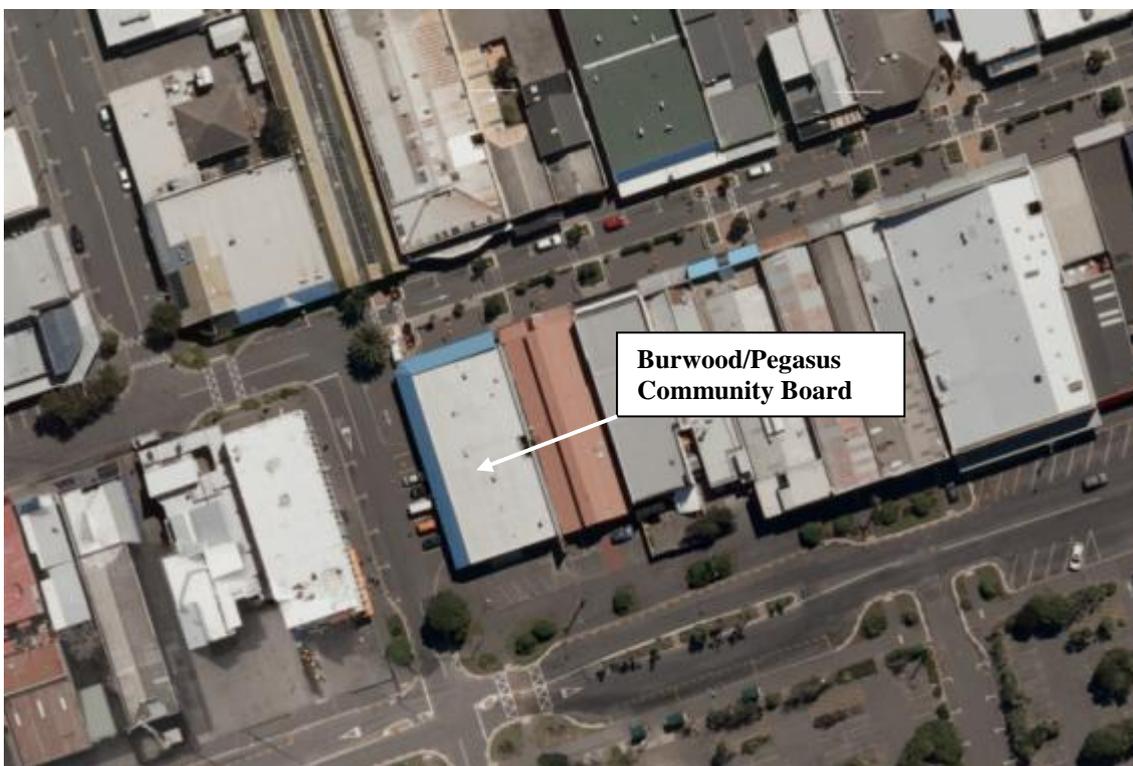
Figure 8.1 Post February 2011 Earthquake Aerial Photography<sup>4</sup>

Aerial photography taken following the 22 February 2011 earthquake examined for the purposes of this investigation showed no signs of liquefaction (see Figure 8.1 below).

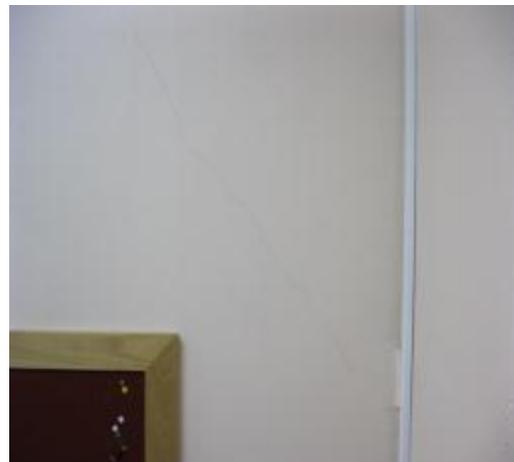
Concrete wall concrete

Some minor residual displacements of the structure were noticed during our inspection of the building. There is a canopy post that appears to be bowed from lateral displacement of its footing. Minor cracking was noted to the precast concrete wall panel and the precast concrete columns.

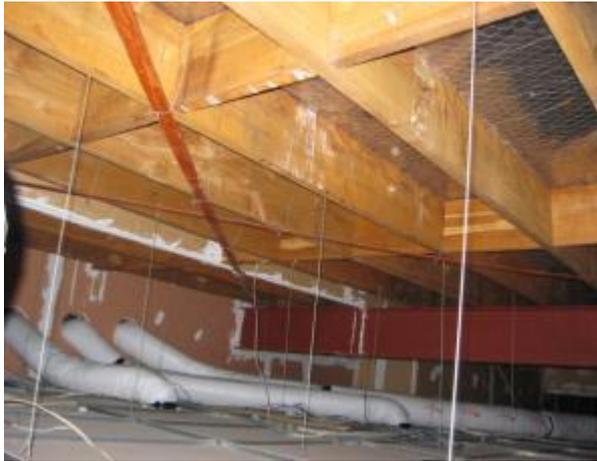
Roof purlins and roof bracing

There is evidence of some yielding of the roof braces but no sign of any failure of the steel members or their connections. From the crack damaged columns, broken windows and sagging roof bracing, this indicates that there is possibly insufficient bracing along the western side of the building.
