Carey Street Housing Complex PRO 1132

**Detailed Engineering Evaluation
Quantitative Assessment Report**

Quantitative Assessment Report

Date: January 2014
Reference: 6-QC325.00
Status: Final

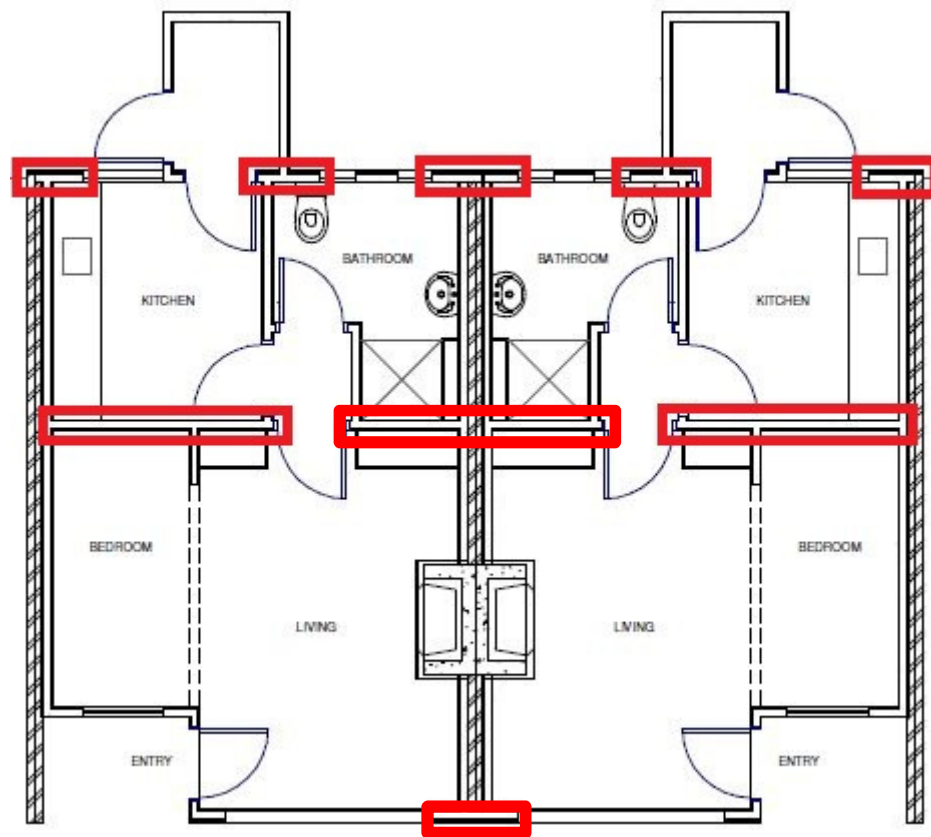
Figure 6: Walls used for bracing in the longitudinal direction.

Hand calculations were performed to determine seismic forces from the current building codes. These forces were applied globally to the structure and the capacities of the walls were calculated and used to estimate the %NBS. The walls, highlighted in Figure 6 and Figure 7, were used for bracing in their respective directions.
