**Concord Place
Housing Complex
BE 1063**

**Detailed Engineering Evaluation
Quantitative Assessment Report**

Date: 24/01/2013
Reference: 6-QUCC1.95
Status: Final

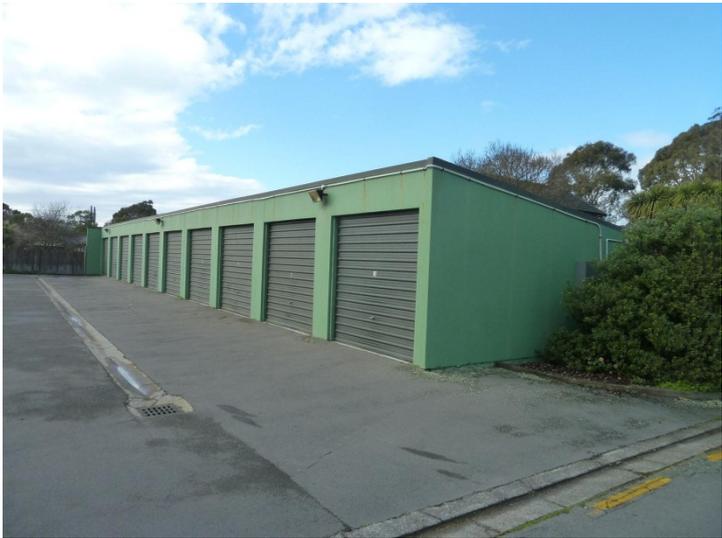
Site Name		
No.	Item description	Photo
Garage Block		
1	Front Wall
