Dog Shelter Detailed Engineering Evaluation BU 0890-001 EQ2 Quantitative Report

Prepared for Christchurch City Council (Client)

By Beca Carter Hollings & Ferner Ltd (Beca)

11 June 2013

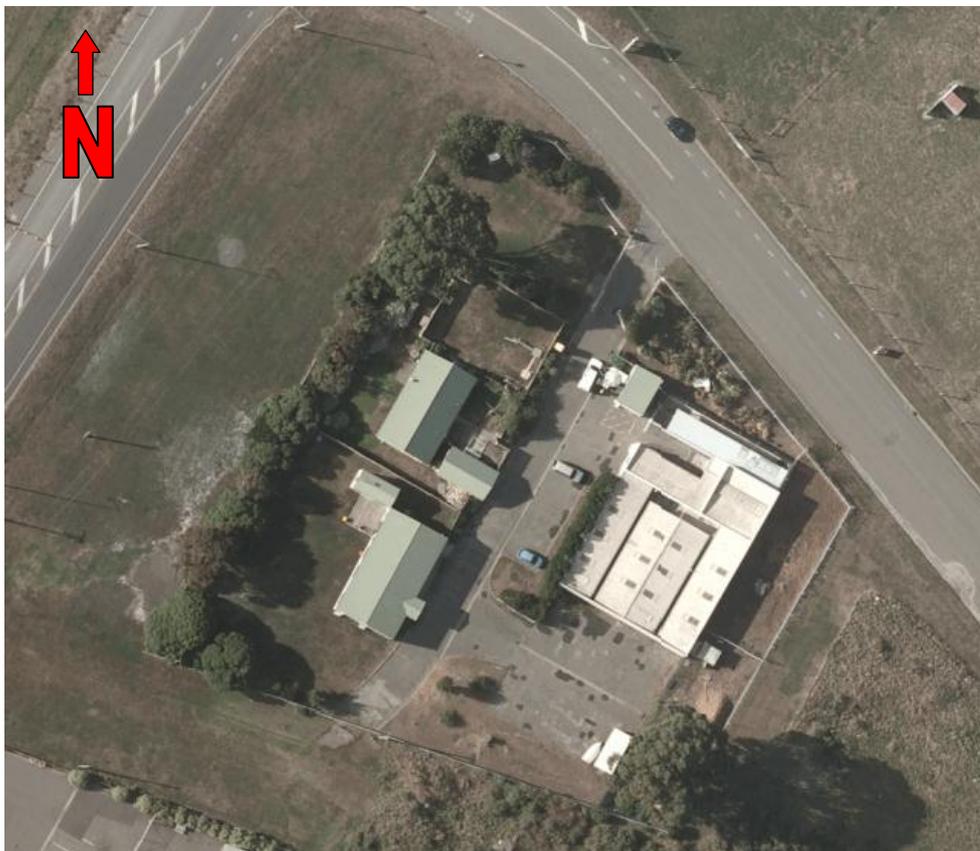
Figure 2: Site plan showing post-February liquefaction in the area. (Photo courtesy of Koordinates)

| Damage type | | | | | Comment |
|---|---|---|---|---|---|
| liquefaction | | ✓ | | | Post-earthquake imagery from Koordinates Ltd shows liquefaction occurring in the vicinity of the structure. (Refer to Figure 2 in Appendix A). |
