Edmonds Phone Booth Poplars Reserve
PRK 1927 BLDG 002 EQ2
Detailed Engineering Evaluation
Qualitative Report
Version FINAL

Christchurch City Council

Date
12th December 2013

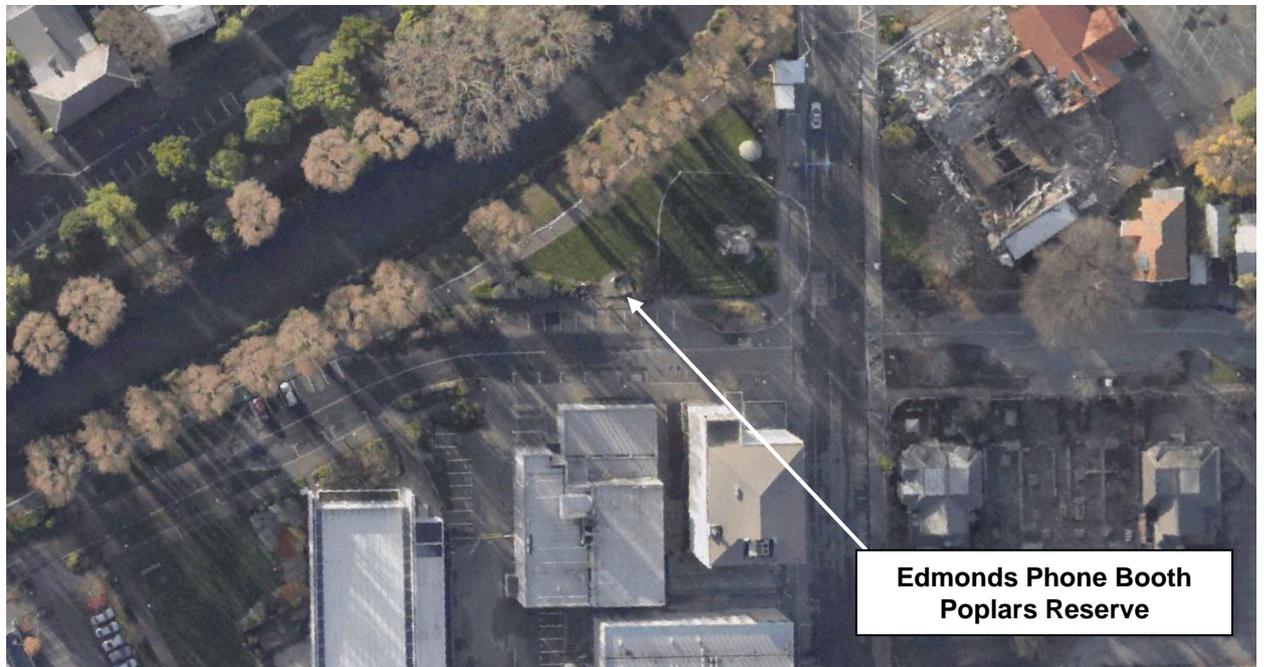
Figure 3 Post June 2011 Earthquake Aerial Photography⁵

Aerial photography taken following the 14-15 June 2011 earthquake shows signs of liquefaction adjacent to the site, as shown in Figure 3. There are no signs of liquefaction from previous earthquakes.

Should a more comprehensive liquefaction and/or ground condition assessment be required, it is recommended that intrusive investigation be conducted.

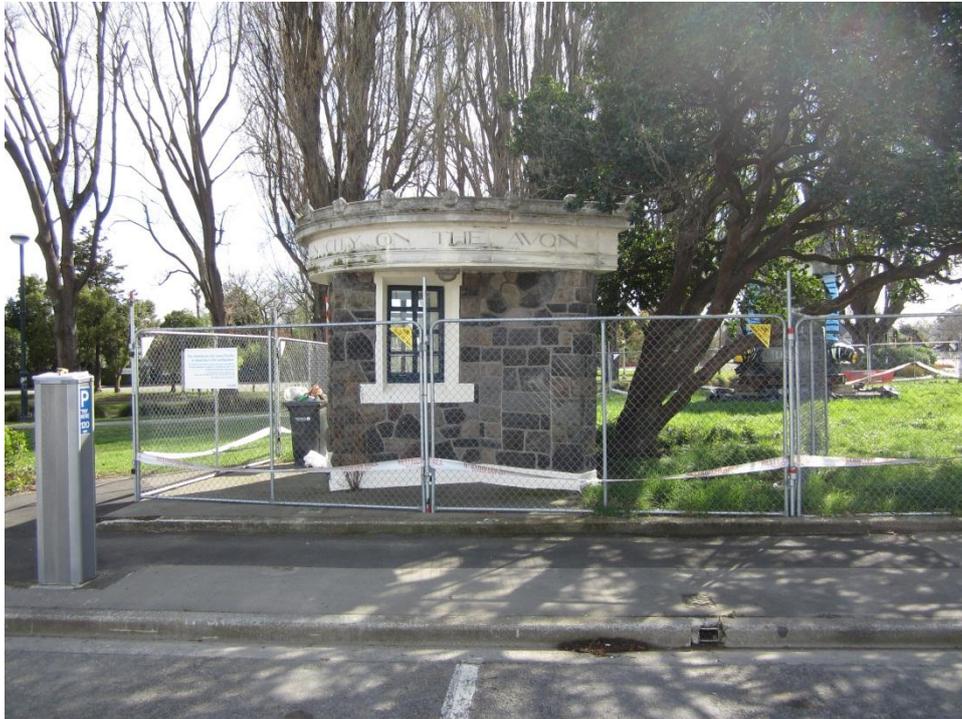
The clock tower to the north-east of the phone booth in Poplars Reserve has suffered earthquake damage. The clock tower has been partially deconstructed. The top section of the clock tower has been removed and placed on the ground. The removed section can be seen in the background in Photograph 1. The clock tower was constructed at the same time and from the same materials as the phone booth.

Photograph 1 View from Chester Street

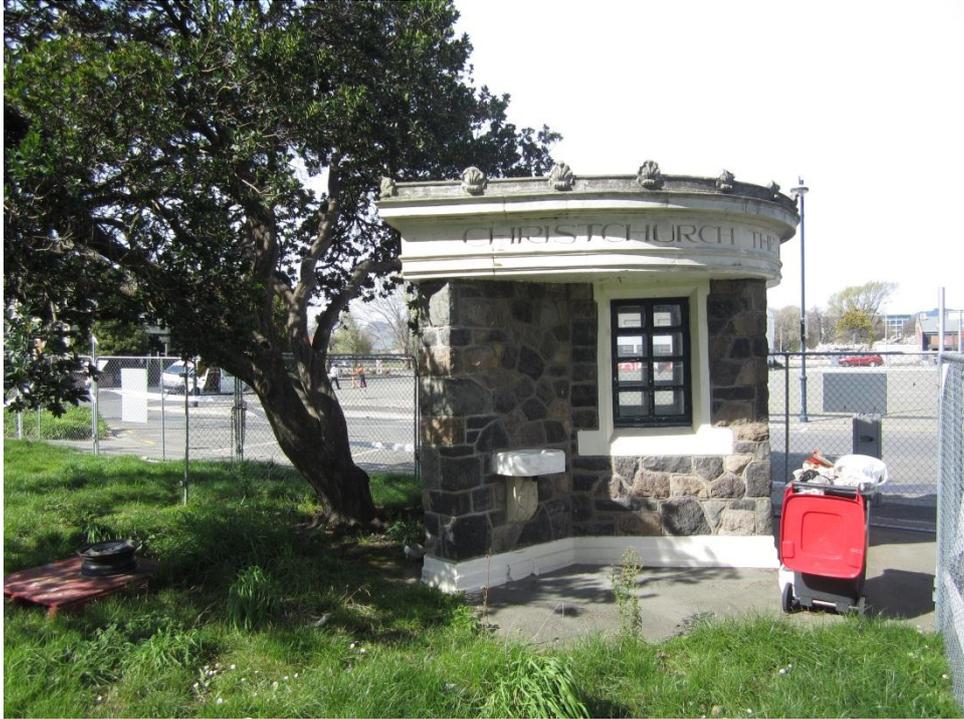
Photograph 3 View from Oxford Terrace

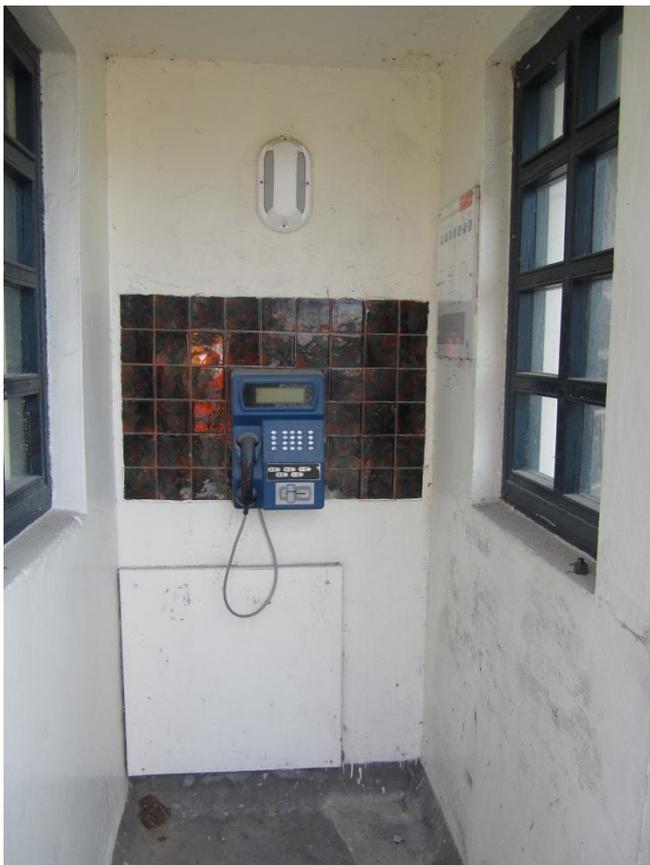
Photograph 4 Phone booth interior
