Forfar Courts Housing Complex PRO 0629

**Detailed Engineering Evaluation
Quantitative Assessment Report**

**95 Forfar Street, St Albans,
Christchurch**

Date: January 2014
Reference: 6-QC341.00
Status: Final

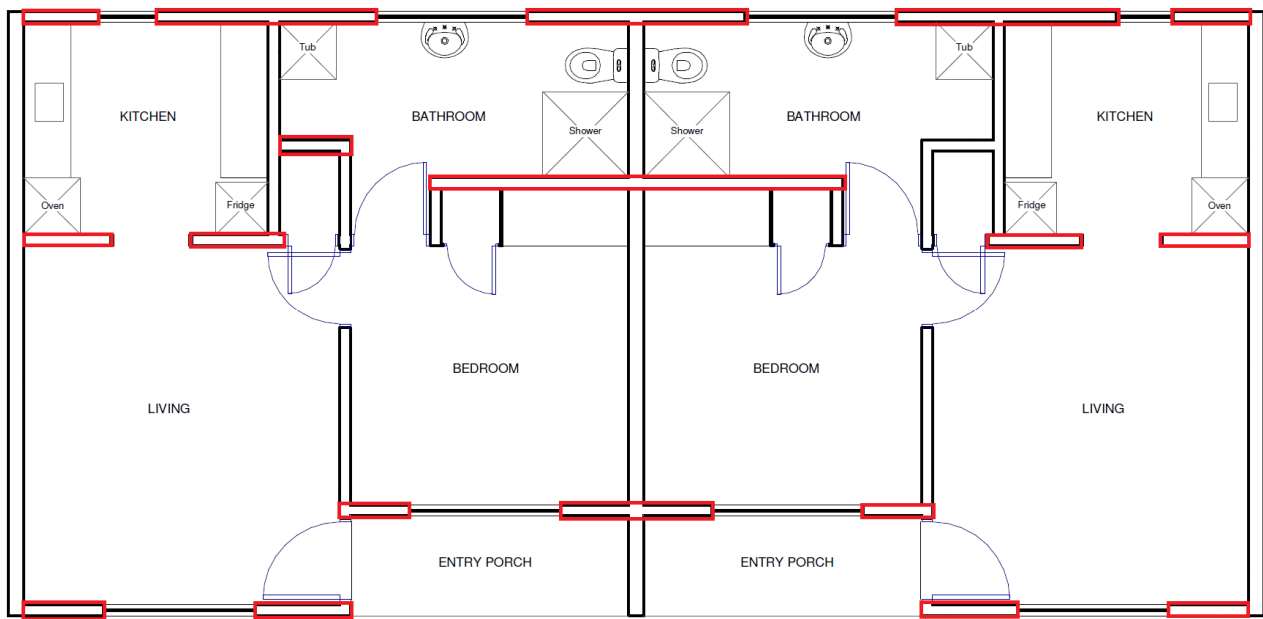
Figure 8: Walls used for bracing in the longitudinal direction (Residential Units).

Hand calculations were performed to determine seismic forces from the current building codes. These forces were applied globally to the structure and the capacities of the walls were calculated and used to estimate the %NBS. The walls, highlighted in Figure 8-11, were used for bracing in their respective directions.

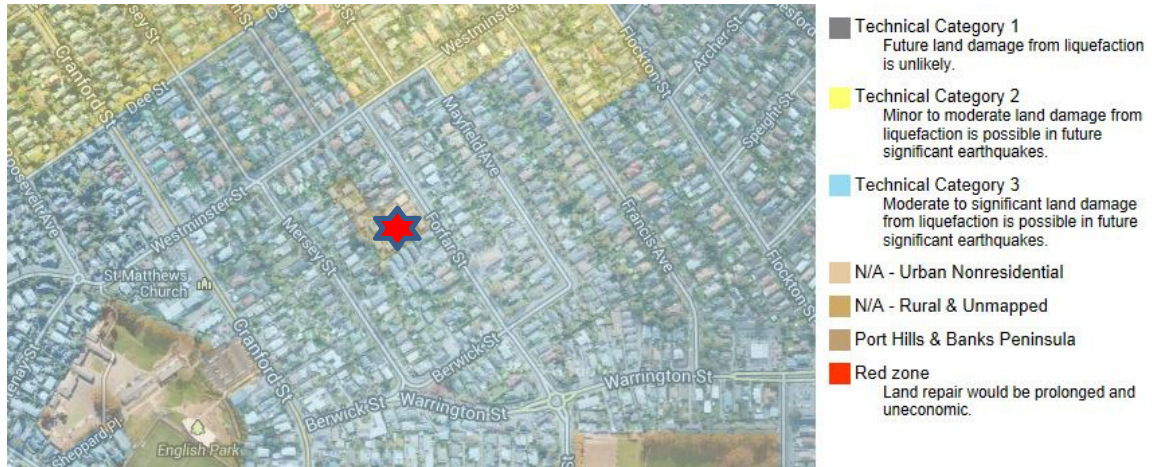
Figure 12: CERA Technical Categories map (loc. starred).

CERA indicates that Forfar Courts is located in a TC3 zone (as shown in Figure 12). This classification suggests future significant earthquakes will cause moderate to significant land damage due to liquefaction and settlement.

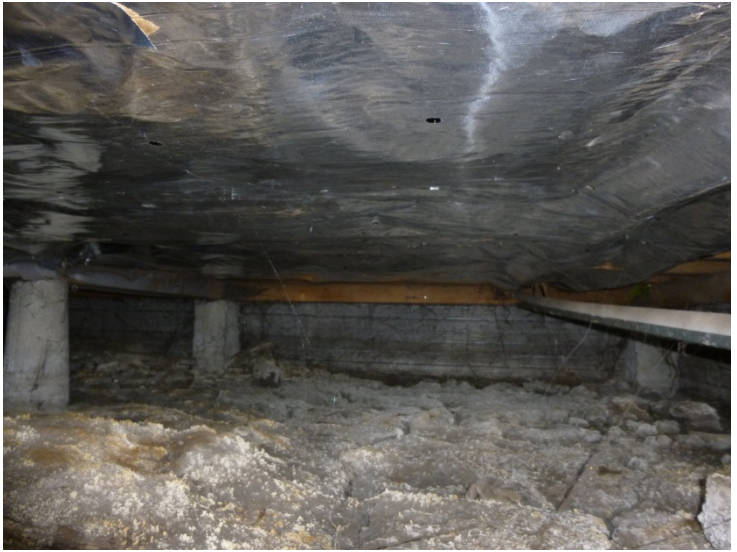
6.	Typical floor void
