CHRISTCHURCH CITY COUNCIL
PRK_0348_BLDG_006 EQ2
The Groynes – Dwelling No.2
182 Johns Road

QUANTITATIVE ASSESSMENT REPORT

- Rev B
- 26 February 2014

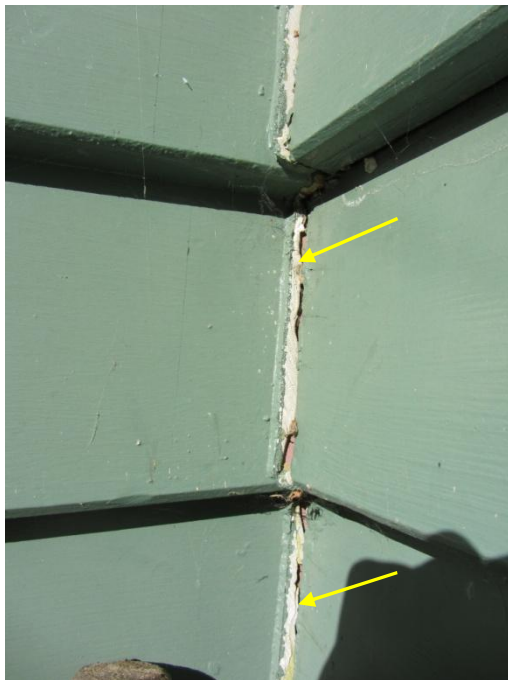
Photo 7: Close Up of Photo 5

- 1) No visual evidence of settlement was noted at this site. Therefore a level survey is not required at this stage of assessment.
- 2) Vertical joints in the weatherboard cladding have opened up (PHOTO 3 & 4).
- 3) Wall joint between the garage and the house in the north-west corner has opened up (PHOTO 5 & 7).
- 4) Hairline cracking along the wall joint in the corners along the north elevation (PHOTO 6 & 8).

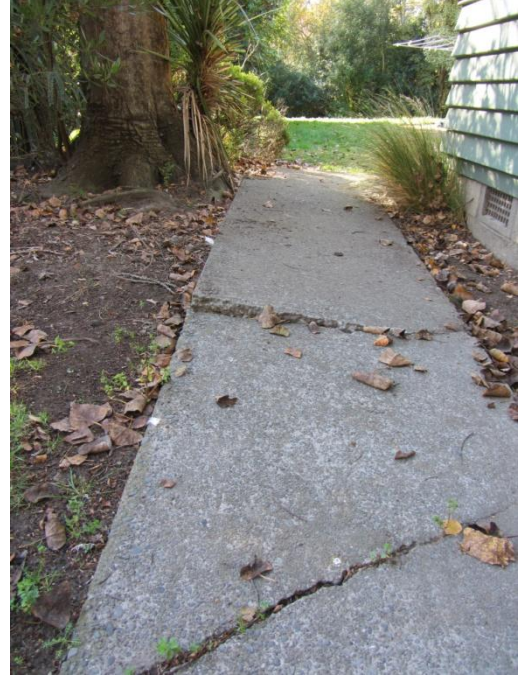
Photo 10: Close Up of Photo 10

- 5) Cracking and damage to concrete path near the north-east corner of the main house. This damage appears to be a result of the tree roots growing under the path and as a result has not been considered as earthquake damage (PHOTO 9 & 10).
- 6) Northern timber deck has pulled away from the main house structure (PHOTO 11 & 12).
- 7) Southern timber deck appears to have fallen off the centre row of piles. This has resulted in the deck caving in at the middle and becoming very springy (PHOTO 13 & 14).

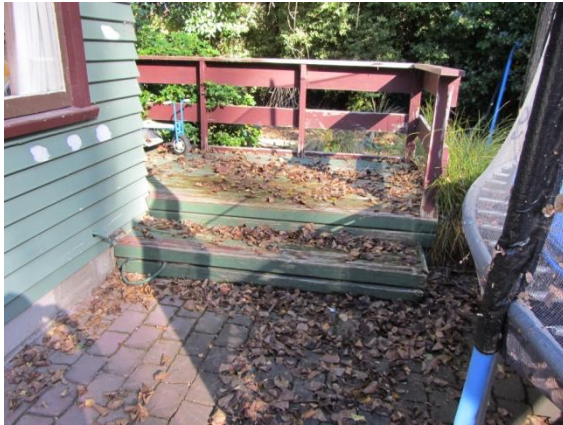
Photo 11: Northern Deck has Pulled Away from House Structure

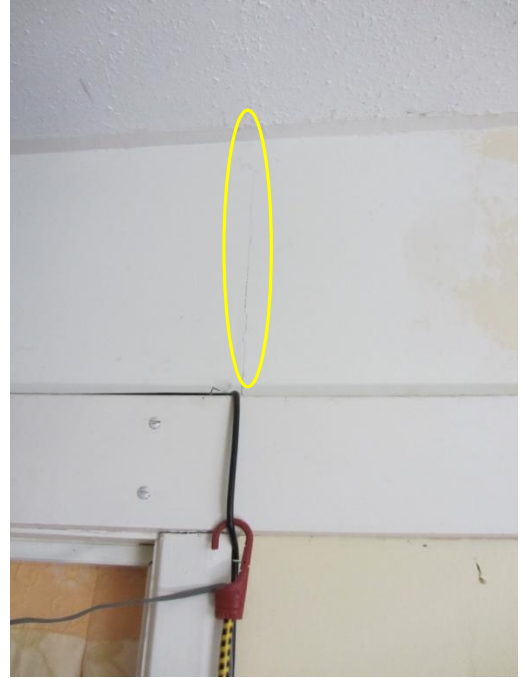
Photo 18: Close Up of Photo 17

- 1) Hairline cracking present along wall lining joints, located above the west wall opening, the west wall French doors and the east wall window (PHOTO 17, 18, 19, 20 & 21).
- 2) Hairline crack present along the ceiling lining joint above the west wall window (PHOTO 22).

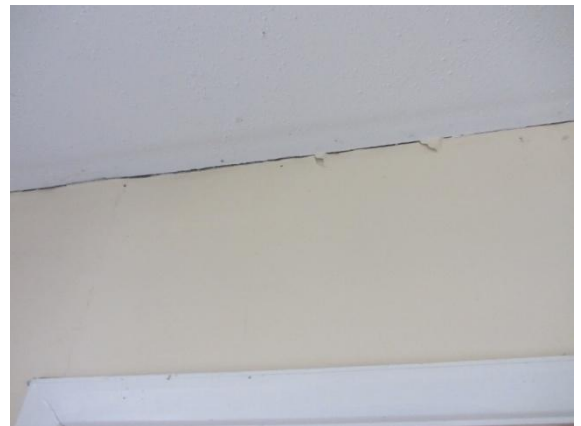
Photo 26: Close Up of Photo 25

- 1) Hairline cracking present along the ceiling lining joint near the south-east corner (PHOTO 24).
- 2) Hairline cracking along the wall and ceiling lining joint, present on the east and west walls (PHOTO 25, 26 & 27).
- 3) Cracking present along the wall lining joint in the north-east corner (PHOTO 27).
- 4) Hairline cracking present along the wall lining joint above the French doors (PHOTO 28).
- 5) Hairline cracking along wall lining joint on east wall near south corner (PHOTO 29 & 30).

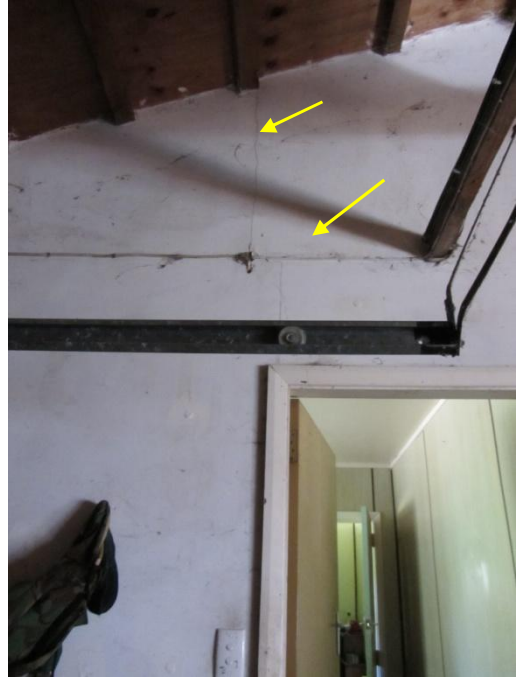
Photo 32: Close Up of Photo 31

- 1) Hairline cracking present along the wall lining joint above the door on the west wall (PHOTO 31 & 32).

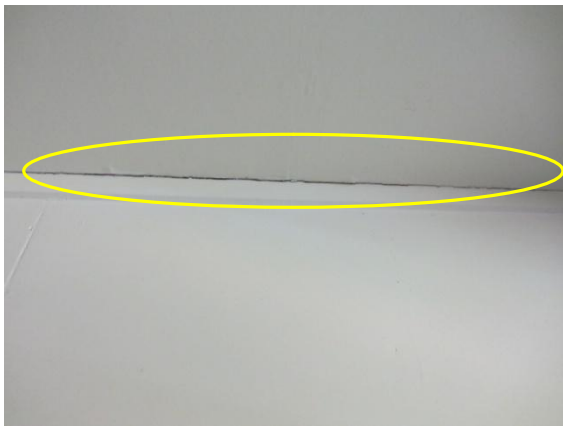
Photo 35: Close Up of Photo 34

- 1) Hairline cracking present along wall lining joint above the window.
- 2) Hairline cracking present along the ceiling lining and scotia joint (PHOTO 34 & 35).
- 3) Hairline cracking along the wall lining and the timber trim present in the north-east and south-east corners (PHOTO 34).

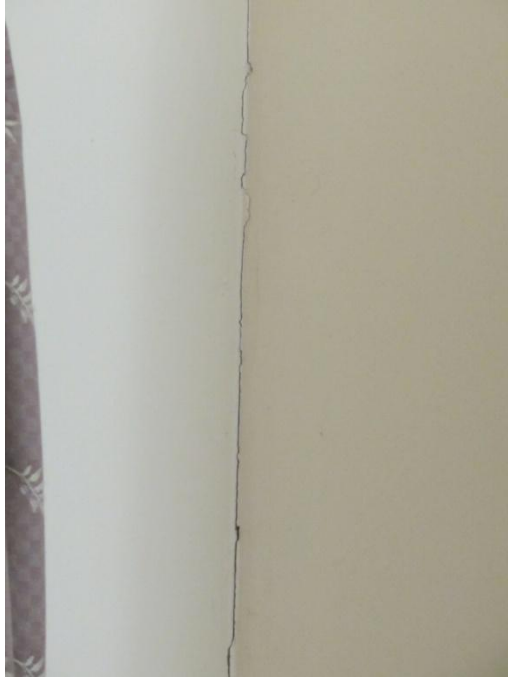
Photo 55: Close Up of Photo 53

- 1) Hairline cracking present along the ceiling lining joints (PHOTO 52).
- 2) Hairline cracking present along the wall lining joints above all windows (PHOTO 54).
- 3) Cracking present along the wall lining joint in the south-west corner (PHOTO 53 & 55).
- 4) Cracking present along the wall lining joint under the north-west window (PHOTO 56 & 57).
- 5) Cracking present along the wardrobe architrave and wall lining joint (PHOTO 58 & 59).
- 6) Hairline cracking present along the wall lining joint under south wall windows (PHOTO 60 & 61).

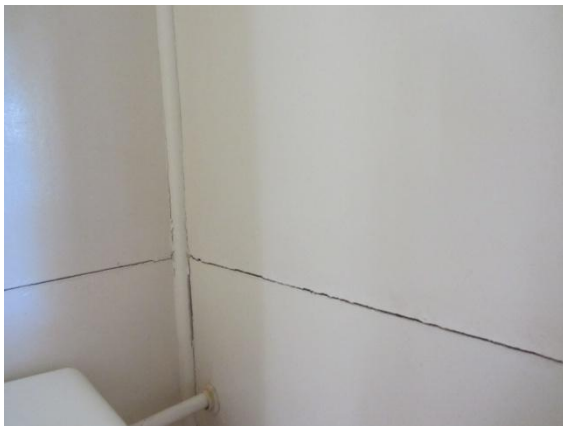
Photo 63: Close Up of Photo 62

- 1) Cracking present along wall lining joints (PHOTO 62 & 63).
- 2) Hairline cracking present along the ceiling lining and scotia joint (PHOTO 62 & 64).
- 3) Hairline cracking present along wall lining and timber trim joint in the corners (PHOTO 64).
- 4) Cracking present along the skirting board and wall lining joint (PHOTO 65 & 66).
