Christchurch City Council

PRK_0348_BLDG_020

Toilets No 1 Ground East

QUALITATIVE ASSESSMENT REPORT FINAL

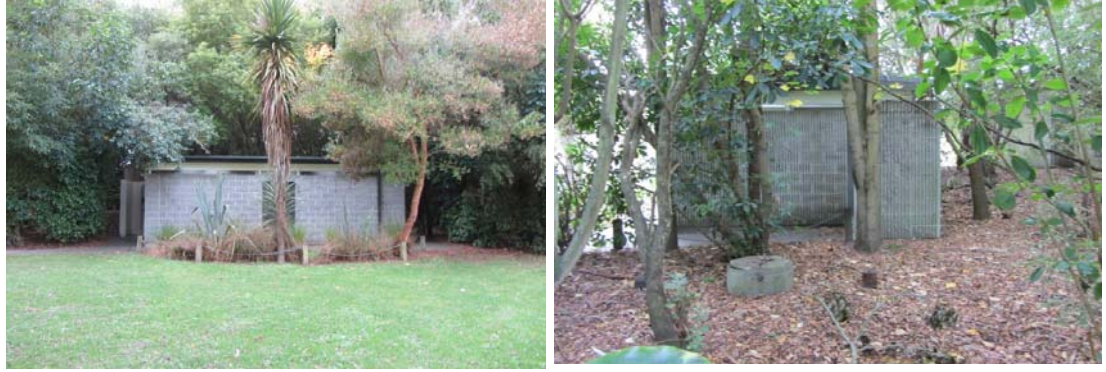
1.1 Photos (attach sufficient to describe building)

This building is a single storey toilet block. It is constructed from reinforced filled masonry walls with a timber framed corrugated iron roof which is connected with steel tubes and brackets cantilevering vertically from the walls. Due to the architecture we believe it was built in the 1970's.

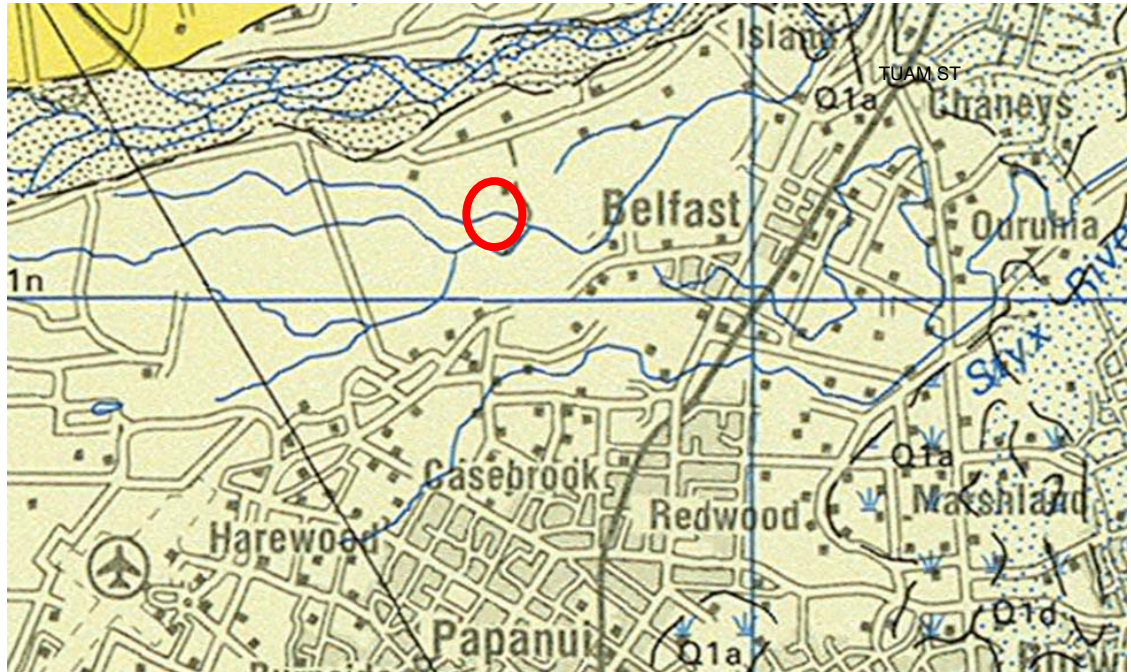
■ Figure 2 – Regional geological map (Forsyth et al, 2008). Site marked in red.

The local geological map of the Christchurch area does not extend to the location of the site.

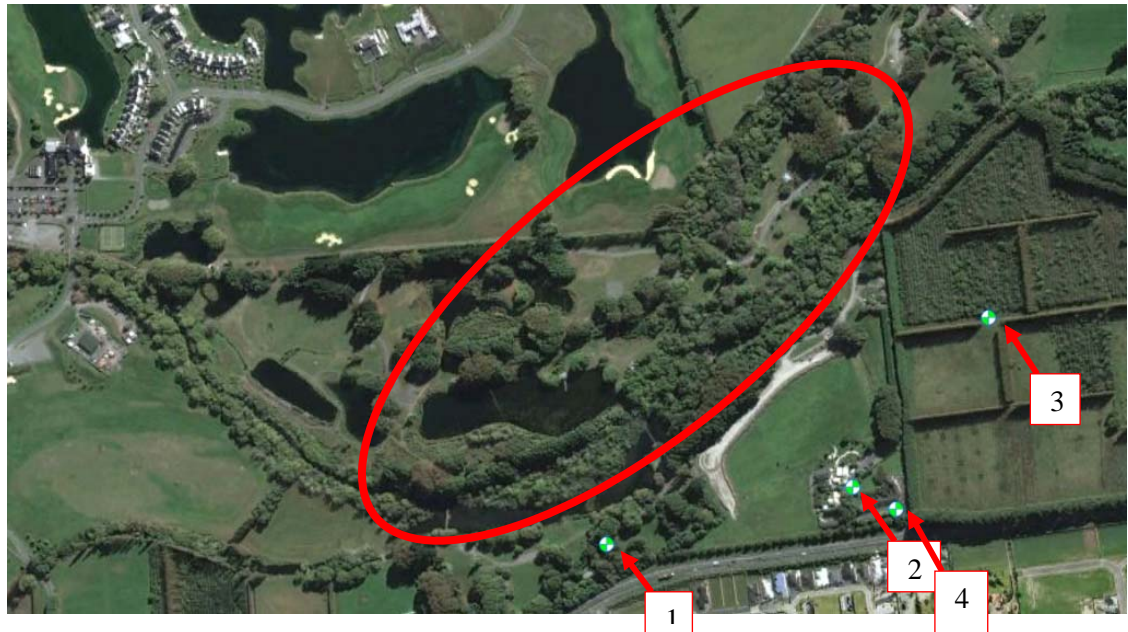
■ **Figure 5 – Local boreholes from Project Orbit and SKM files**
(<https://canterburyrecovery.projectorbit.com/>)

Where available logs from these investigation locations are attached to this report (Appendix B), and the results are summarised in Appendix C.

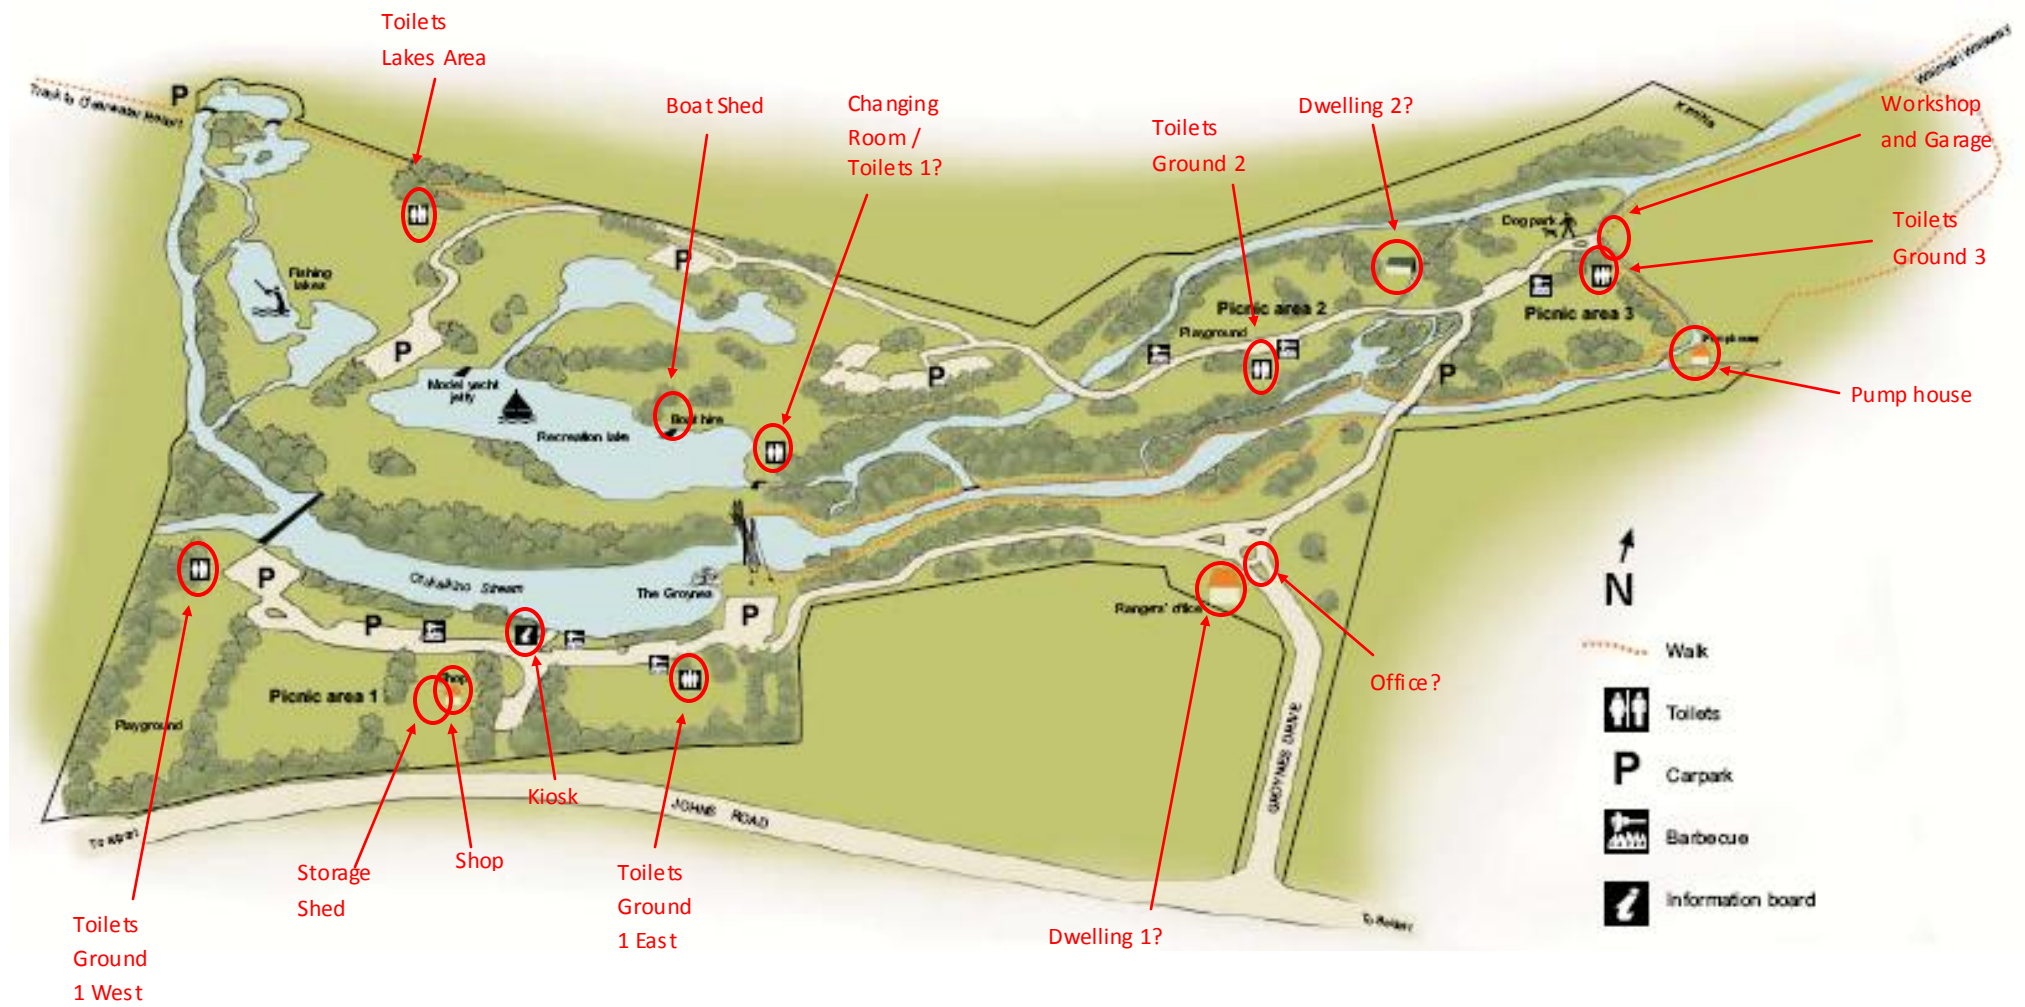
Appendix D – Site Plan outlining the location of the building as named in the external site walkover

Could not find – Toilets Kimihia? Or Toilets – CLOSED (behind toilet block?)
