Christchurch City Council
PRK_0348_BLDG_007 EQ2
The Groynes - Office
182 Johns Road

QUALITATIVE ASSESSMENT REPORT

- Rev C
- 23 May 2013

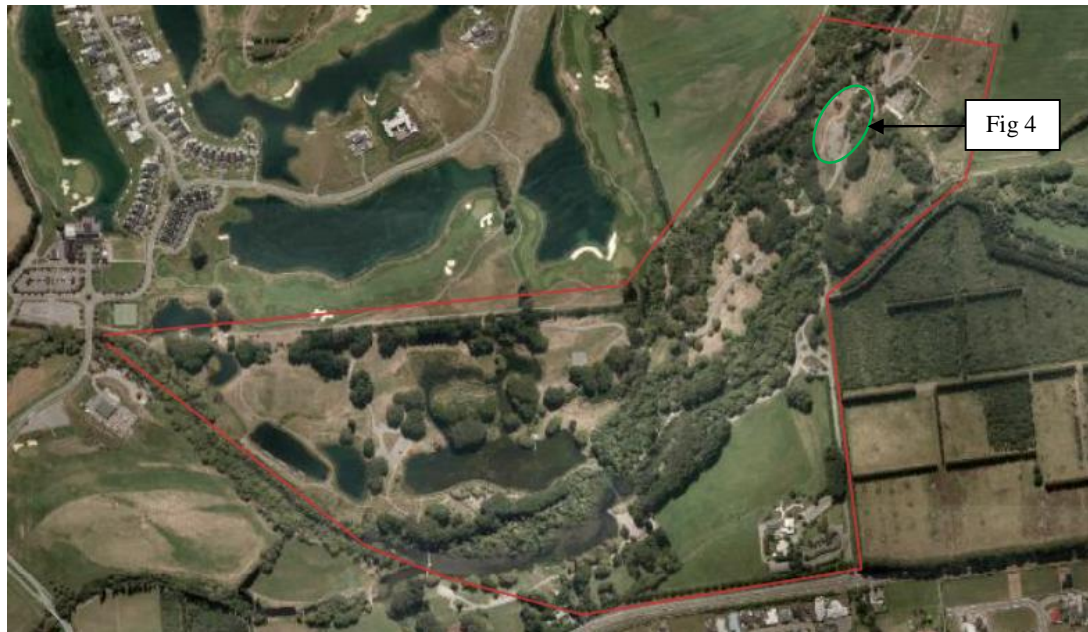
- Figure 3 – Aerial photography from 24 Feb 2011 (<http://viewers.geospatial.govt.nz/>)

The aerial photograph appears to show some evidence of liquefaction occurring on site due to the 22 February earthquake, with localised sand boils and liquefied material ejected near the road way visible in figure 4.
