**Guise Lane
Housing Complex
PRO 1519**

**Detailed Engineering Evaluation
Quantitative Assessment Report**

6 Guise Lane, Hoon Hay,

Date: March 2014
Reference: 6-QC349.00
Status: Final

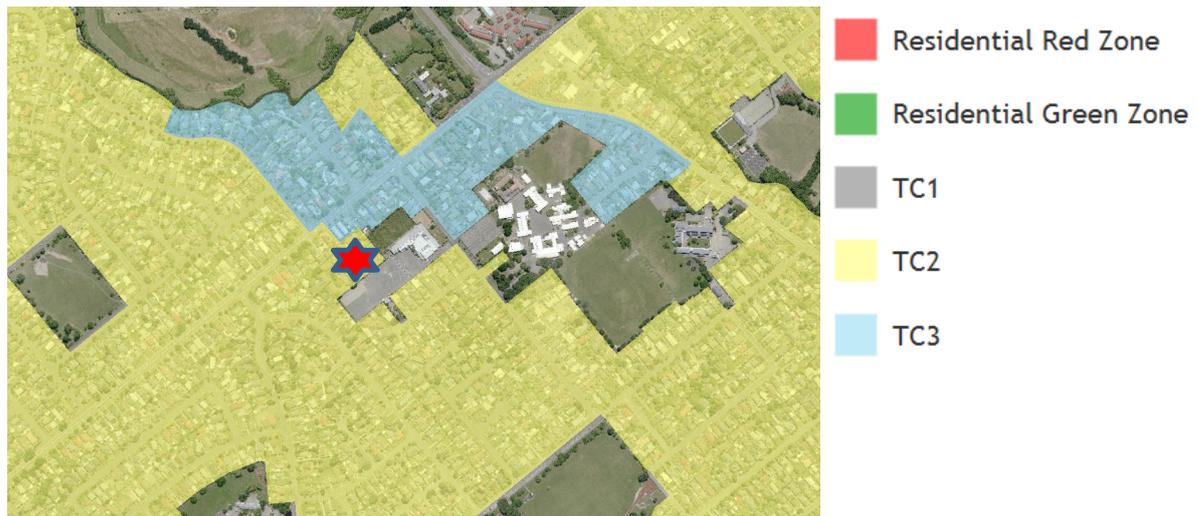
CERA indicates that Guise Lane is located in a TC2 zone (as shown in Figure 8). This classification suggests future significant earthquakes will cause minor to moderate land damage due to liquefaction and settlement. Note that the proximity to the TC3 zone is consistent with the variations found with the floor levels.

Figure 8: CERA Technical Categories map (loc. starred).

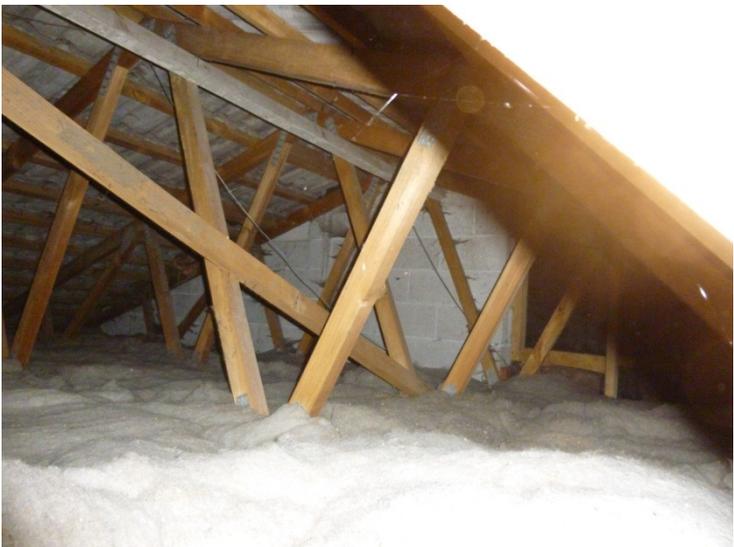
10.	Typical roof space showing fire wall and truss system (note heavy tile roof)

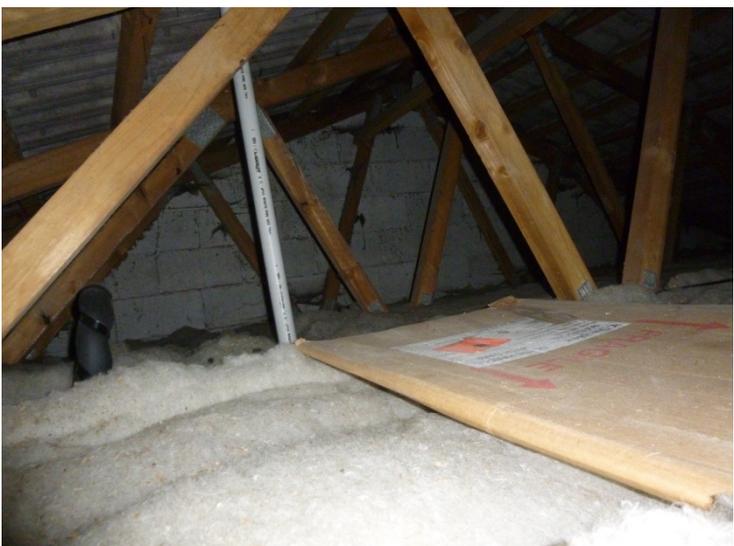
11.	Typical roof space showing fire wall and truss system

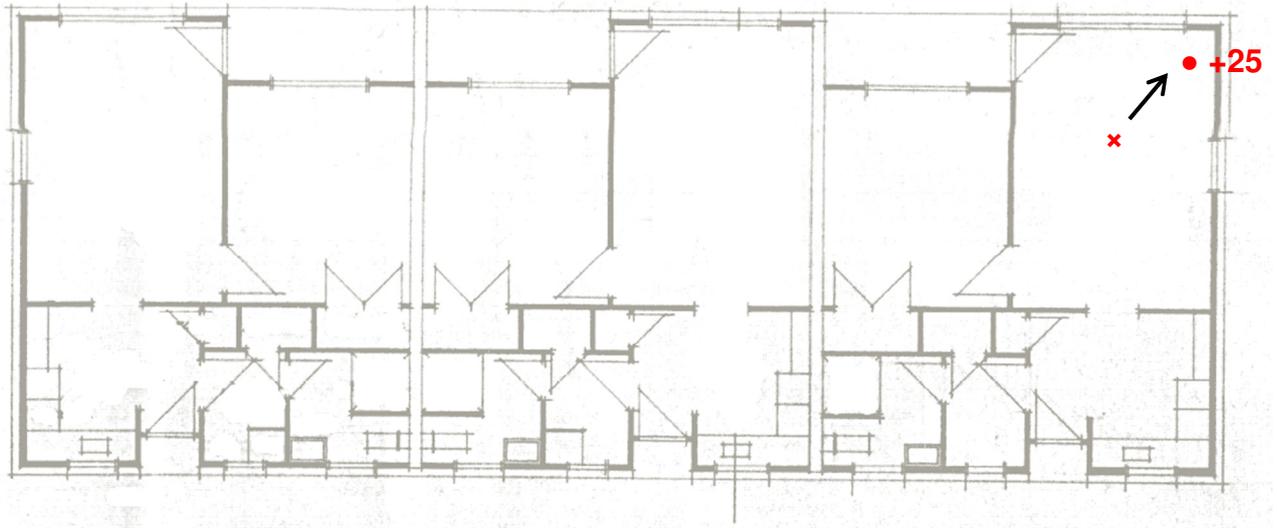
Block	Unit No.	Comment	Maximum Fall*
A	1	Pass	-
	2	Fail	5 mm/m
	3	Pass	-
B	4	Pass	-
	5	Pass	-
	6	Pass	-
C	7	Pass	-
	8	Pass	-
	9	Fail	7 mm/m
D	10	Pass	-
	11	Pass	-
	12	Fail	13 mm/m
E	13	Fail	6 mm/m
	14	Pass	-
F	15	Pass	-
	16	Pass	-
	17	Fail	5 mm/m
G	18	Fail	13 mm/m
	19	Pass	-
	20	Fail	7 mm/m
	21	Fail	6 mm/m
