CHRISTCHURCH CITY COUNCIL  
BU 0812-006 EQ2  
Guthrey Courts – Block F  
72a Olliviers Road, Phillipstown

QUANTITATIVE ASSESSMENT REPORT  
FINAL

- Rev E
- 03 May 2013

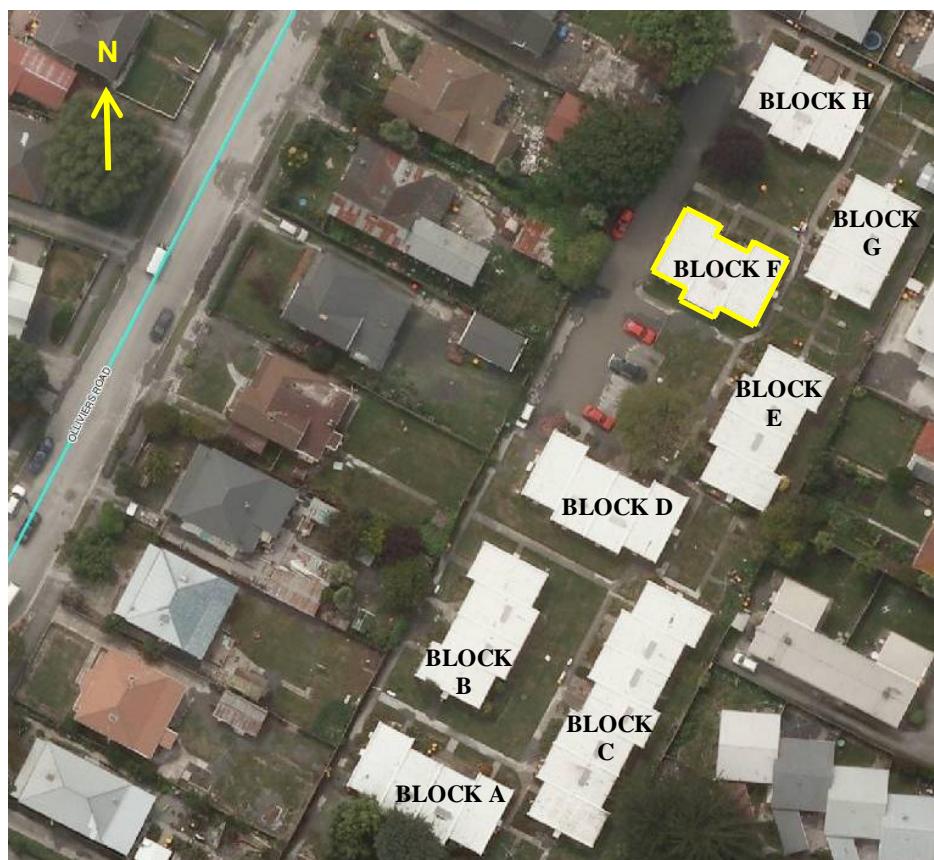
■ Figure 1 Aerial Photograph of 72a Olliviers Road

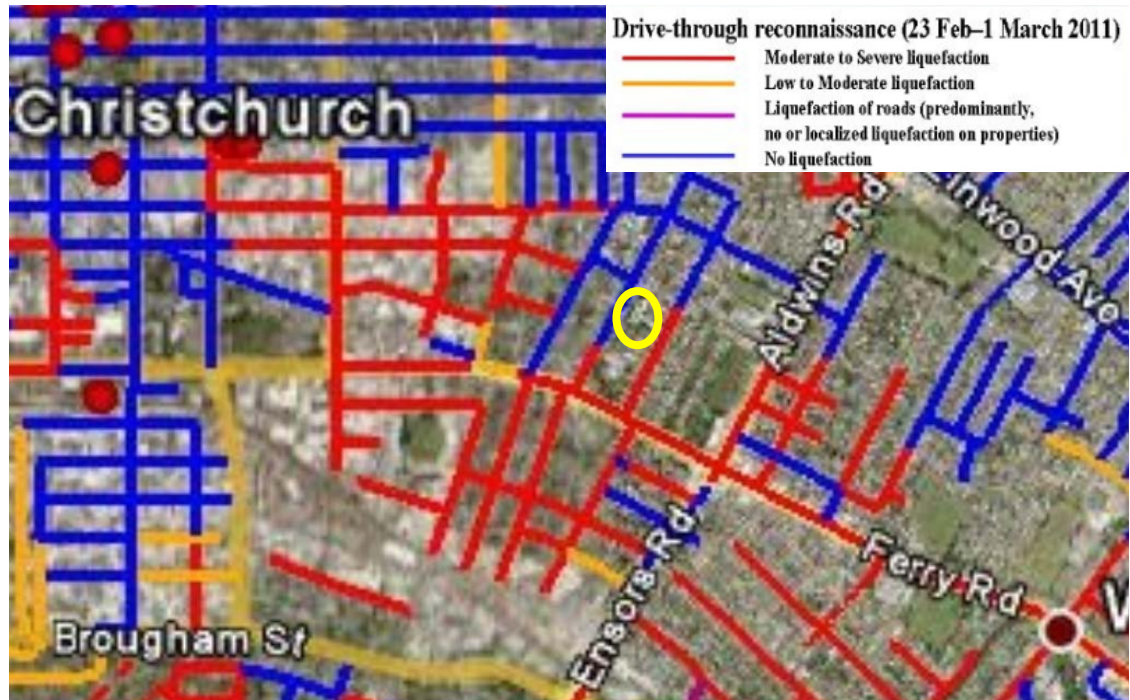
■ Figure 4 – Liquefaction map (Cubrinovski & Taylor, 2011). Site marked in yellow.

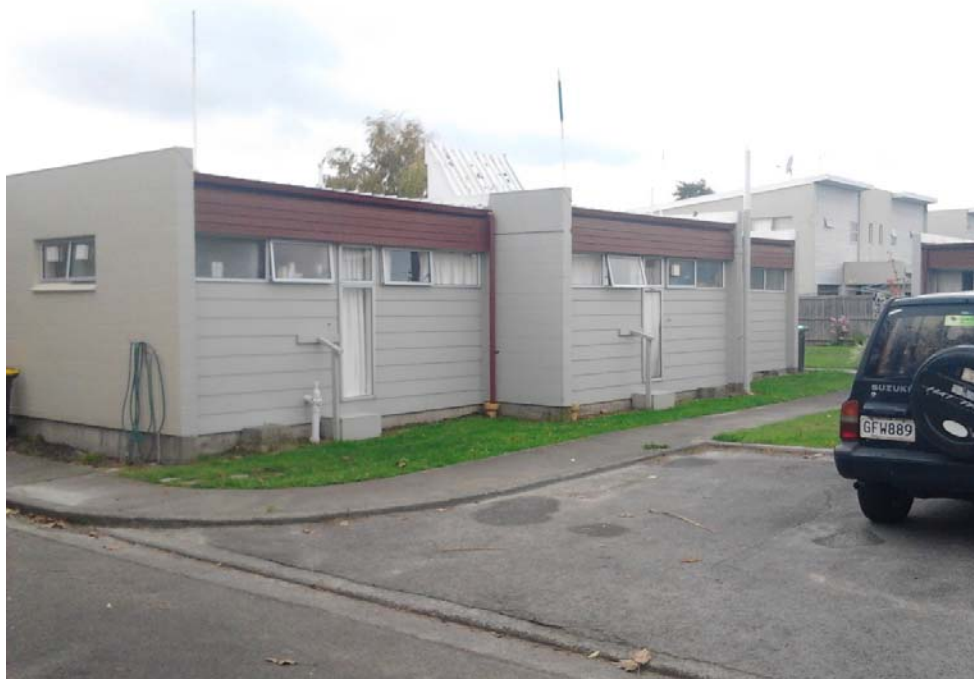
Significant land damage was observed during the external site walkover. The site had significant liquefaction during the Feb 2011 earthquake, as there was evidence of this over a year later. There were remaining sand ejecta on the site, significant ground undulations including domes in the driveway where sand boils were ejected beneath the asphalt. There was undulating grass land and settlement of footpaths. It is expected that some settlement of the structure would have occurred as a result of significant liquefaction of underlying ground.

■ **Figure 7 Overview of the block units on site**

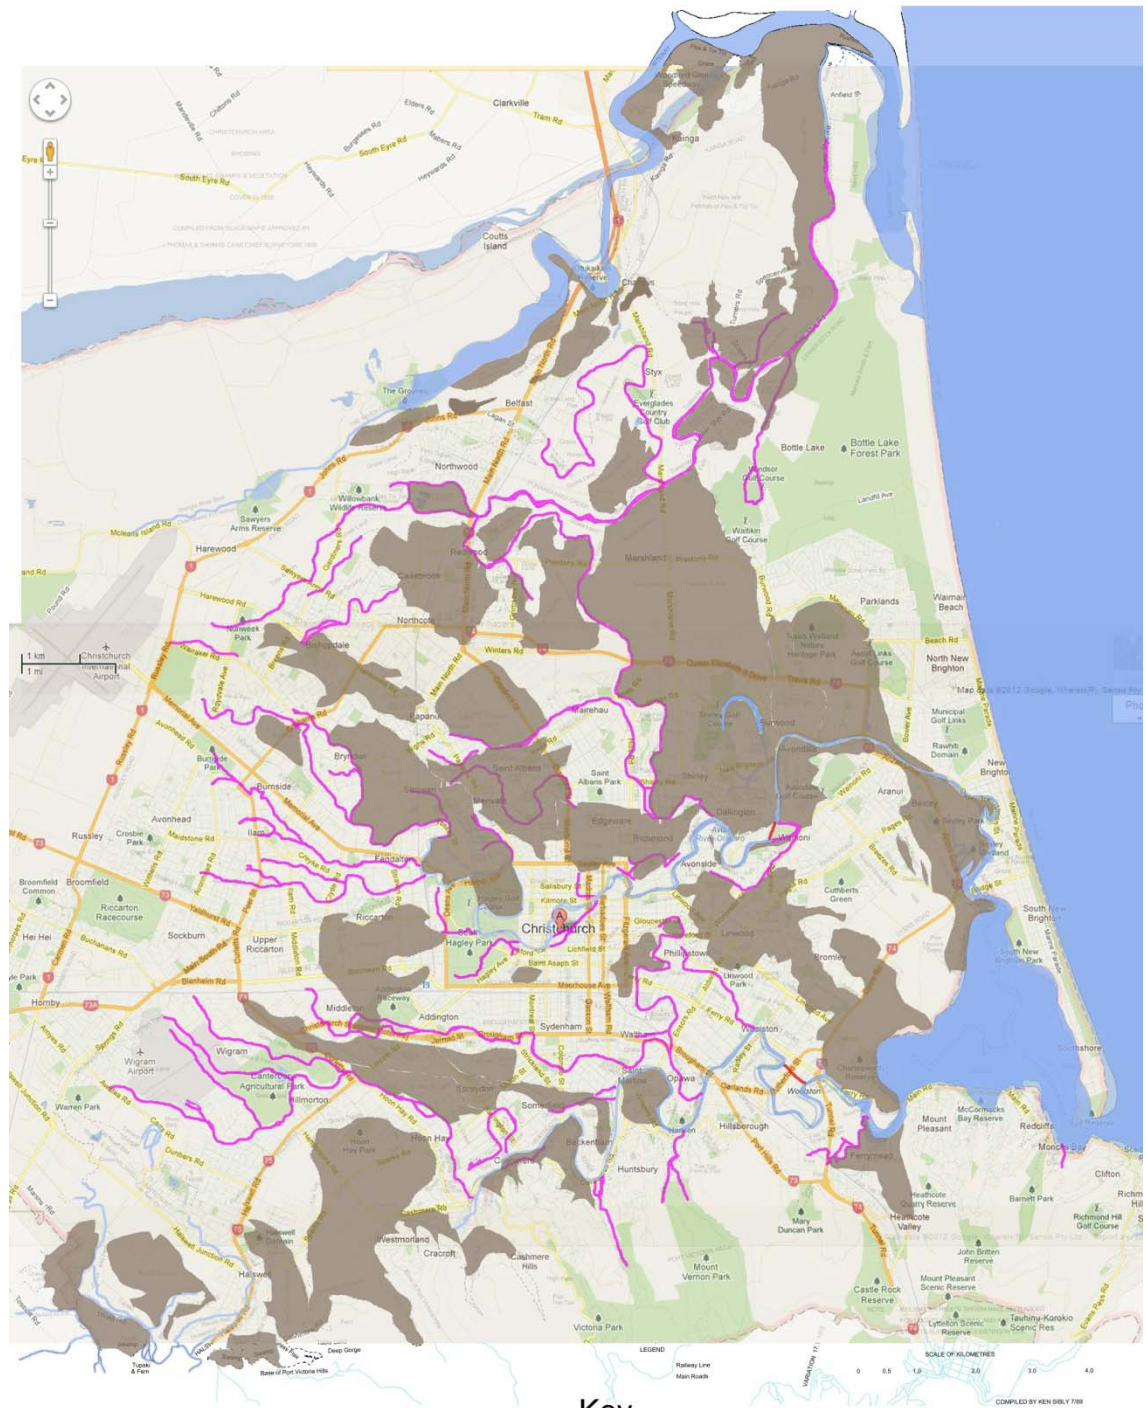
Reference to historical documents (eg Appendix A) shows that the site was recorded to lie near two rivers or creeks in 1856. Additionally, area west of the site is recorded to have been swamp or marshland. This suggest, that soft river or swamp material could be present in the underlying geology of the site.

The swamps and previous creeks/ivers from 1856 have been overlayed onto a map of Christchurch in 2012
