**Haast Courts Block D**  
**BU 0792-004 EQ2**  
Detailed Engineering Evaluation  
Quantitative Report  
Version FINAL

Units 1 to 5, 149 Stanmore Rd., Linwood

Christchurch City Council

**Date**  
**31 October 2012**

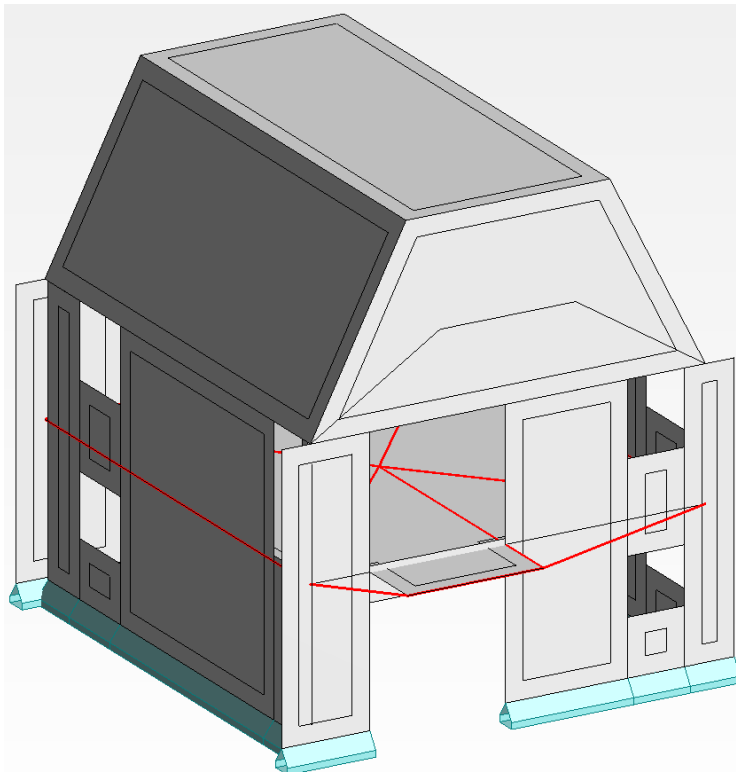
**Figure 6 Walls of structure reduced to smaller panels for analysis**

For the purposes of analysing the demand, each block was considered to be separate. Each precast wall was divided into a combination of smaller panels (See Figure 6). Forces acting on the edges and centrelines of each of the smaller panels were extracted for comparison with their individual capacities. The balconies were assessed as being part of the internal floor slabs cantilevering from the face of the wall. As each floor is tied into all four exterior walls they effectively act as rigid diaphragms, spreading loads evenly between the walls.

The capacity of each wall element is taken as the capacity of the weakest part of the panel making up that wall element. Panels spanning vertically were analysed as columns for shear and both in-plane and out-of-plane flexure (Table 7 and Table 8) and spandrel beam panels spanning horizontally

between columns were analysed for shear capacity and in-plane flexure (Table 9 and Table 10). A map of panel locations for each wall is included in Appendix F.

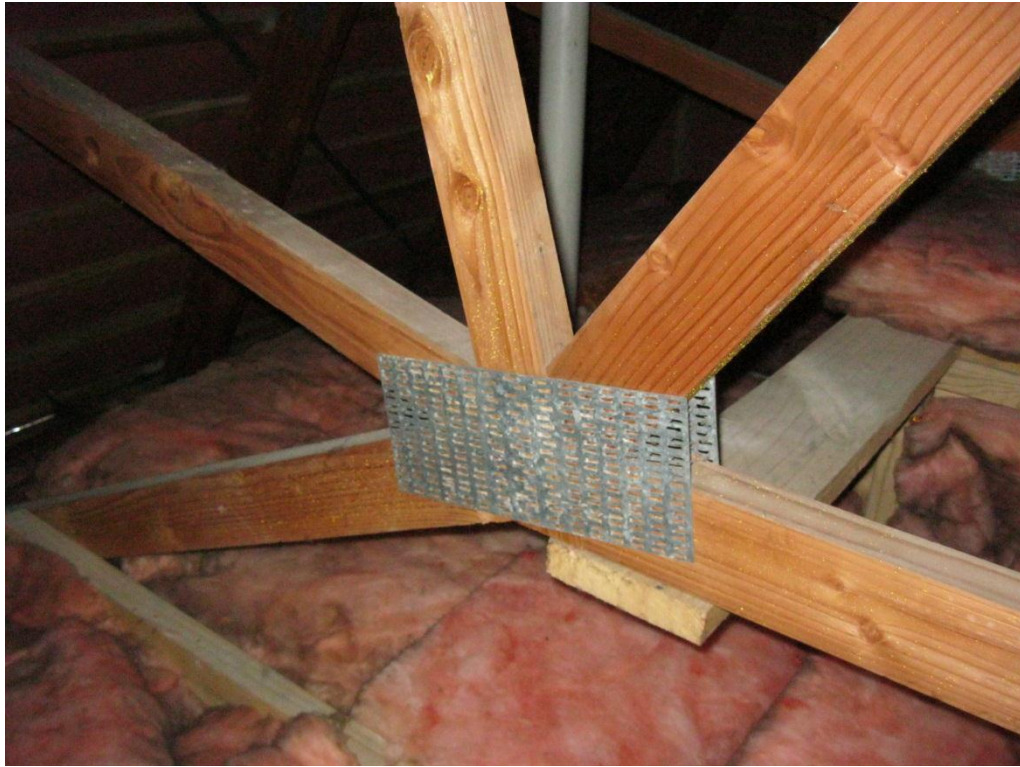
**Photograph 11 Connection of timber roof truss members.**

The timber framed roof members were not included in the model but the weight was accounted for. The roof is lightweight and fixings have been assumed to be adequate based on visual inspections. Connections between the roof trusses and the precast concrete panel walls appear to be adequate based on visual inspections (See photographs 11 and 12).
