CHRISTCHURCH CITY COUNCIL
PRK_1190_BLDG_011 EQ2
Hagley Park North—Toilet – Lake Albert
Hagley Park, Christchurch

QUANTITATIVE ASSESSMENT REPORT
FINAL

- Rev B
- 24 September 2013

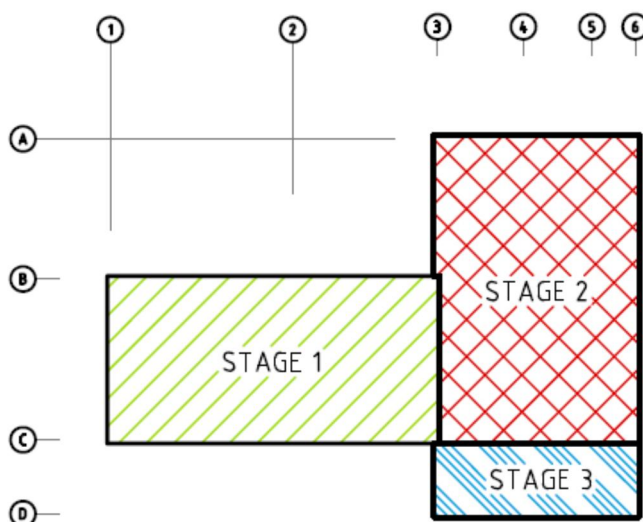
Figure 3: Sketch indicating likely construction sequence

The building consists of various structural configuration which leads to conclusion that the building was built in number of stages over the time as shown in Figure 3

While the Stage 1 building is constructed of 140mm thick unreinforced hollow block masonry walls, the Stage 2 building is constructed of 190mm thick concrete infilled reinforced walls typically with D12 @ 600mm vertical and horizontal centres. The Stage 3 building is of similar construction to the Stage 2 building, to which it is evidently attached (with visible construction joints).

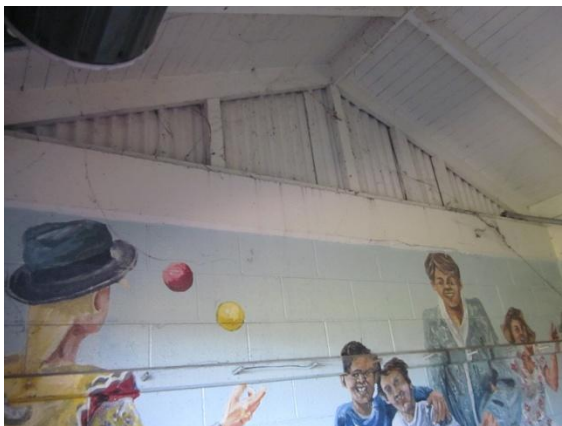
PHOTO 7: Internal south wall of the southern-most storage area.

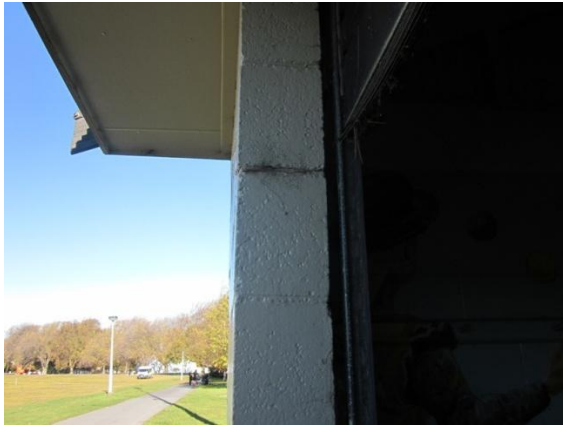
PHOTO 9: Joint between masonry wall and roller door for southern-most storage area.

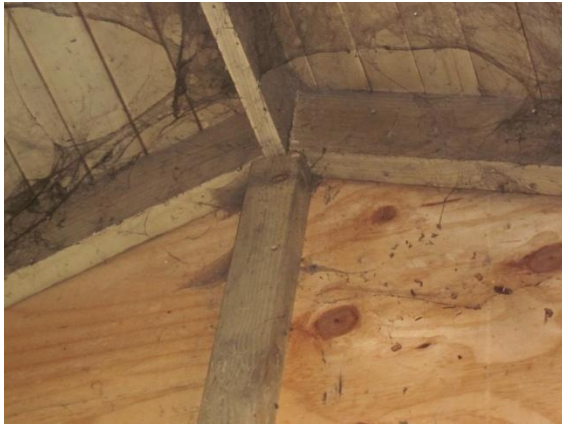
PHOTO 13: Central ceiling connection on the internal north wall of the central storage area.

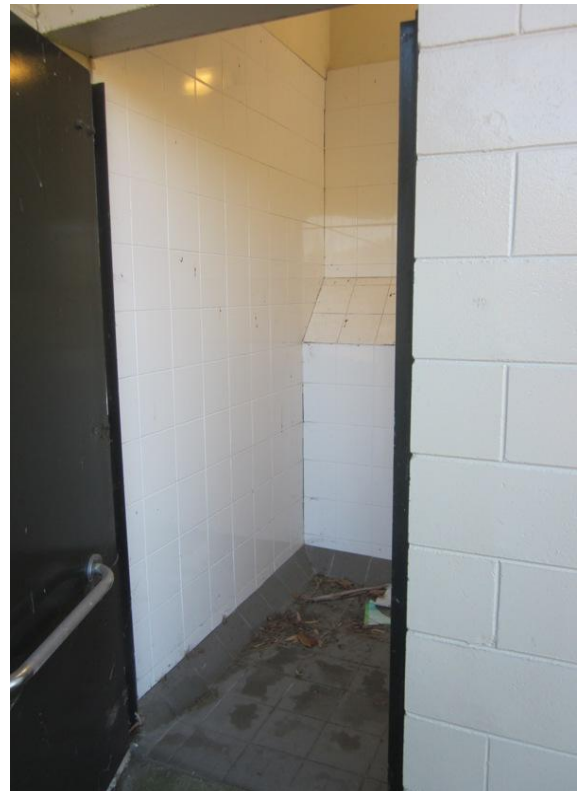
PHOTO 16: Interior of locked toilet.

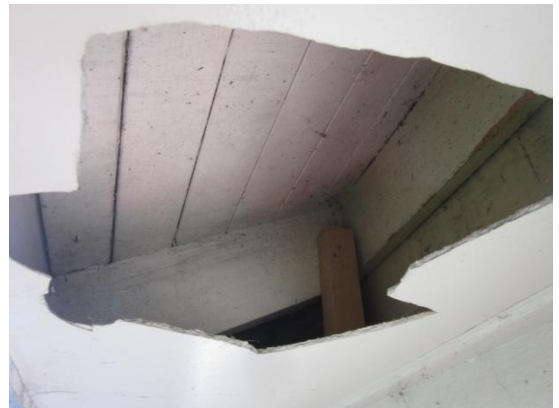
PHOTO 42: View at roof overhang through hole in cementitious ceiling – Stage 1 building

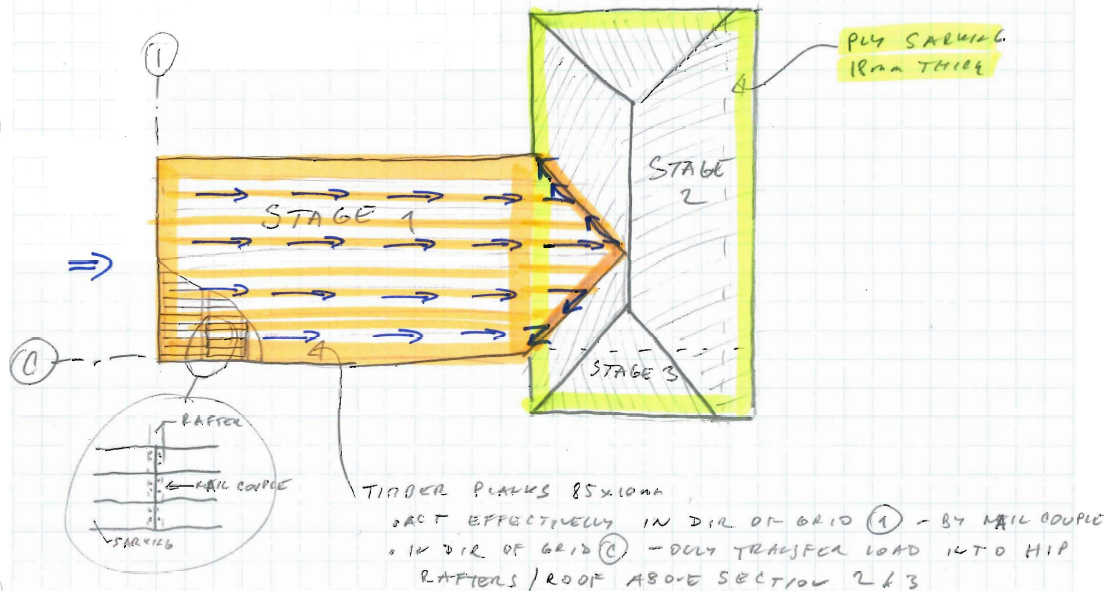
- ROOF ABOVE STAGE 2 & 3 IS CONSTRUCTED OF TIMBER RAFTERS COVERED BY PLY SARKING (18mm MEASURED DURING INTENSIVE INVESTIGATION). FURTHER STABILITY IS PROVIDED BY ACTION OF HIP RAFTER STARTING FROM THE CORNERS OF PERIMETER WALLS.

- ROOF ABOVE STAGE 1 IS CONSTRUCTED OF TIMBER RAFTERS COVERED BY TIMBER SARKING (PLANKS 85x10mm) RUNNING PARALLEL TO GRID LINE C. WHILE THE DIAPHRAGM WORKS EFFECTIVELY BY ACTION OF "RAIL COUPLE" IN DIRECTION PARALLEL WITH GRID LINE 1, IT IS INEFFECTIVE IN DIRECTION PARALLEL TO GRID LINE C AS IT IS ONLY TRANSFERRING DIAPHRAGM LOADS ONTO SUPPORTING ELEMENTS → SUCH LOADS ARE TRANSFERRED BY TENSION & COMPRESSION INTO ROOF STRUCTURE ABOVE STAGE 2 BUILDING, WHERE THE FORCES ARE TAKEN TO THE SUPPORTING WALL BY TRIANGULATION OF HIP RAFTERS.

ROOF DIAPHRAGM WAS FOUND SUFFICIENT BY INSPECTION

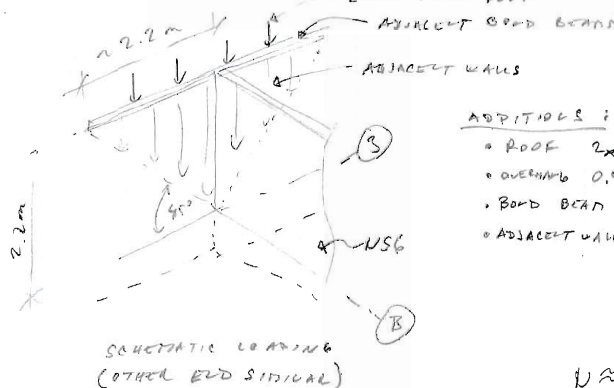
• MASONRY WALL	$3.7 \times 2.2 \times 4.78$	=	38.9
• BOARD BEAM	$0.24 \times 0.19 \times 3.9 \times 24$	=	5.15
• FOOTING	$0.6 \times 0.22 \times 4.1 \times 24$	=	13
		Σ	57 kN

THIS IS TOO CONSERVATIVE, ADD MORE MASS FROM ADJACENT STRUCTURES WHICH CONNECT TO THE SUBJECT WALL

• ROOF	$2 \times 2.2 \times 3.7 \times 0.235$	=	3.83
• OVERHANG	$0.45 \times 2 \times 0.367$	=	0.33
• BOARD BEAM	$4 \times 2.2 \times 0.19 \times 0.29 \times 24$	=	11.64
• ADJACENT WALL	$3 \times \frac{2.2 \times 2.2}{2} \times 4.78$	=	34.70
	$1 \times \frac{2.2 \times 2.2}{2} \times 1.443$	=	3.5
		Σ	54

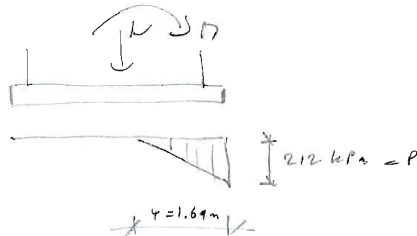
MAX PRESSURE AT TOE

$$P = \frac{2N}{B\gamma} = \frac{2 \times 111}{0.62 \times 1.69} = 212 \text{ kPa}$$

SOIL PROPERTIES NOT KNOWN TO DATE → TESTING TO OBTAIN GROUND BEARING CAPACITY IS REQUIRED TO VALIDATE THIS CALCULATION (SCALAR TESTING FOR INSTALLATION AT LEAST IN ABSENCE OF MORE COMPREHENSIVE INVESTIGATION).

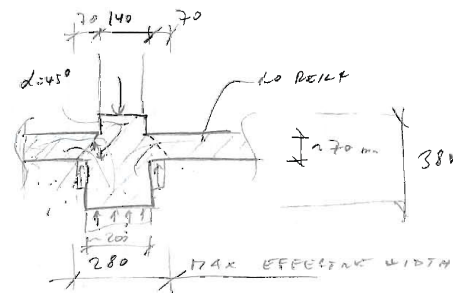
② TRY OVERTURNING MOMENT IN WALL EW2 (2/B-C)

• THIS WALL HAS EFFECTIVELY NARROWER FOUNDATIONS AND CONTRIBUTION OF SEAB IS LESS EFFECTIVE SINCE THERE IS NO DESH

$$M = F_{EW2} \times 2.87 = 27 \times 2.87 = 77.5 \text{ kNm}$$

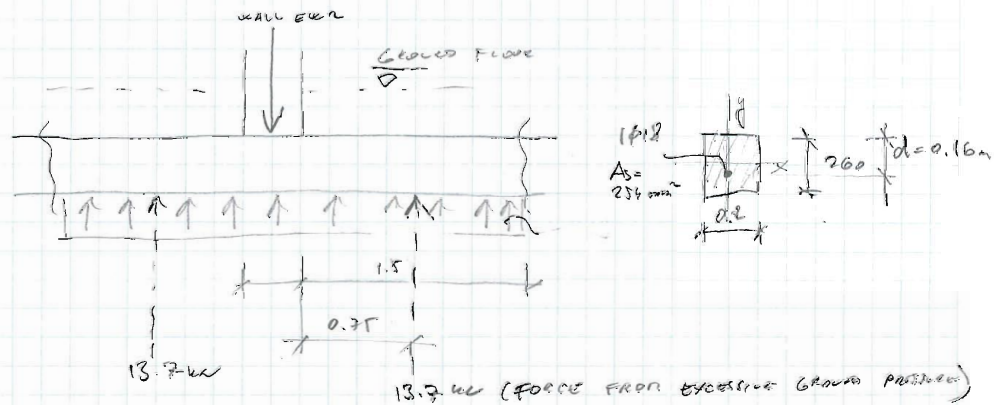
CHECK IF STRIP FOOTING CAN RESIST BEULGING

$$\text{BEULGING } \pi^* = 13.7 \times 0.75 = \underline{10.28 \text{ kNm}}$$

$$\begin{aligned} \phi \pi_{ux} &= \phi A_s \times f_y \left(d - 0.59 \frac{f_y A_s}{f_{ck} b} \right) \\ &= 0.85 \times 254 \times 10^{-6} \times 250 \left(0.16 - 0.59 \frac{250 \times 254 \times 10^{-6}}{30 \times 0.26} \right) \\ &= 8.37 \text{ kNm} < \pi^* = 10.28 \text{ kNm} \quad \text{FAILS} \end{aligned}$$
