Halswell Domain Toilets
PRK 1691 BLDG 007
Detailed Engineering Evaluation
Qualitative Report
Version Final

301 Halswell Road

Christchurch City Council

Date
20th May 2013

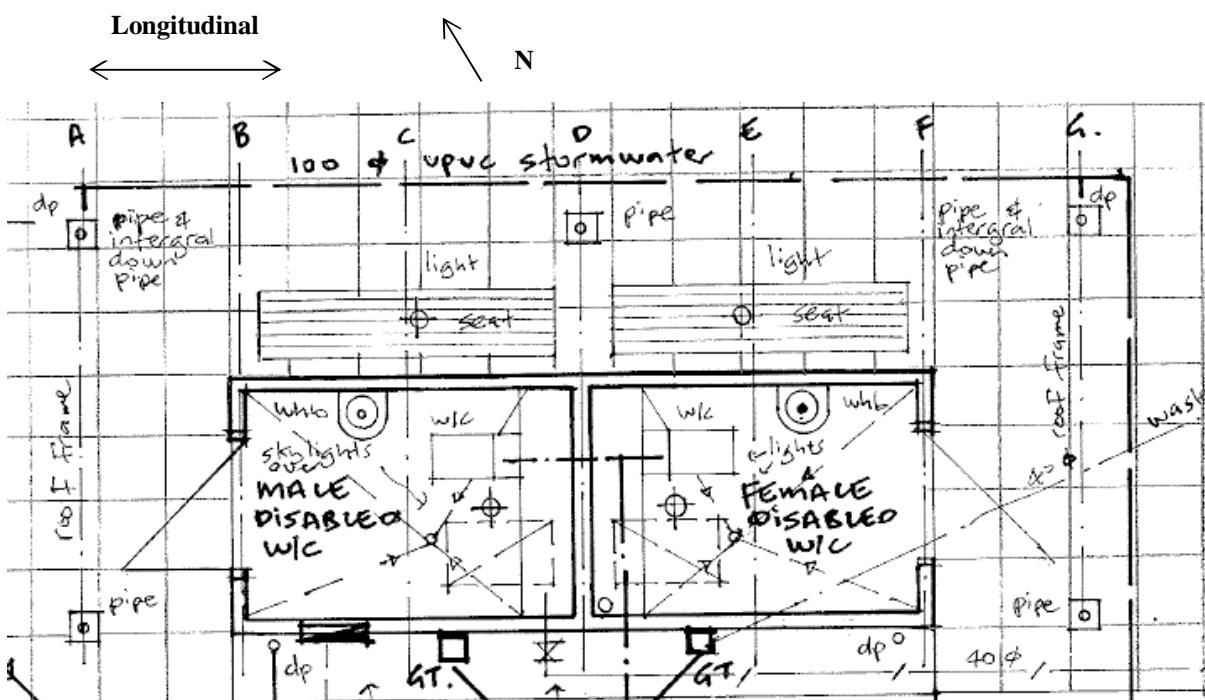
Figure 2 Architectural Plan

The building is approximately 6.6m in length by 2.8m in width with a height of 2.4m. The building has an approximate footprint of 19m². The nearest building, associated with the park's model railway, is located over 65m to the west. The flat site contains a small lake approximately 10m from the building.
