Halswell Quarry - Toilet
PRK 1887 BLDG 005
Detailed Engineering Evaluation
Qualitative Report
Version FINAL

Christchurch City Council

Date
20th May 2013

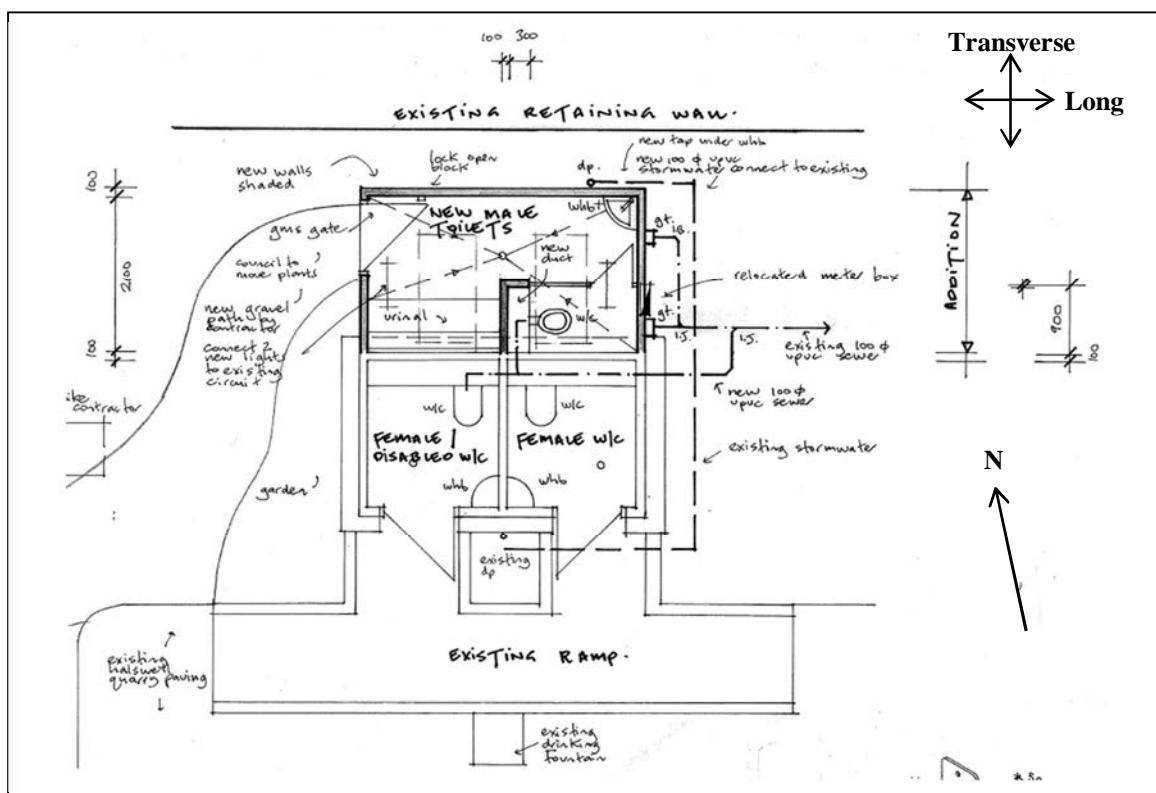
Figure 2 Plan Sketch Showing Key Structural Elements

The original structure is found on strip foundations which supports a concrete floor slab. Lightweight timber framed perimeter walls extend from the concrete slab to eave level at 2.2m which forms a rectangular structure. A timber framed partition wall extends to the roof, forming two cubicles. The southern elevation has two doors opening. Timber trusses spaced at approximately 700 support timber boards which are clad with corrugated steel roofing.

The existing slab and foundations have been extended and an additional section has been built to the north of the existing structure. Timber framed walls have been added to form the shaded layout seen below. The walls extend up to a timber framed roof single pitched at 12 degrees. The northern and eastern perimeter walls have diagonal steel bracing providing additional lateral support. Similarly to the original roof the rafters support timber boards spanning the longitudinal direction and are clad with corrugated steel roofing. There are two sky lights creating openings in the new roof.
