Hei Hei Community Link
PRO 1559-002 EQ2
Detailed Engineering Evaluation
Qualitative Report
Version FINAL Rev 2

12 Wycola Avenue, Hei Hei

Christchurch City Council

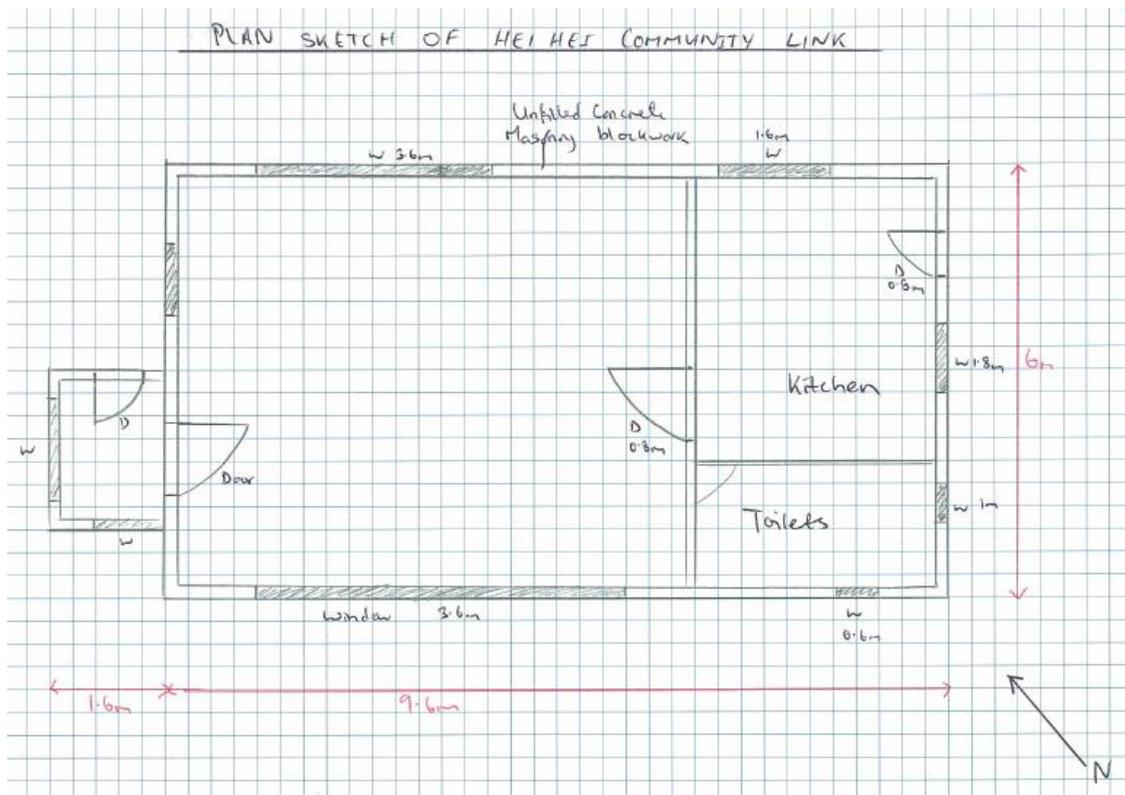
Figure 2 Plan Sketch Showing Key Structural Elements

The gravity loads acting on the structure are resisted by the external concrete masonry walls. Gravity loads from the roof are transferred through timber purlins spanning between the timber rafters. The loads are then transferred into the concrete masonry walls and into the foundations of the building. It should be noted that the foundations were not inspected. They are not assumed to consist of an internal concrete slab with reinforced strip footings to the masonry walls.

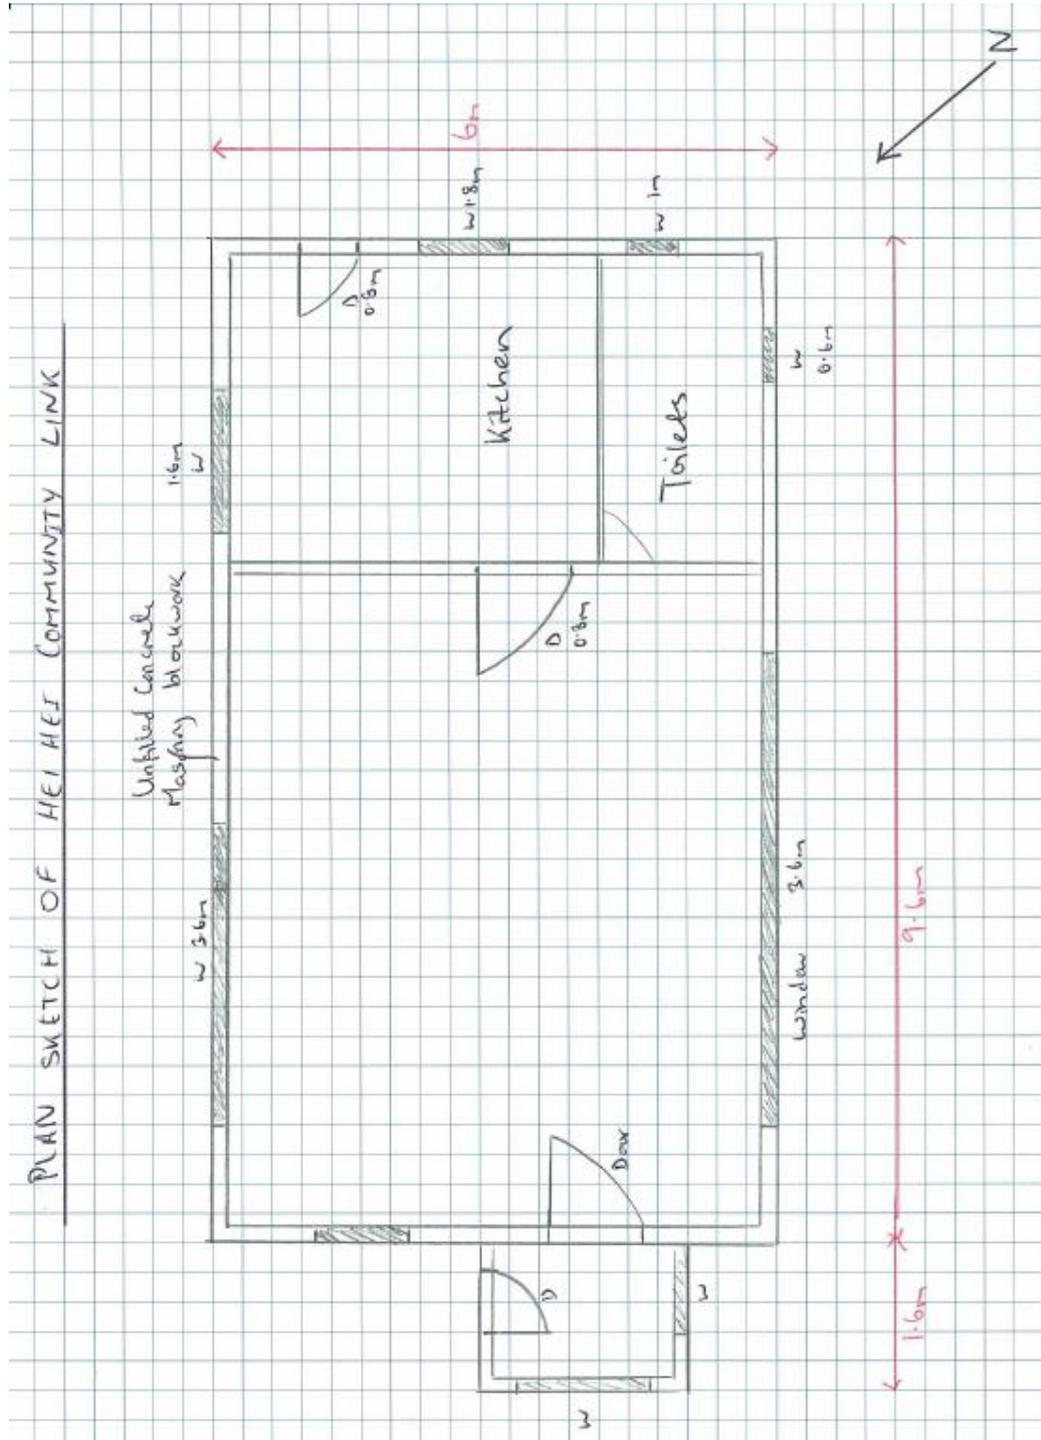
No drawings have been made available for this building. Shown below is a sketch of the building showing key structural elements.
