Home and Family Building PRO 2513

**Detailed Engineering Evaluation
Quantitative Assessment Report**

56 Barrington Street, Somerfield,

Date: March 2014
Reference: 6-QC359.00
Status: Final

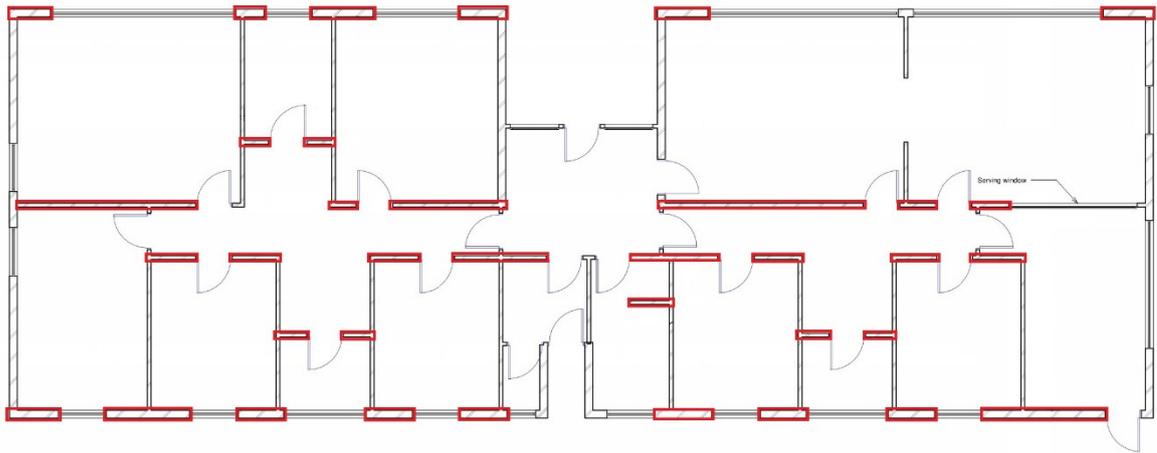
Figure 5: Walls used for bracing in the longitudinal direction.

Hand calculations were performed to determine seismic forces from the current building codes. These forces were applied globally to the structure and the capacities of the walls were calculated and used to estimate the %NBS. The walls, highlighted in Figure 5 and Figure 6, were used for bracing in their respective directions.

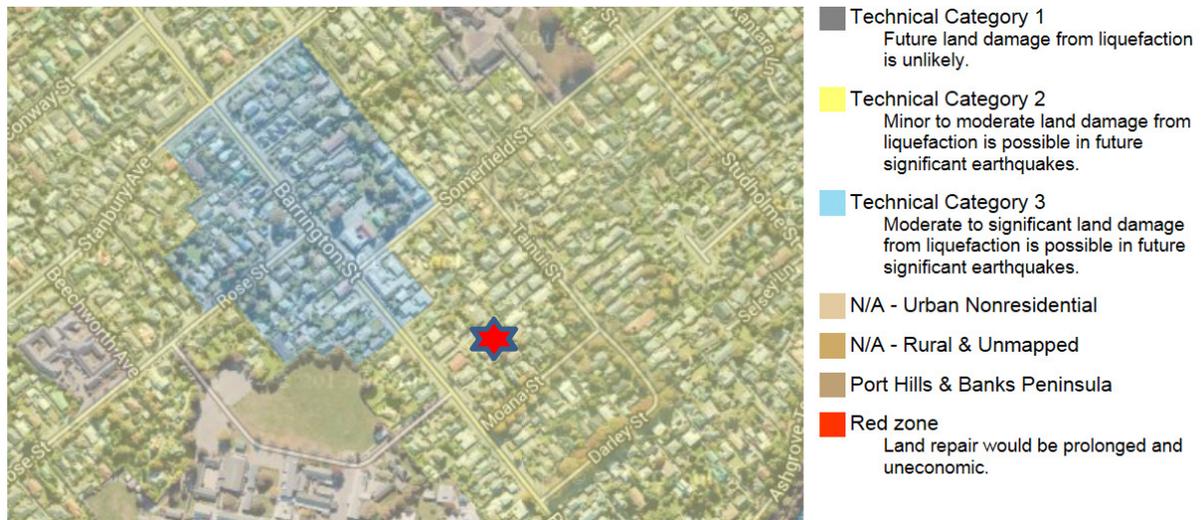
Figure 7: CERA Technical Categories map (loc. starred).

CERA indicates that the Home and Family building is located in a TC2 zone (as shown in Figure 7). This classification suggests future significant earthquakes will cause minor to moderate land damage due to liquefaction and settlement.

There is no evidence to suggest that further geotechnical investigation is warranted for this site.

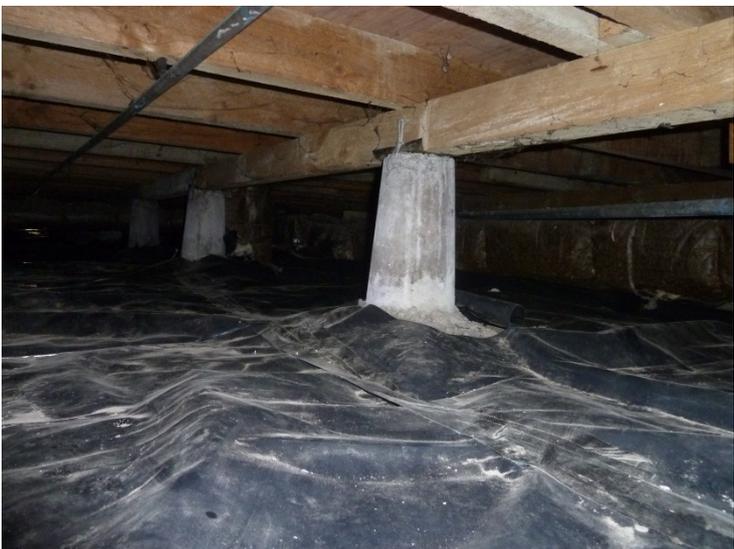
No damage was observed to the foundations.

5.	Main building floor cavity, showing concrete foundations
