**CHRISTCHURCH CITY COUNCIL**  
PRK\_0966\_BLDG\_001 EQ2  
Huntsbury Community Building  
30F & G Huntsbury Ave

QUALITATIVE ASSESSMENT REPORT

- Rev B
- 14 February 2013

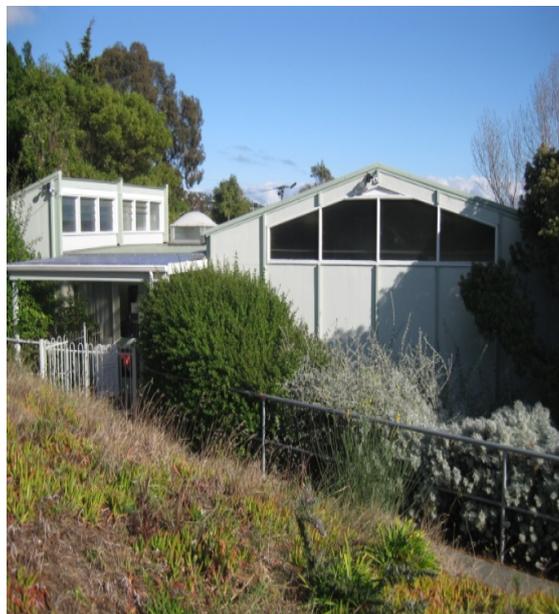
Photo 1: View of the building looking west.

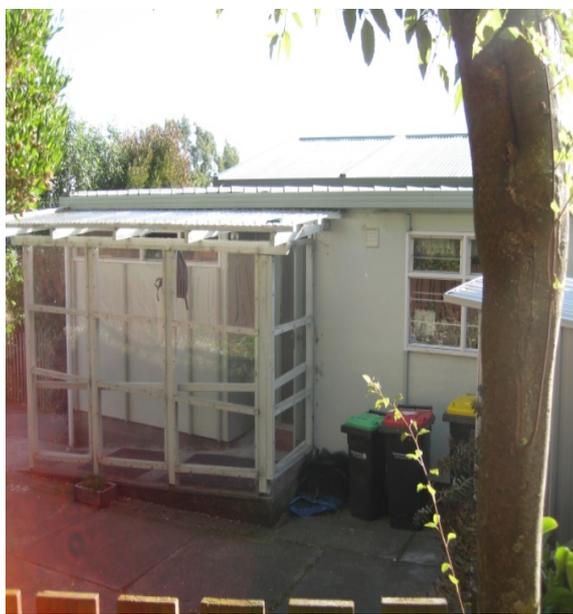
Photo 2: View of the building from south showing alternate access.

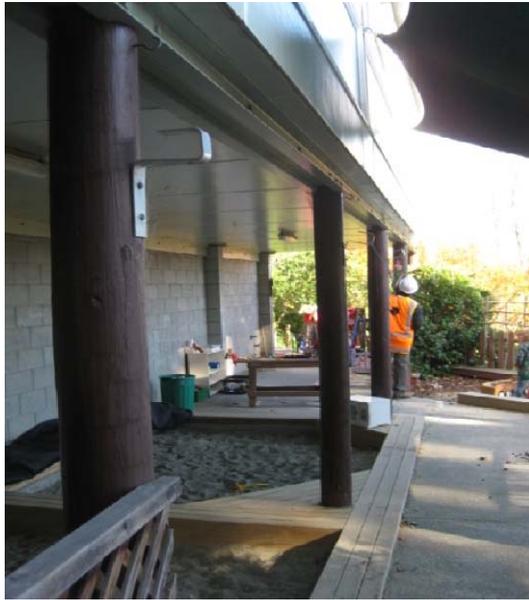
Photo 5: View on the northern side of the building showing the basement walls and timber piles supporting the timber flooring on the ground floor.

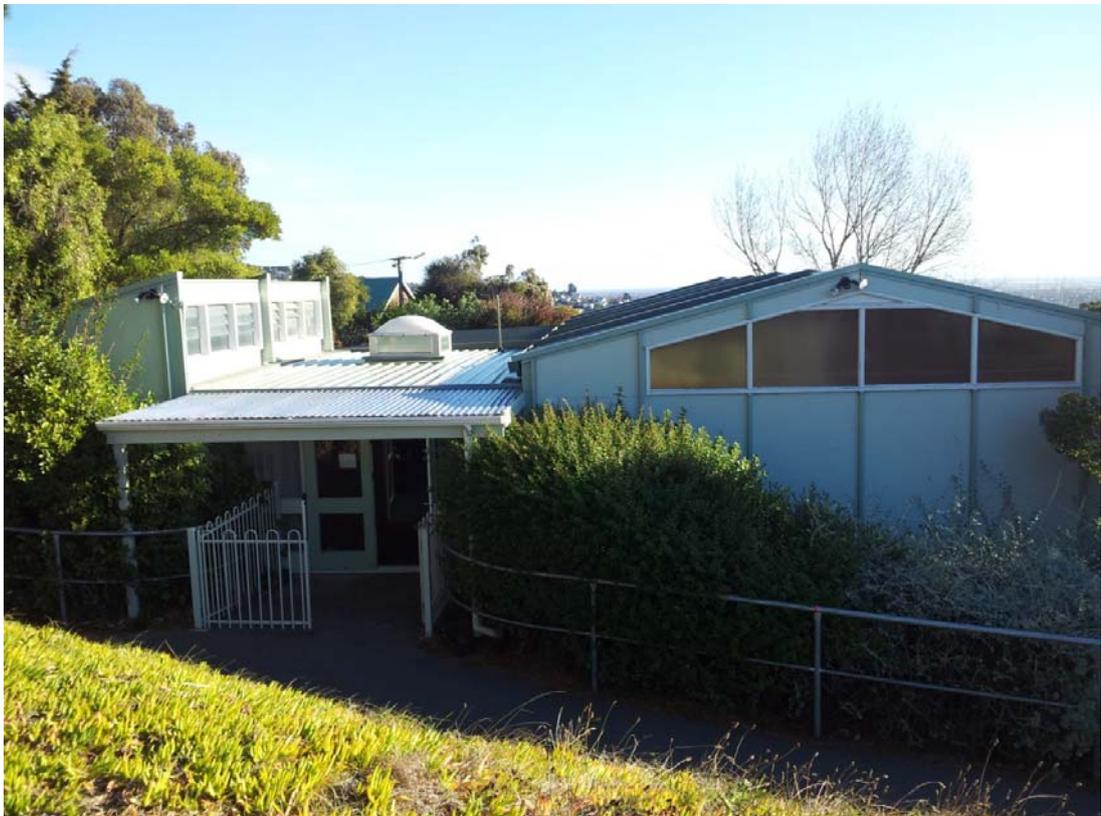
■ **Figure 6 Overview of structures**

There was evidence of tunnel-gully erosion, but this is not believed to be as a result of earthquake damage. No visual evidence of tension cracks was noted within the site; however, a minor gap was observed between the concrete ramp and wall base to the south side of the building, likely as a result of settlement.
