CHRISTCHURCH CITY COUNCIL PRO 0822 B002 EQ2 Linwood Library Support Services 180 Smith St, Linwood

QUANTITATIVE ASSESSMENT REPORT FINAL

- Rev C
- 13 January 2014

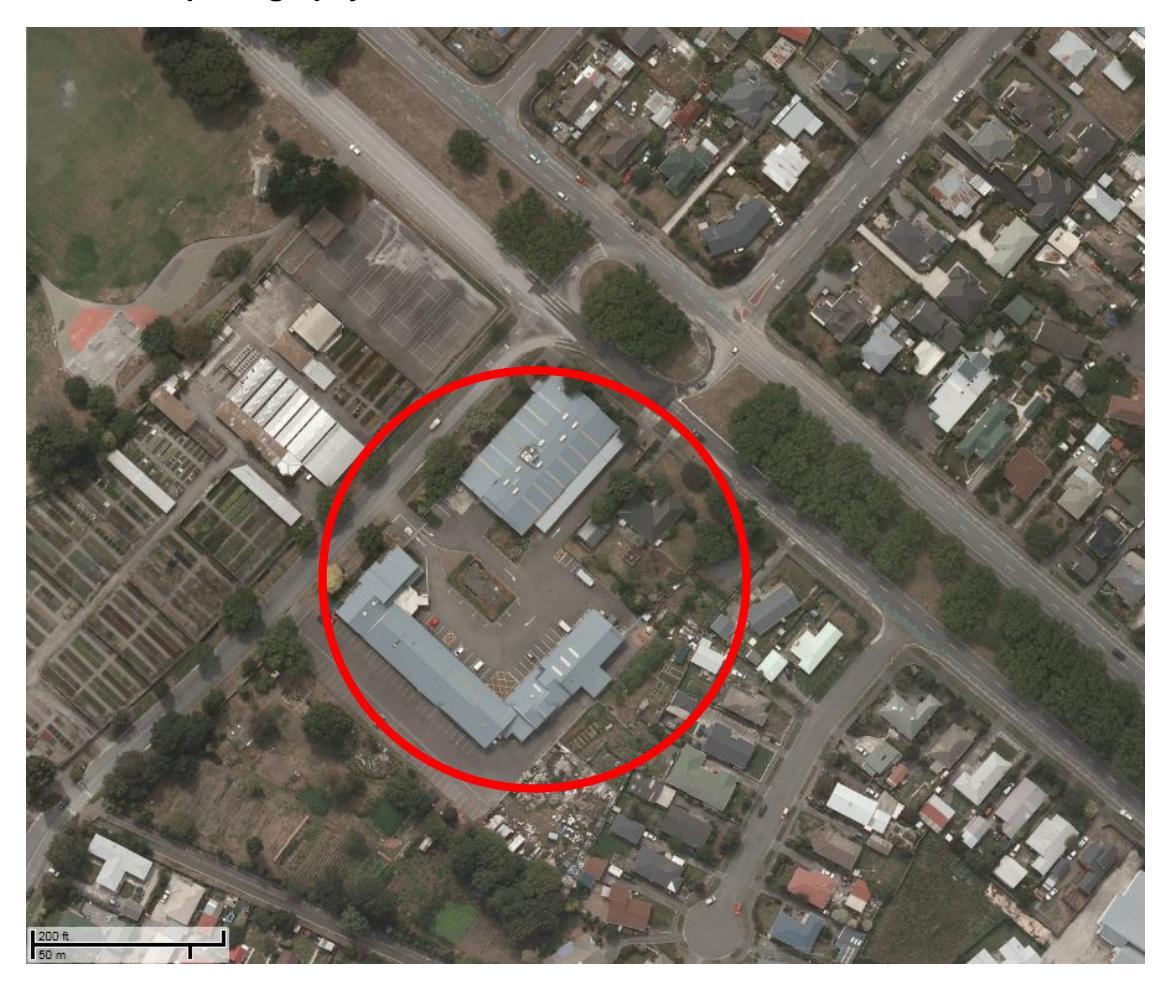
• Figure 5 – Aerial photography from 24 Feb 2011 (http://viewers.geospatial.govt.nz/)

Aerial photography shows relatively little damage after the 22 Feb 2011 event. There appears to be a burst water main on Linwood Avenue, and what may be a single source of liquefied material in the tennis courts to the north west of the property. This coincides with a change of geology as identified on the geological maps.

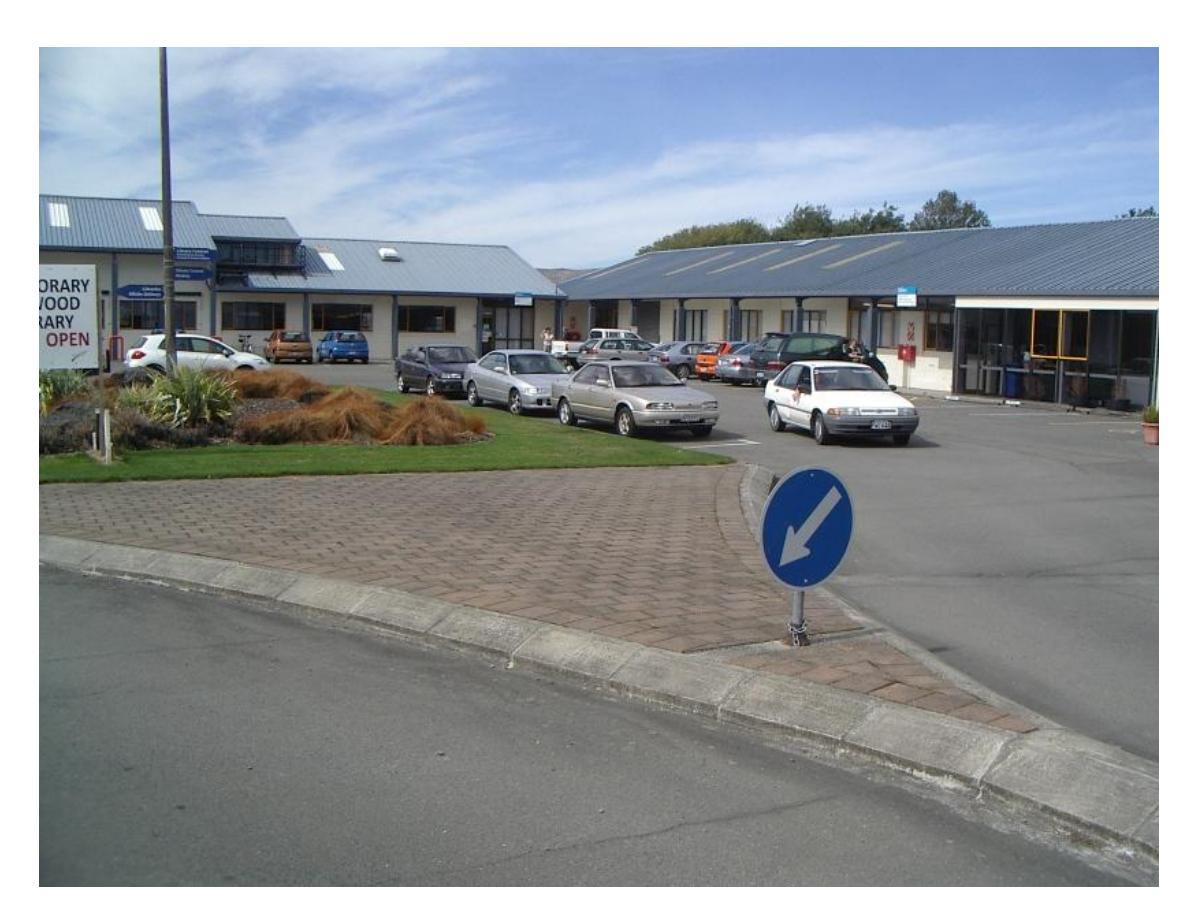
Figure 7 Overview of Linwood Services Centre and Library

The Linwood Resource Centre and Library were mostly constructed using masonry block with an iron roof, Figure 7 shows the overview of the site. The buildings were both in good condition, with no external evidence of structural damage. The majority of the land on the site was asphalt, which showed no signs of land damage. There was no evidence that liquefaction occurred on the site.
