Detailed Engineering Evaluation Quantitative Report

**Monavale Gatehouse
Fendalton Road, Christchurch**

**Prepared For:
Christchurch City Council**

Ref: 1606
31 July 2013

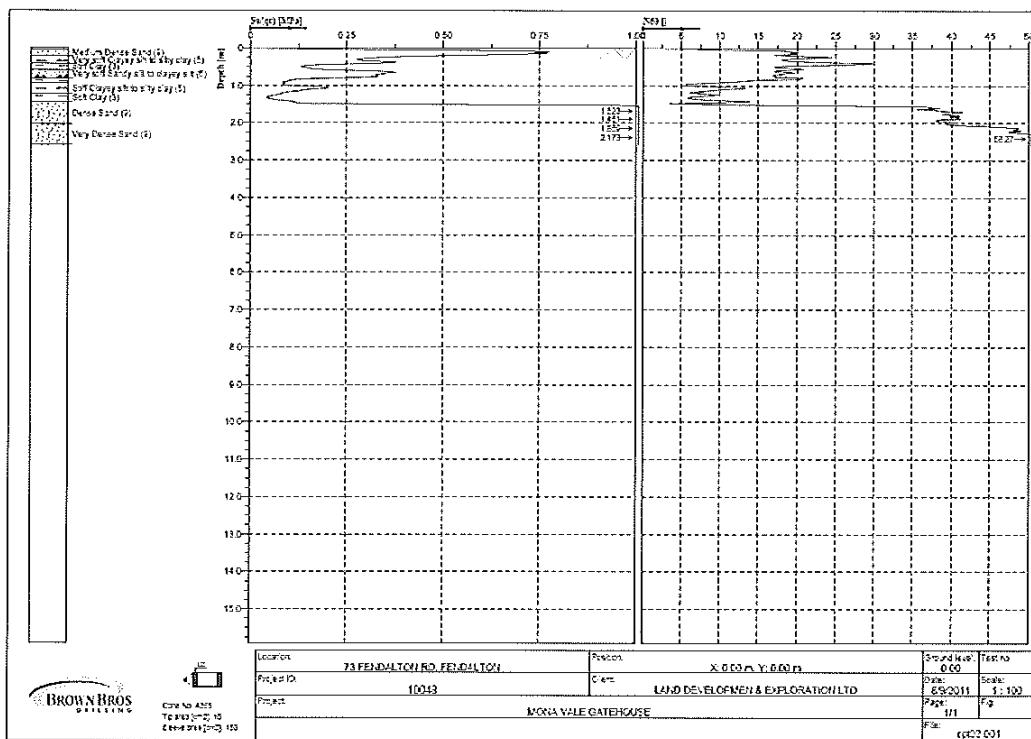
Non-engineered fill up to 1.2m thick is present beneath the eastern side of the building and possibly extends out towards the river bank to the east. Fill was also encountered to 0.3m depth along the northern side. Fill was absent at the rear of the property. The fill includes brick and concrete, and is variable in strength ranging between 50kPa and 160kPa (average 120kPa).

Figure 3: CPT 2 put down to the east of building showing typical ground profile beneath property

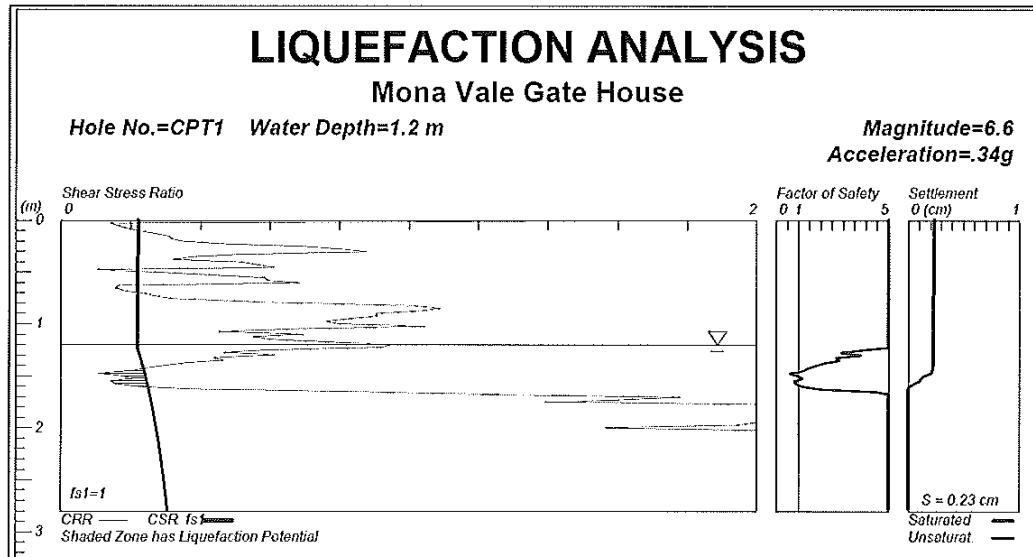
The analyses show that the medium dense to dense layers beneath the site at depth are likely to have liquefied during the February 22 M6.3 earthquake event (see Figure 6). Despite this, the dense sand from 3.8m to 6.4m depth is unlikely to have liquefied and is therefore expected to be a suitable bearing layer.

Figure 4: Layer beneath site shown to be prone to liquefaction.
