# STRUCTURAL CONCEPTS LIMITED

Re: Mona Vale Homestead – POST-EARTHQUAKE INSPECTION

## Scope of this Report

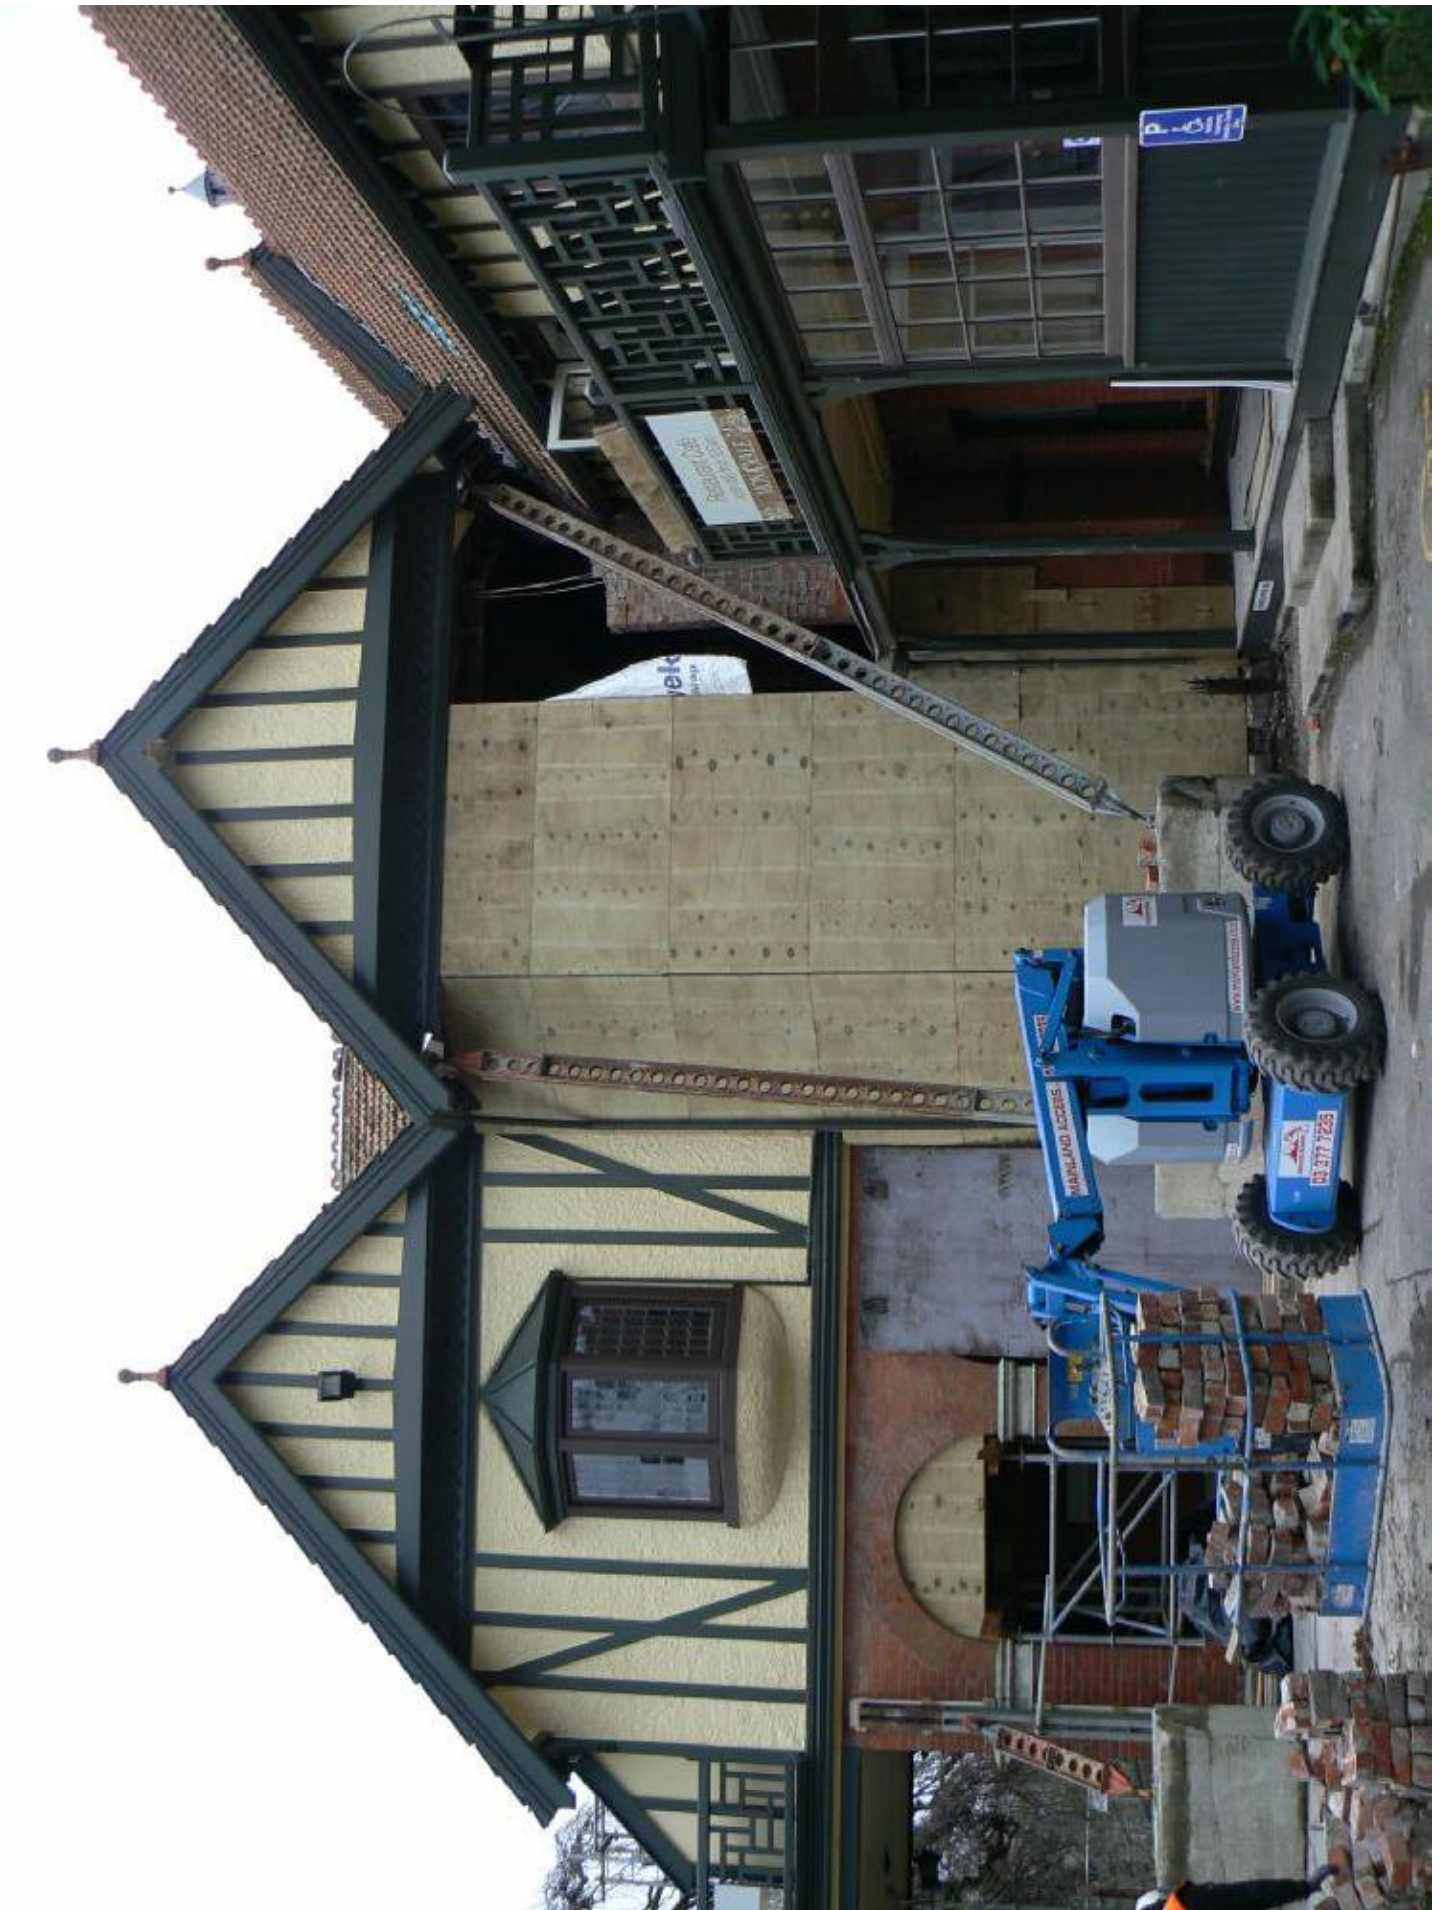
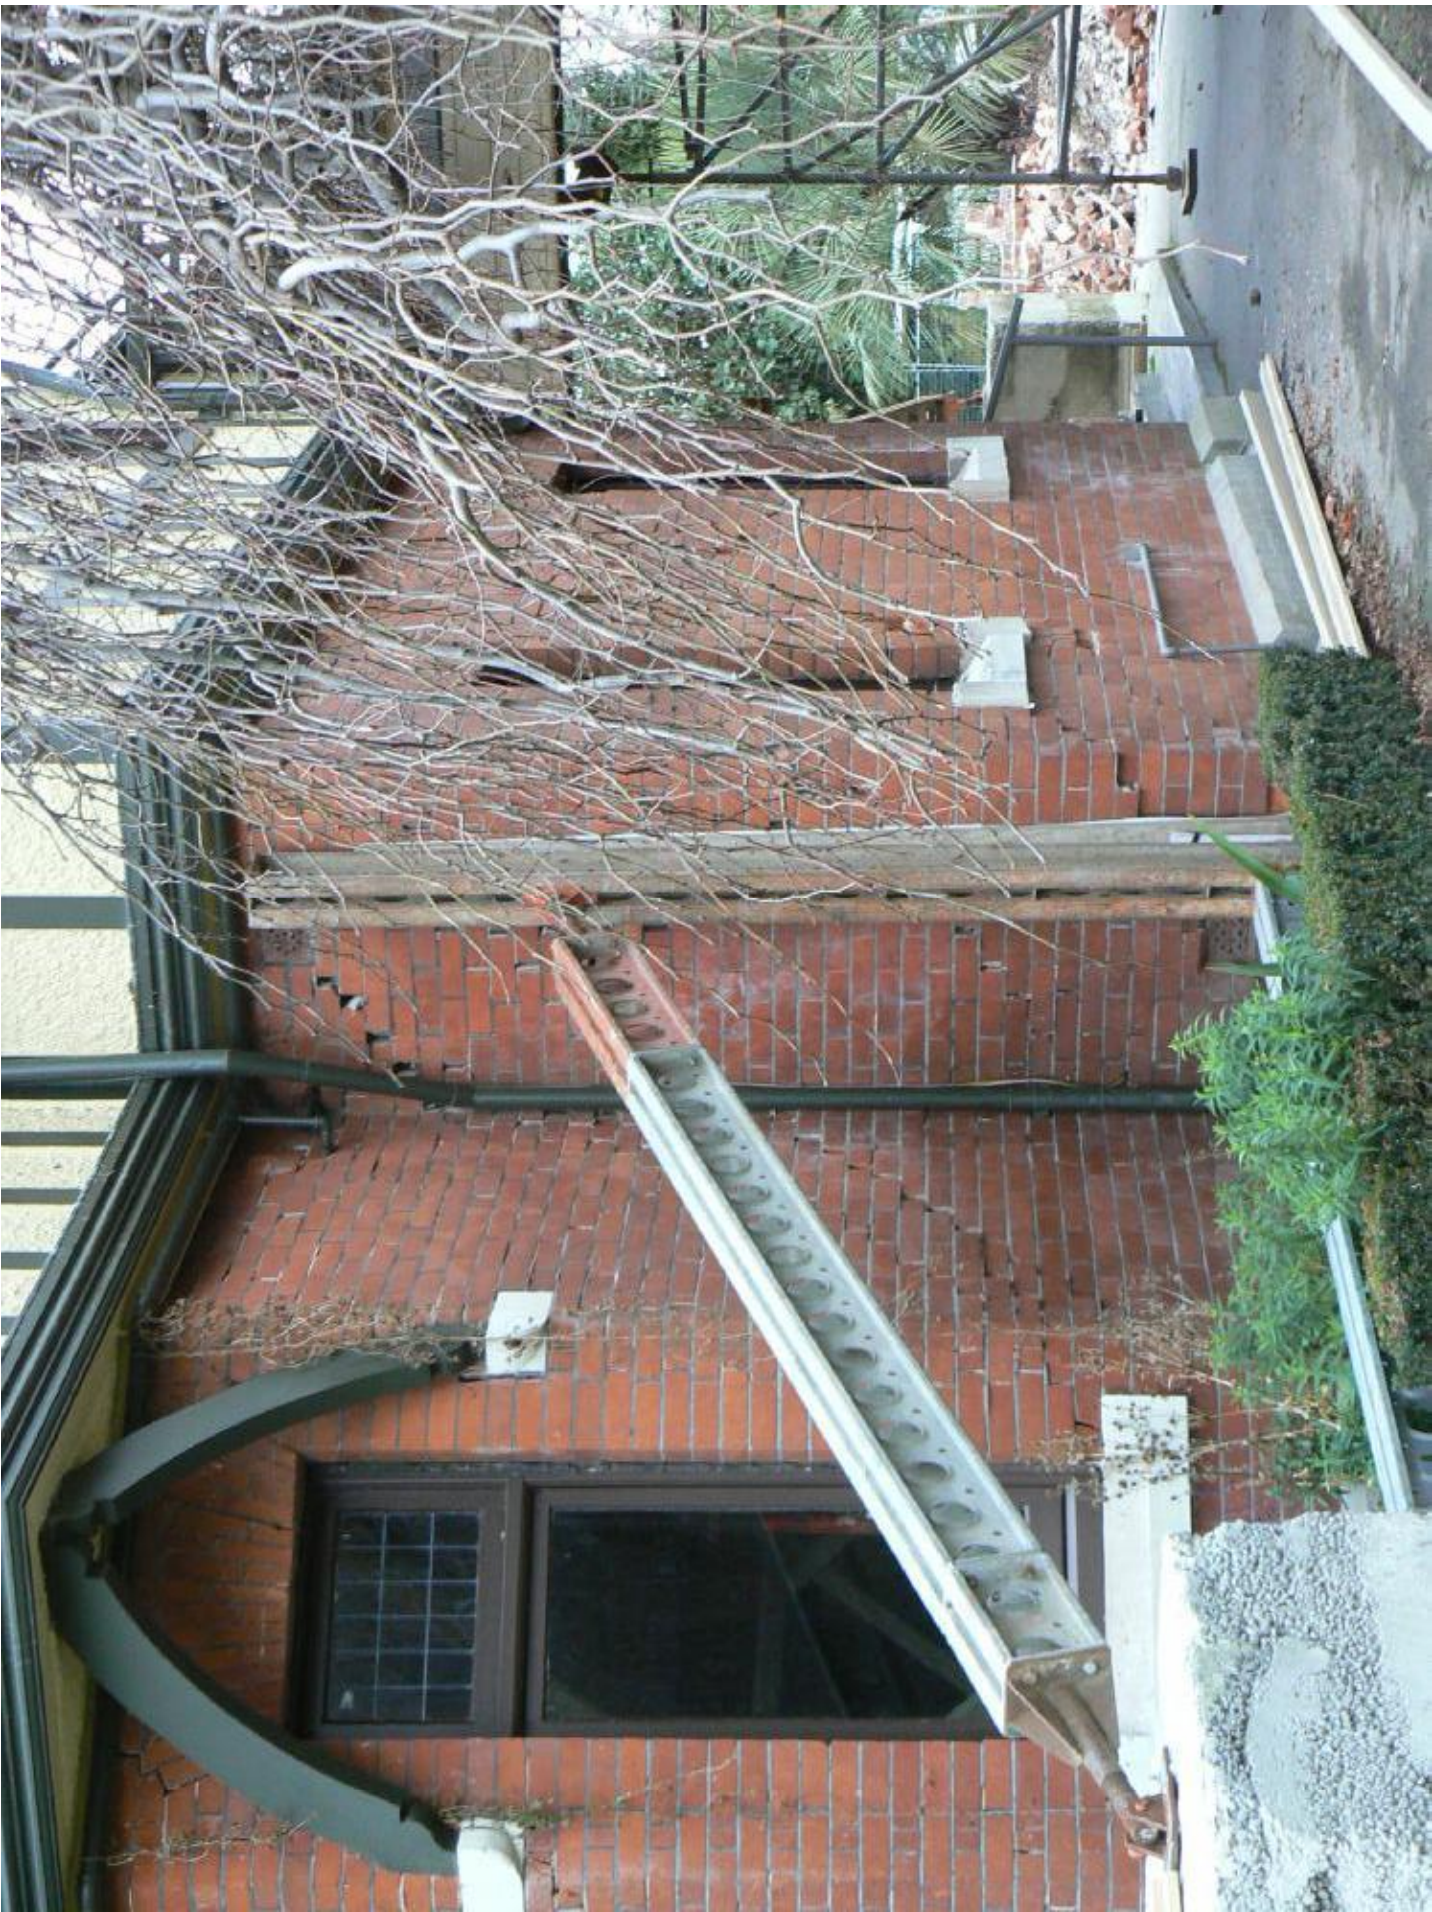
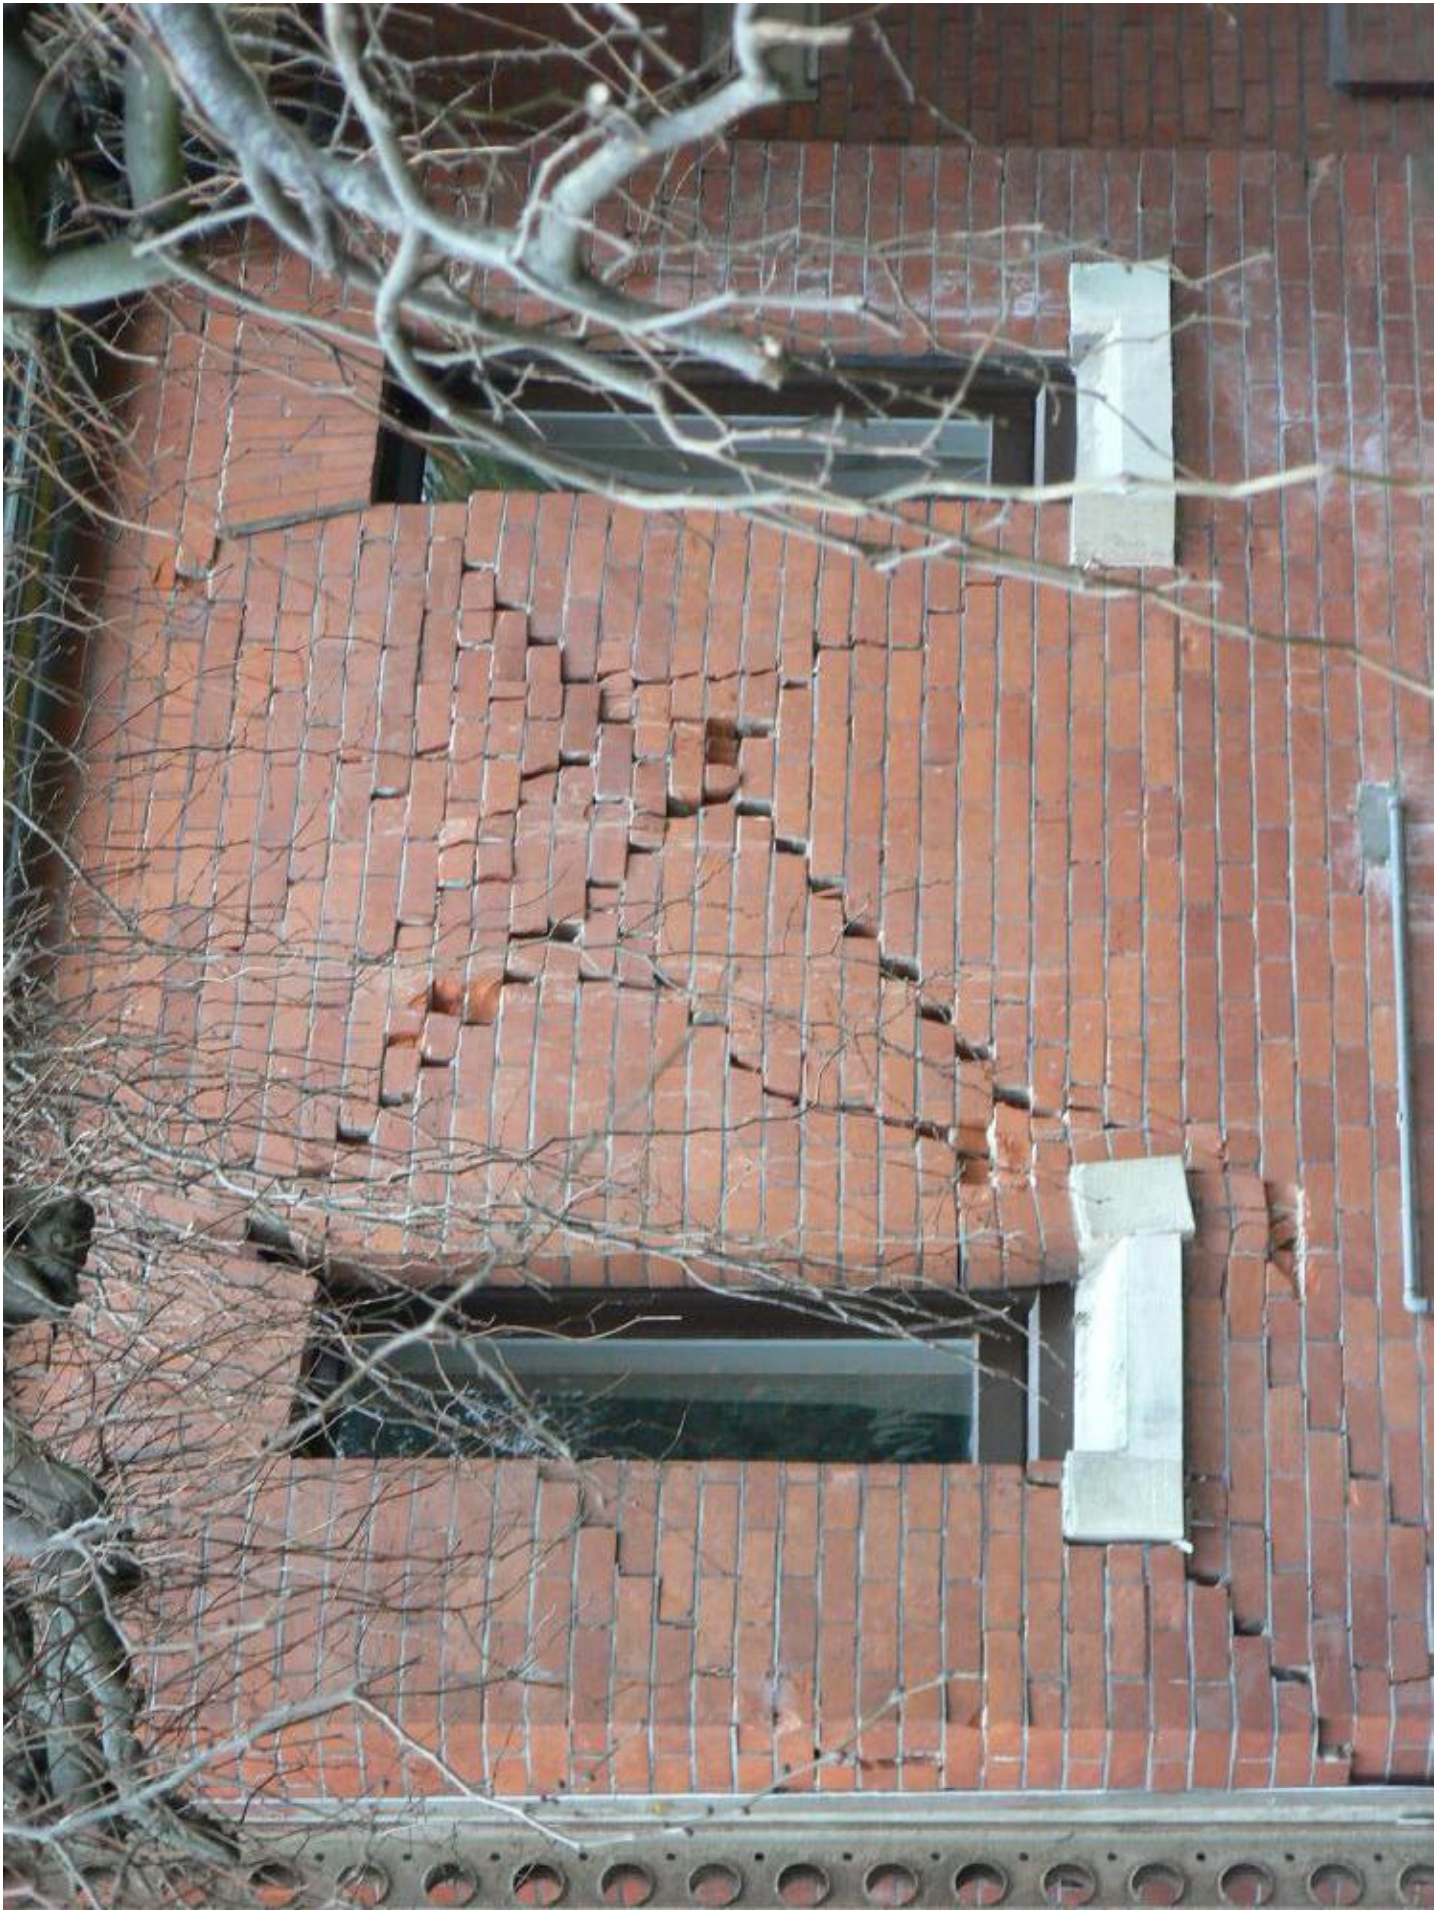
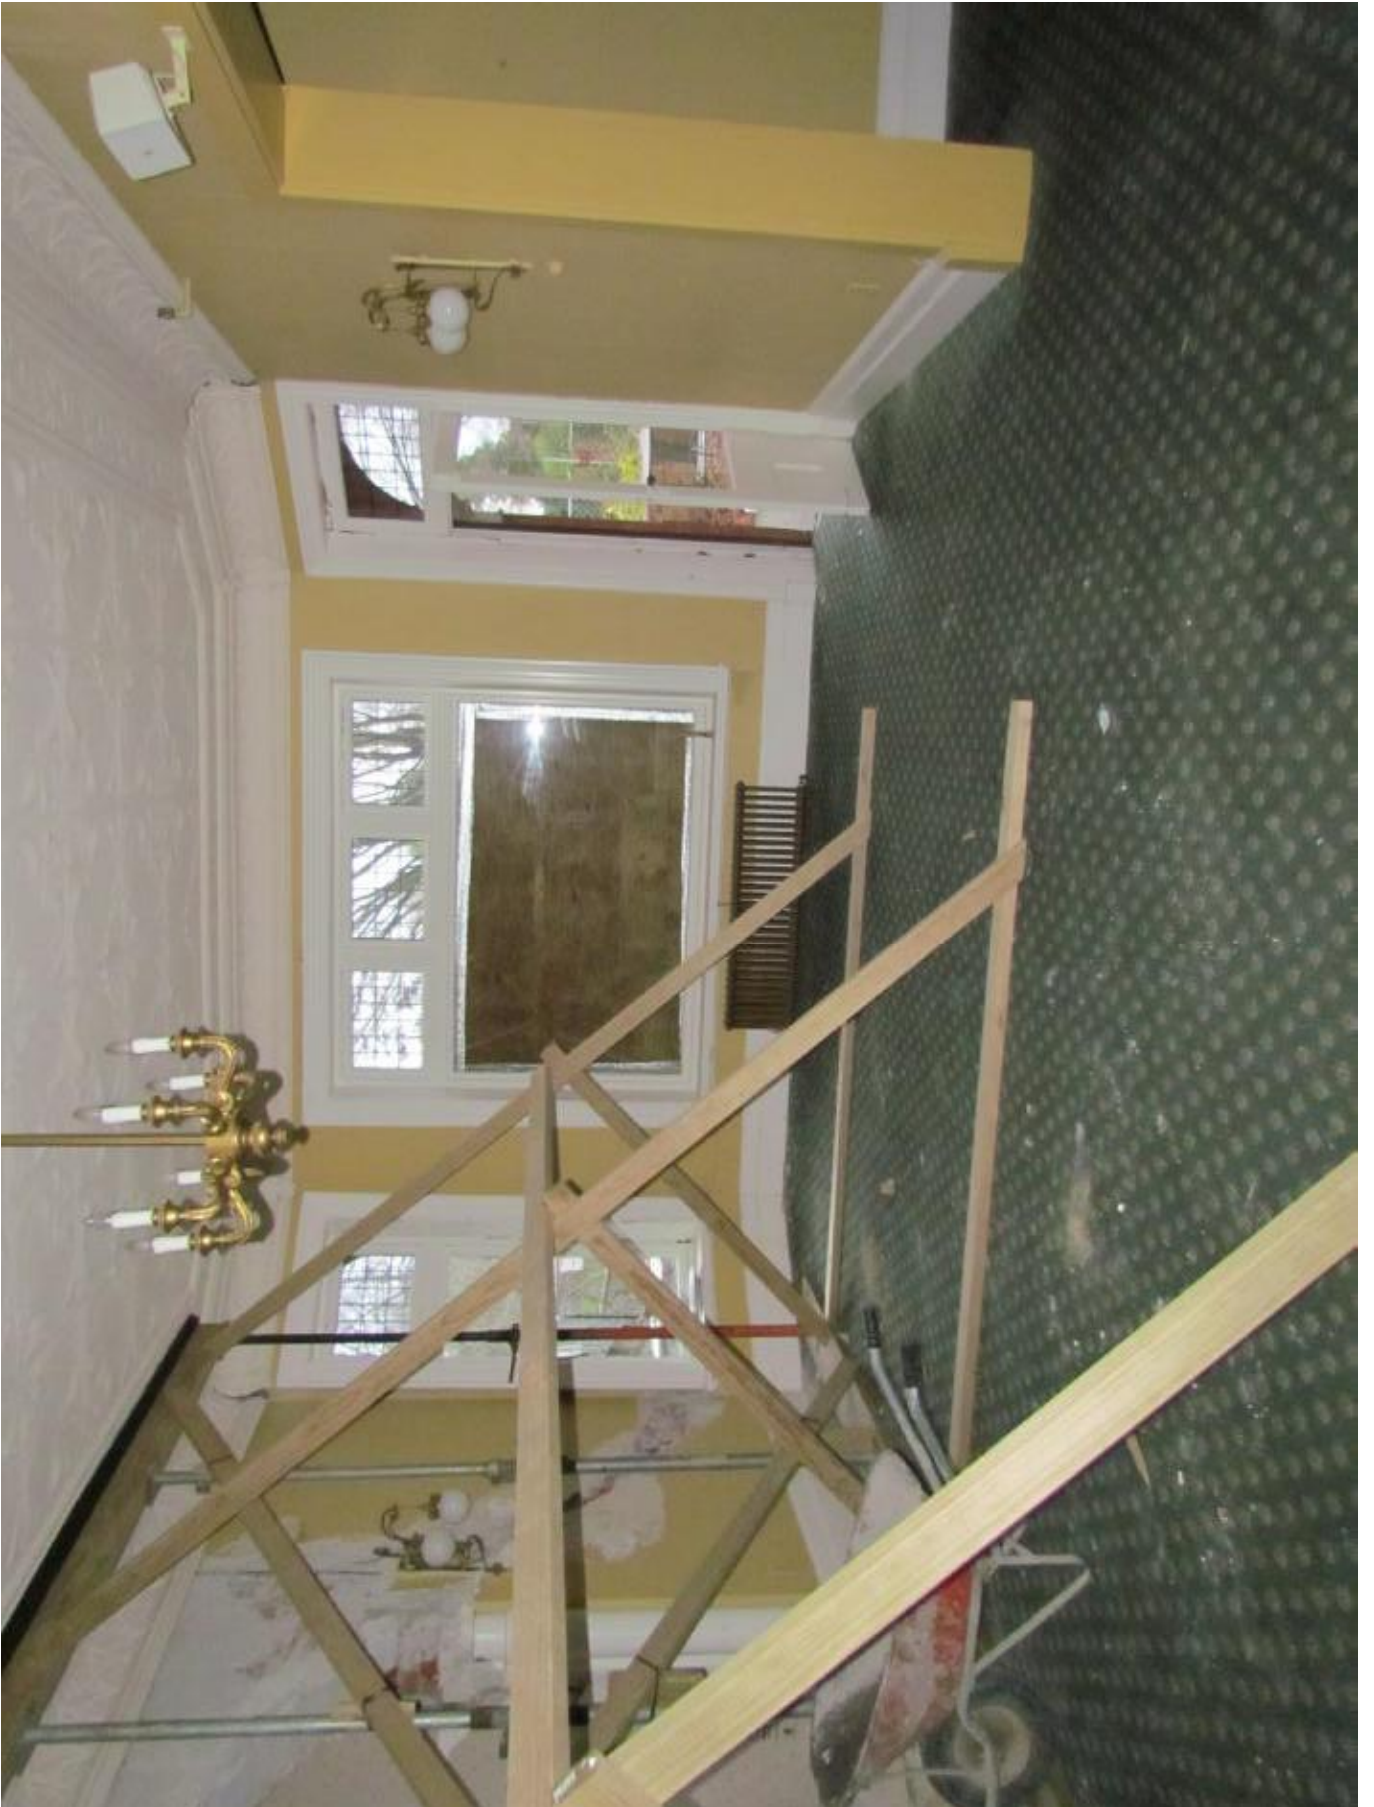
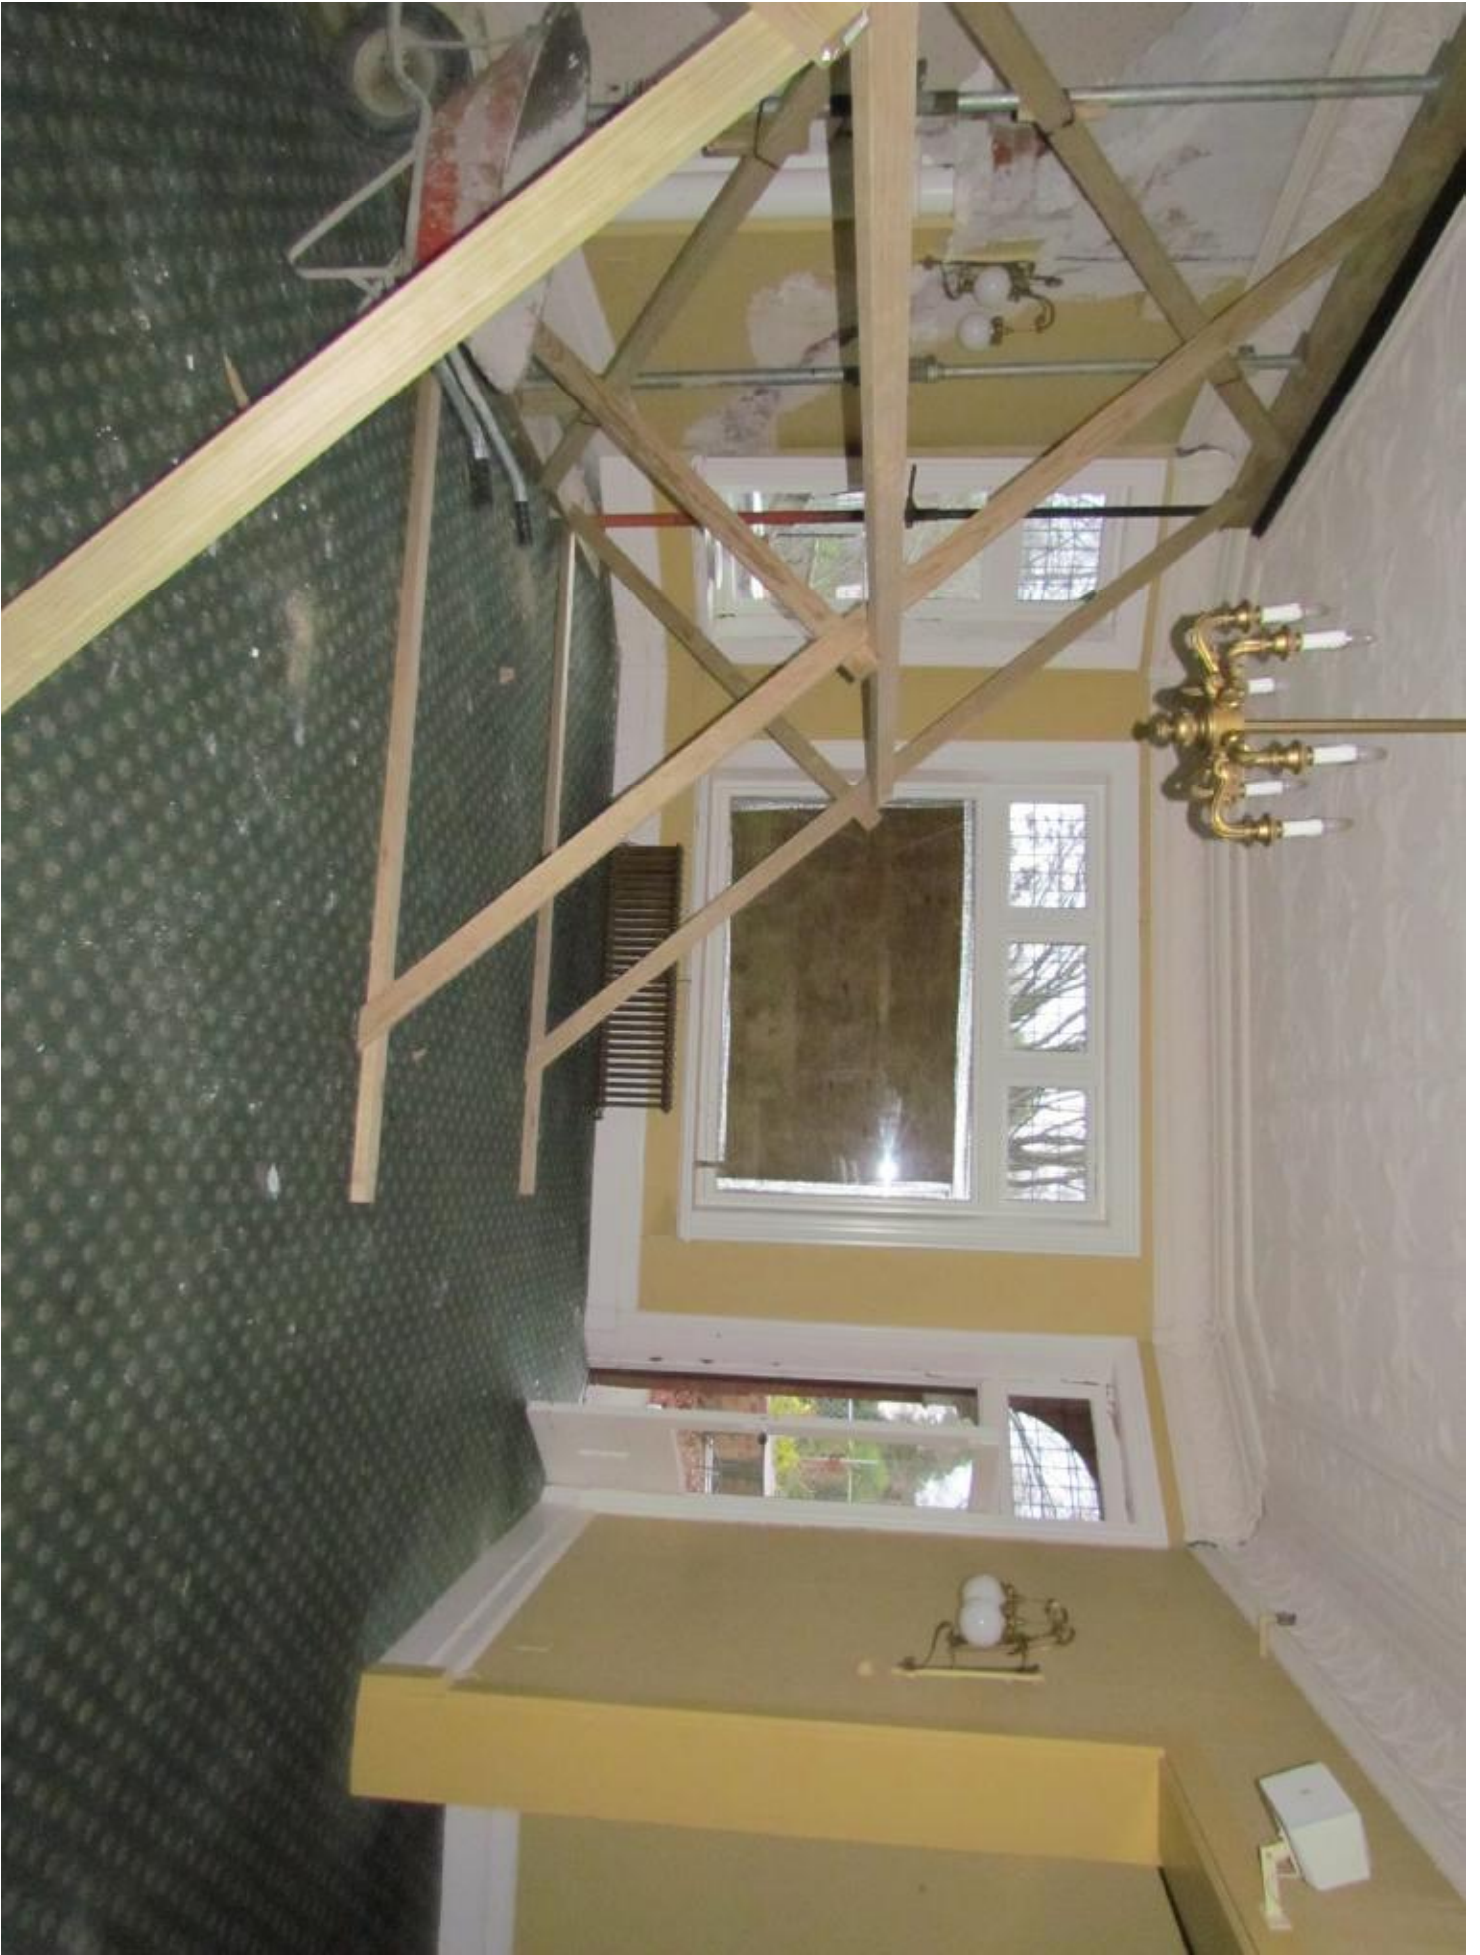
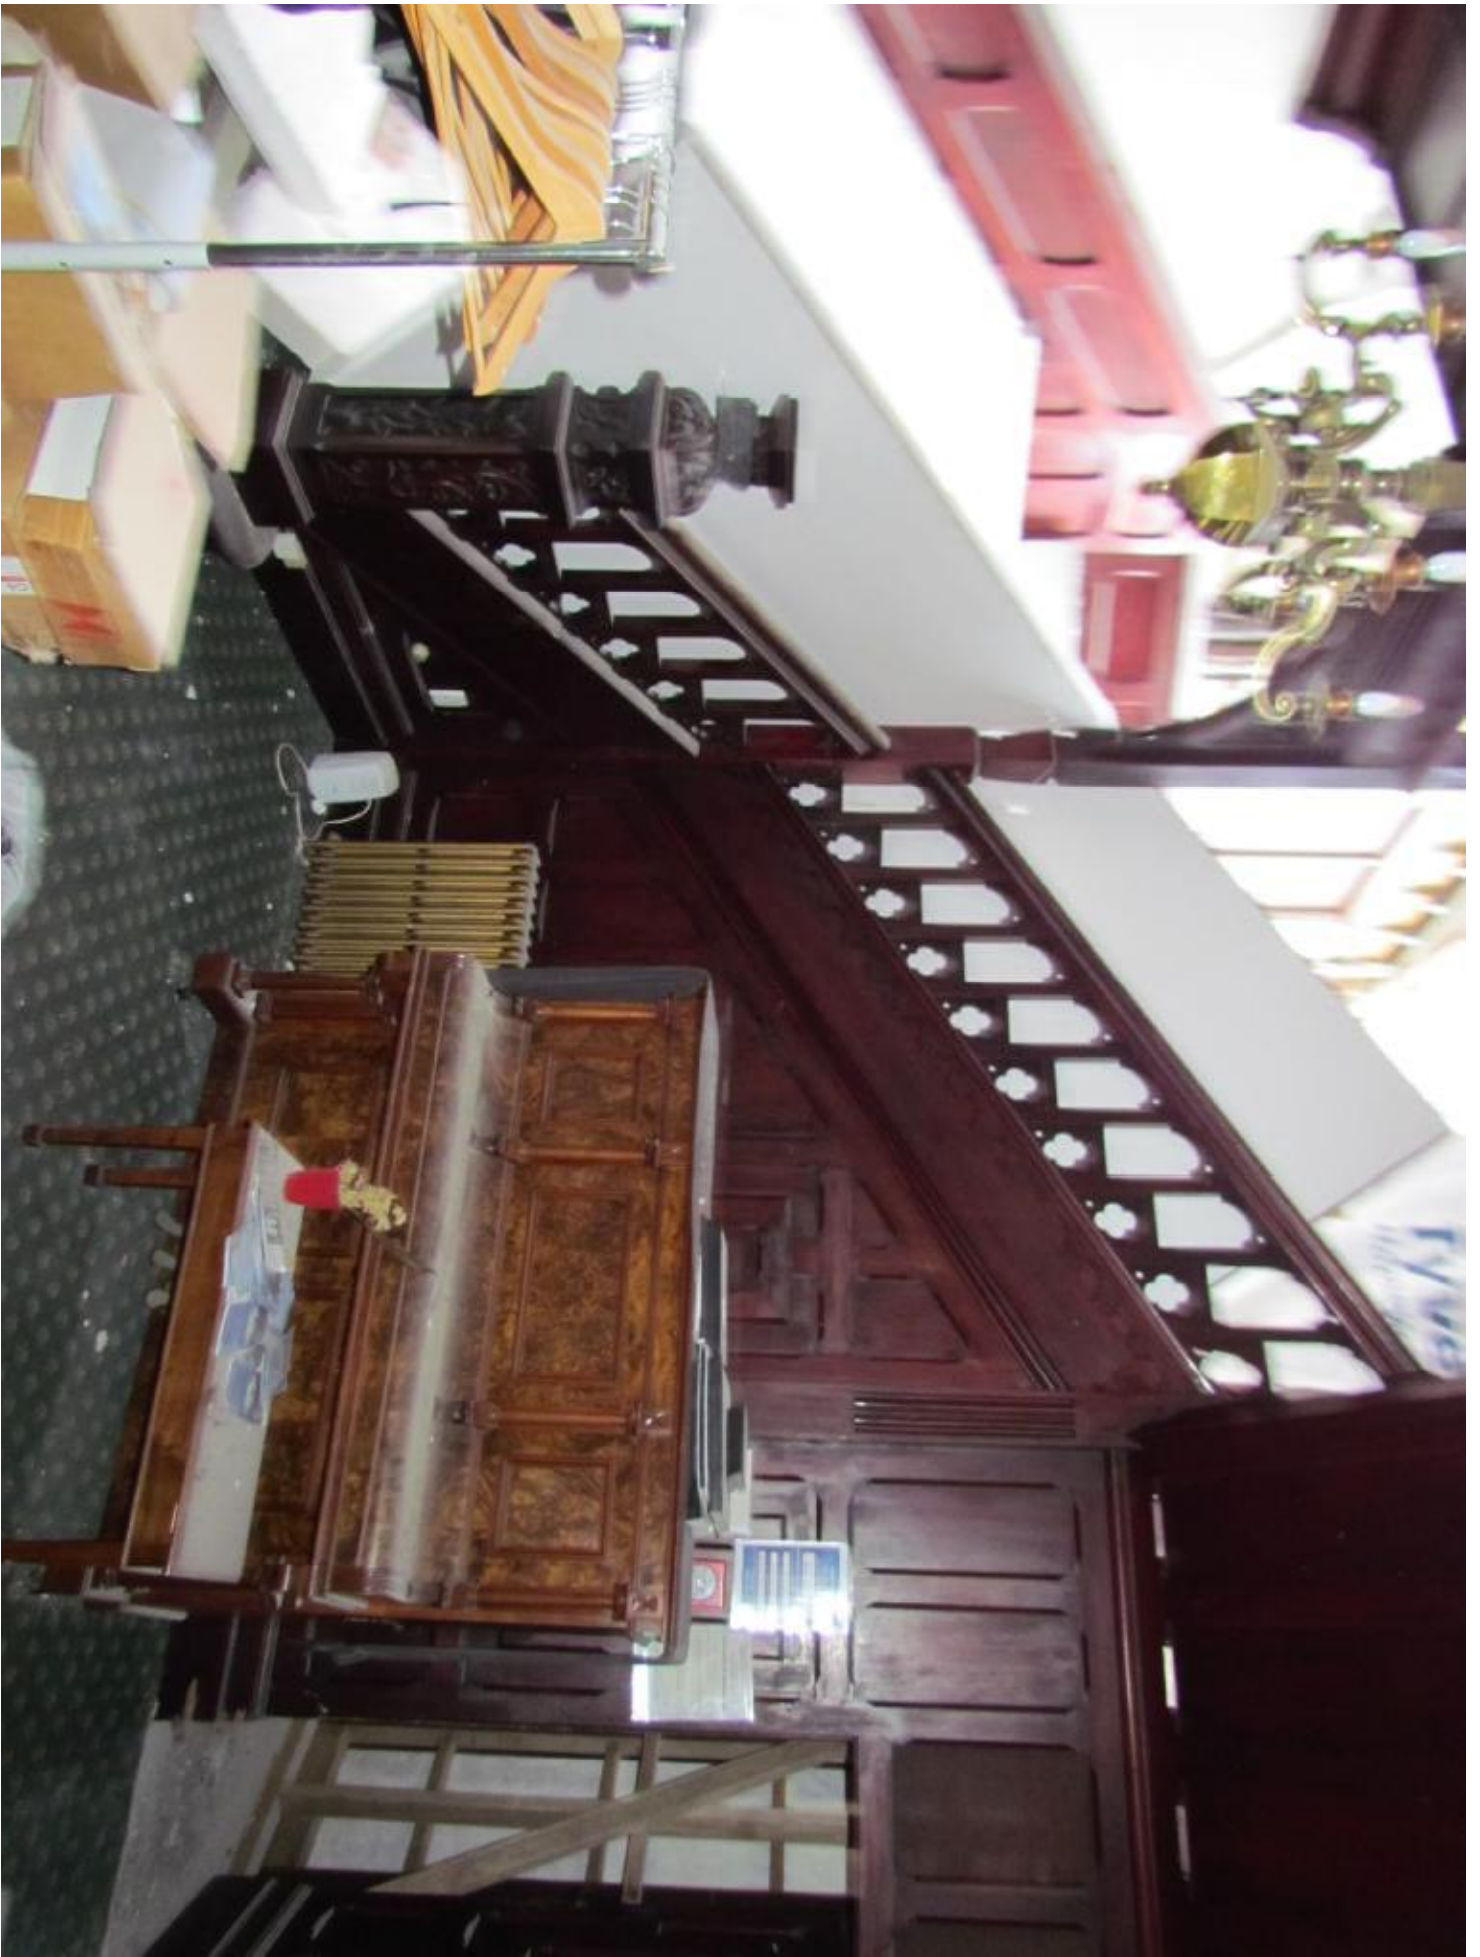
Please note that the photographs provided in this report are not high quality and are for providing information that shows the indicative damage found around the building for structural engineering assessment only.

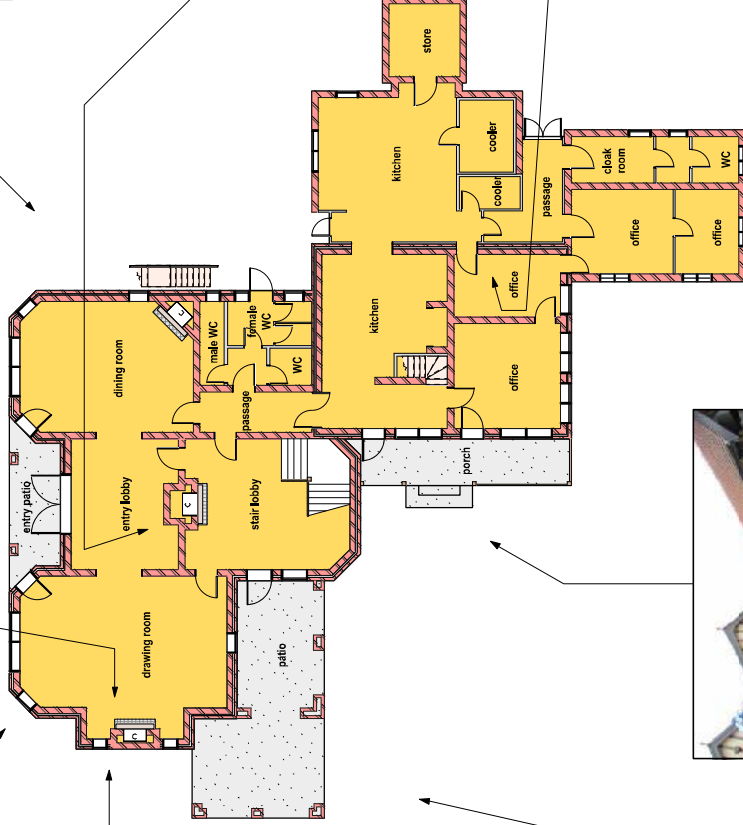
damage to wall around stair lobby
