Christchurch City Council
PRK_0555_BLDG_015 EQ2
Summerhouse Rose Garden
Mona Vale, 65 Fendalton Road

QUALITATIVE ASSESSMENT REPORT
FINAL

- Rev B
- 30 April 2013

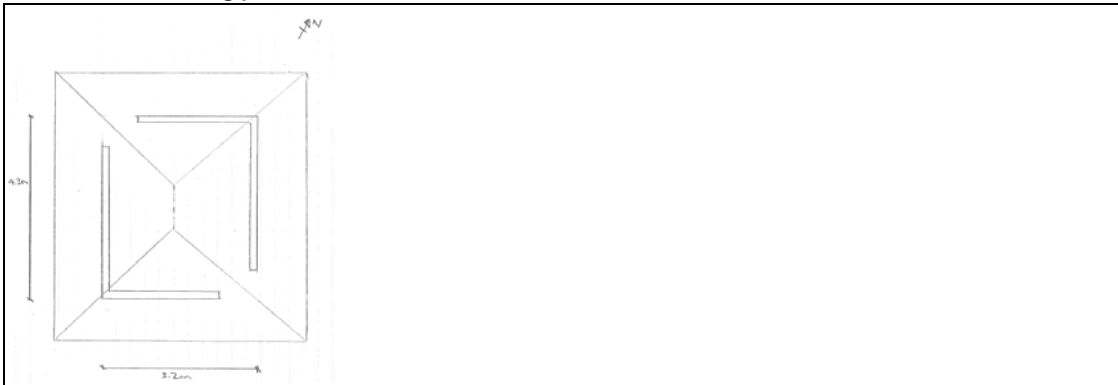
1.2 Sketch of building plan

This is small single storey timber framed structure. It has a timber framed roof that is clad in timber roof shingles. The structure has concrete footings with a concrete floor slab. The plaque inside the building has indicated the building was built in 1994, therefore we have taken a design era of 1992-2004 for our assessment.

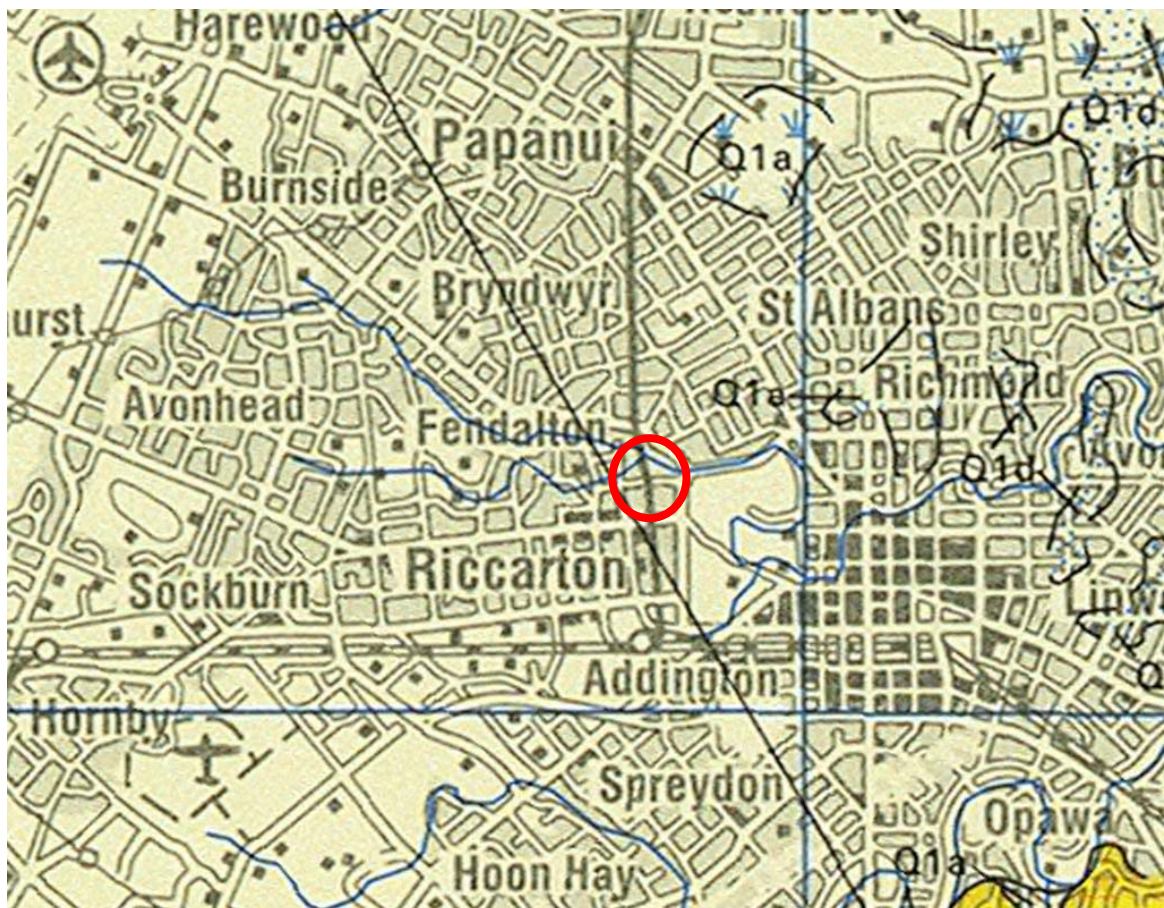
■ Figure 2 – Regional geological map (Forsyth et al, 2008). Site marked in red.

The site is shown to be underlain by Yaldhurst member comprising dominantly alluvial sand and silt overbank deposits of the Christchurch formation. The Avon River approaches to the North of the site.

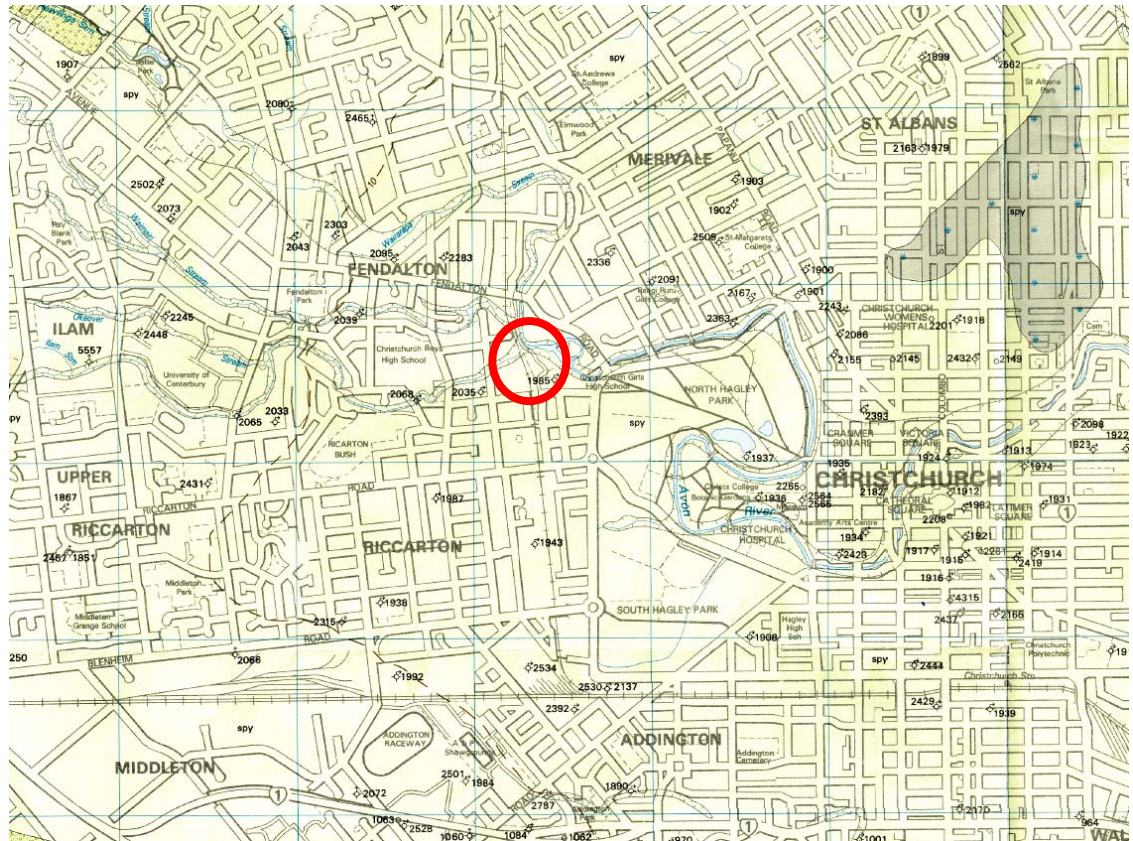
■ Figure 3 – Local geological map (Brown et al, 1992). Site marked in red.

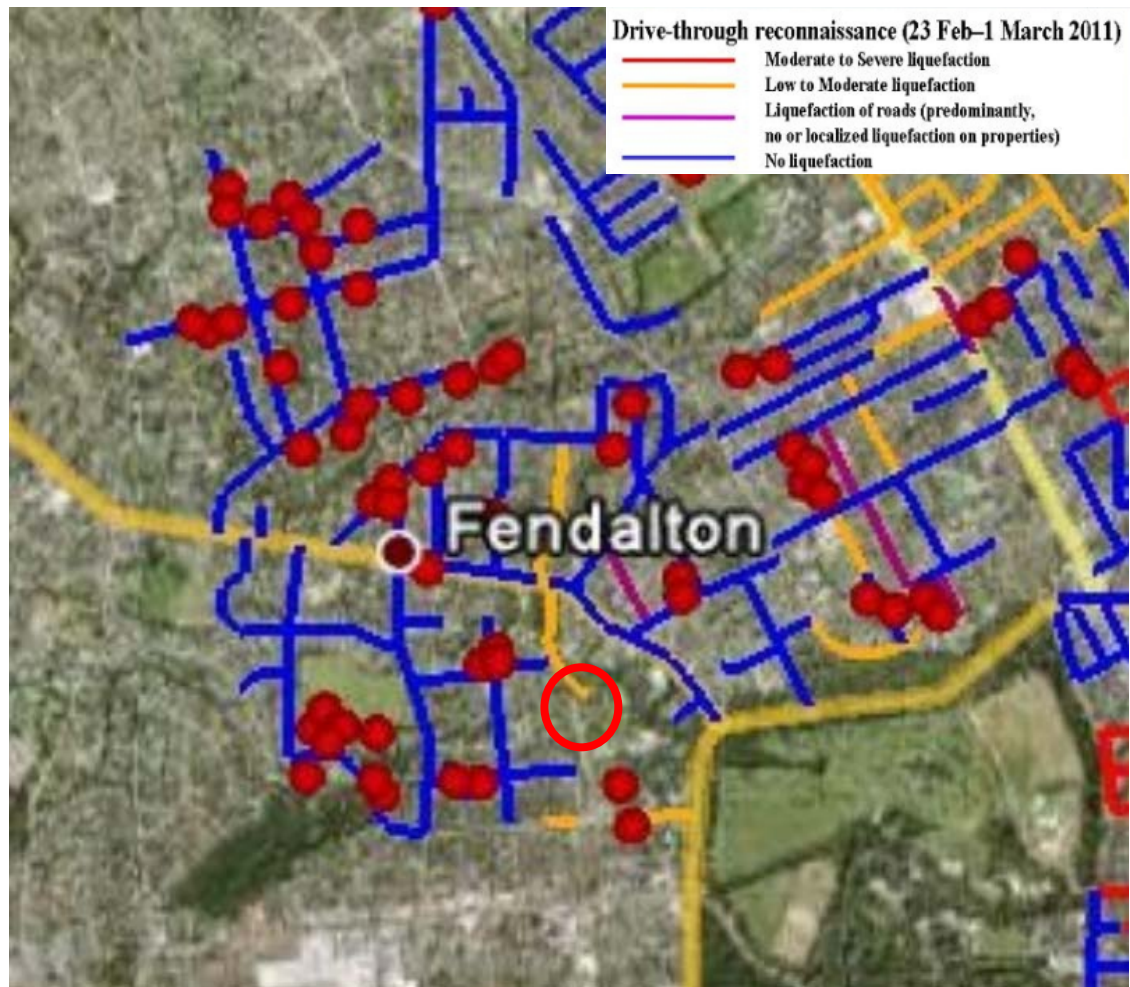
■ Figure 4 – Liquefaction map (Cubrinovski & Taylor, 2011). Site marked in red.

Following the 22 February 2011 event drive through reconnaissance was undertaken from 23 February until 1 March by M Cubrinovski and M Taylor of Canterbury University. Their findings show low to moderate liquefaction was noted near the site.

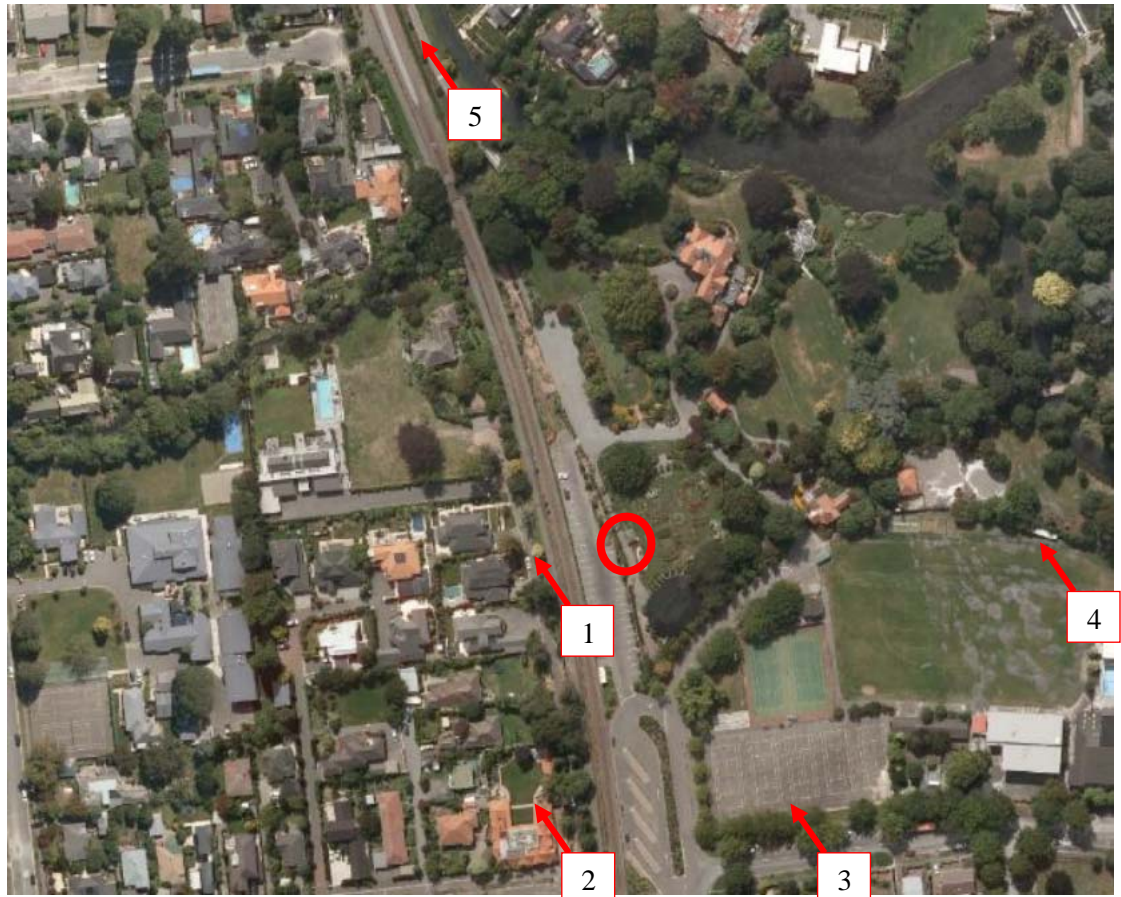
- **Figure 6 – Local boreholes from Project Orbit and SKM files**
(<https://canterburyrecovery.projectorbit.com/>)

Where available logs from these investigation locations are attached to this report (Appendix B), and the results are summarised in Appendix C.

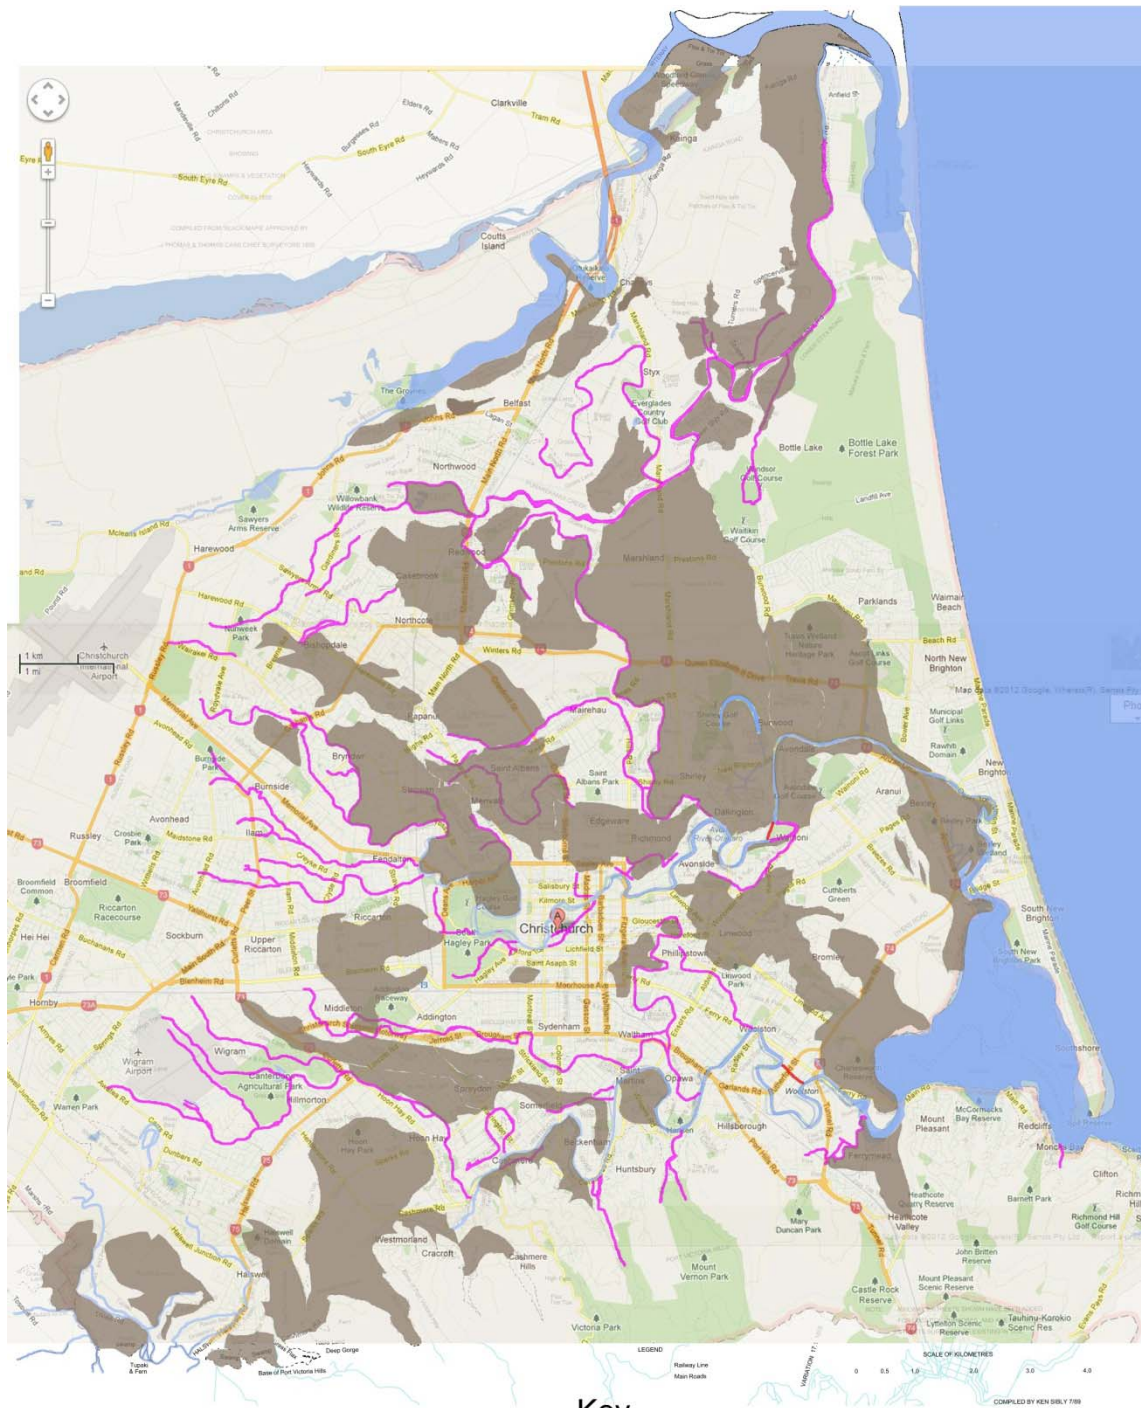
Appendix A – Christchurch 1856 land use

Reference to historical documents (e.g. Appendix A) show that the site lies approximately 150 m south and west of land that was recorded as marshland or swamp in 1856. It is therefore possible that soft or liquefiable ground would be present near the site. Given the relatively low accuracy of these historical documents, it should be considered possible that old swamp deposits are present on the site.

The swamps and previous creeks/ivers from 1856 have been overlayed onto a map of Christchurch in 2012
